**LOWELL REGIONAL WASTEWATER UTILITY
CITY OF LOWELL, MA
PHASE 1 SANITARY SEWER EVALUTION
SURVEYS (SSES) REPORT
KLEINFELDER PROJECT #20220166.003A**

April 11, 2025

PHASE 1 SANITARY SEWER EVALUATION SURVEYS (SSES) REPORT

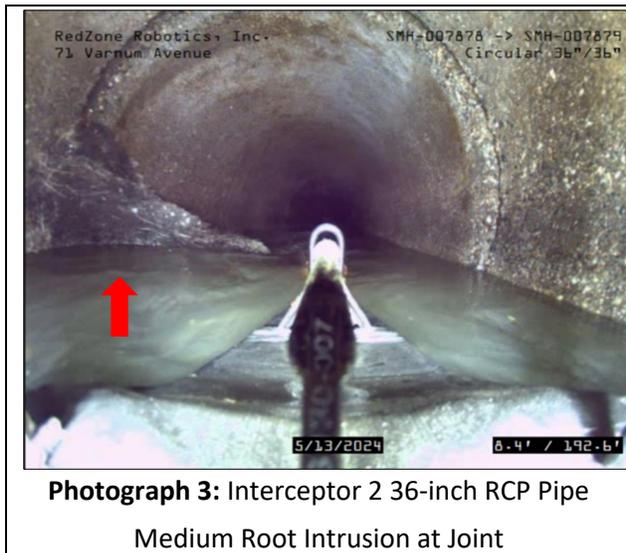
Photograph 3: Interceptor 2 36-inch RCP Pipe
Medium Root Intrusion at Joint

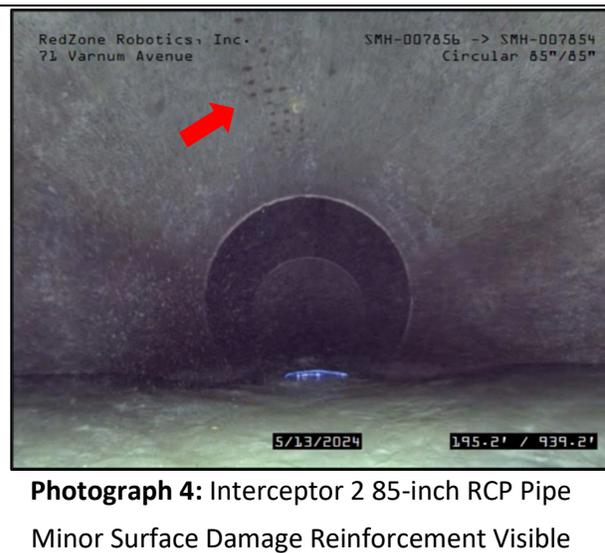
Photograph 4: Interceptor 2 85-inch RCP Pipe
Minor Surface Damage Reinforcement Visible

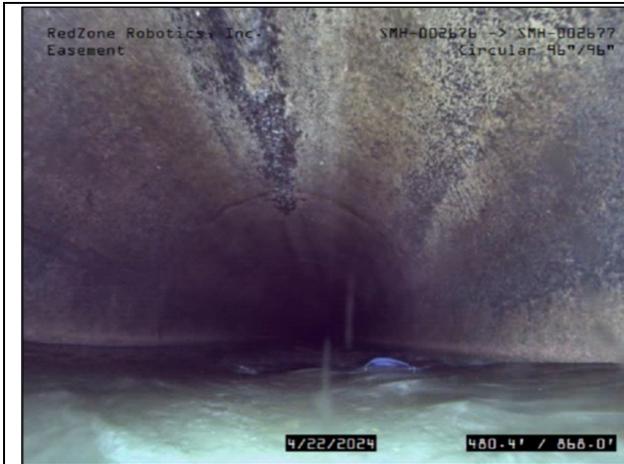
Photograph 5: Interceptor 3 96-inch RCP Pipe
Minor Surface Damage Reinforcement Visible

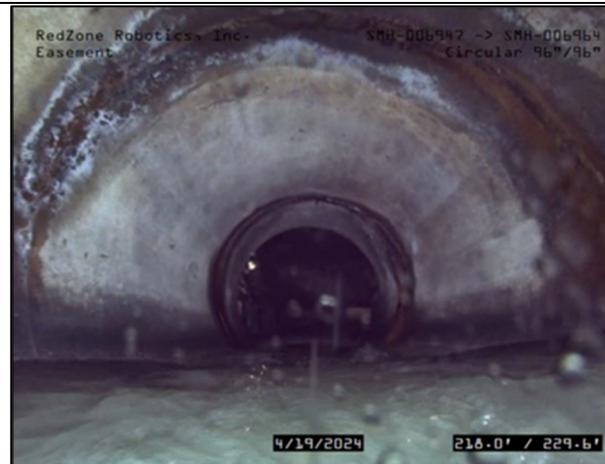
Photograph 6: Interceptor 3 96-inch RCP Pipe
Infiltration at Joint

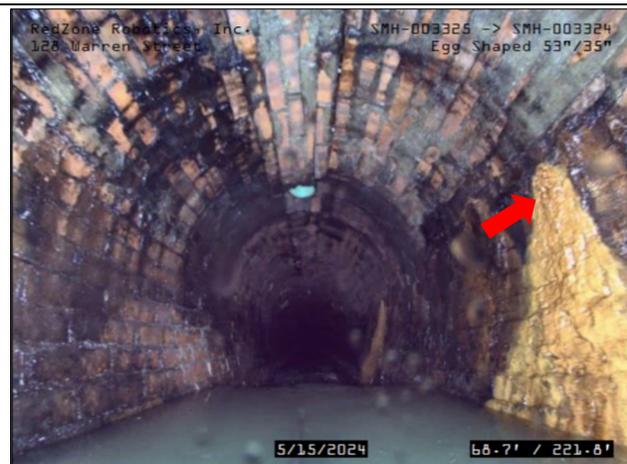
Interceptor 4 is comprised of approximately 4,410 linear feet of 52x35-inch and 32x47-inch brick pipe with an approximately 520-ft section of 48-inch RCP. Its alignment abuts the Pawtucket Canal for a portion and is largely located within Jackson Street and terminates at the Warren Siphon. The majority of maintenance defects in this section were deposits attached encrustation (DAE) and infiltration weepers at barrel (IWB) which were both observed throughout the pipeline. Limited structural defects were surface damage reinforcement visible (SRV) of the small section of RCP in this pipeline and missing bricks and fracture longitudinal (FL) in the brick section. Intersection 4 is subject to higher traffic loadings than other sections which is likely a contributing factor to the structural defects of concern.

Photograph 7: Interceptor 4 53x35-inch Brick Pipe
Barrel Infiltration and Encrustation

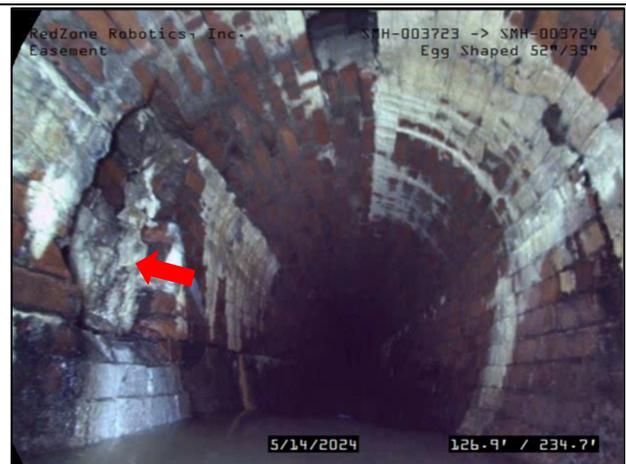
Photograph 8: Interceptor 4 52x35-inch Brick Pipe
Missing Brick

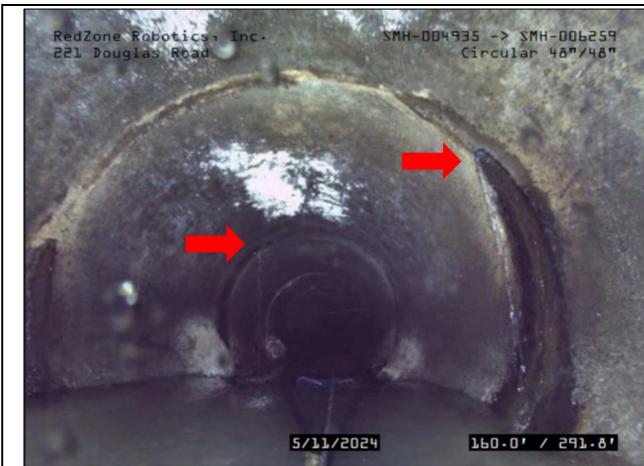
Photograph 11: Interceptor 6 Barasford 48-inch RCP
Infiltration Runner/Gushers at Joint

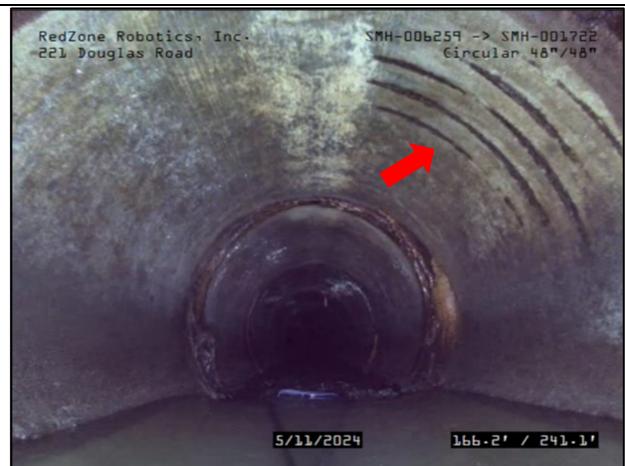
Photograph 12: Interceptor 6 Barasford 48-inch RCP
Moderate Surface Damage Reinforcement Visible

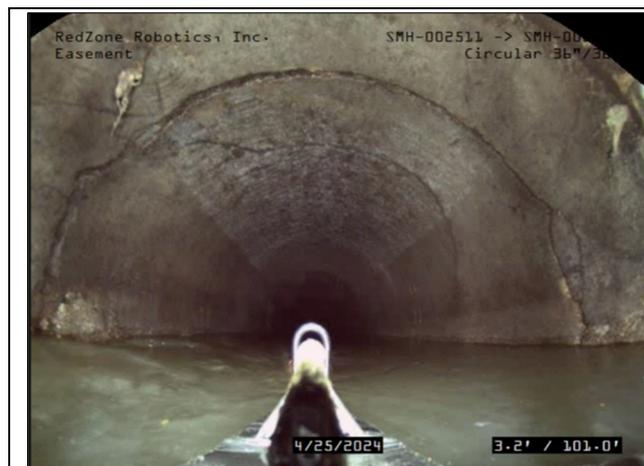
Interceptor 7 is comprised of approximately 4,269 linear feet of 36-inch, 72-inch, and 84-inch RCP along the Lowell Riverwalk abutting the southern boundary of the Merrimack River. The majority of maintenance defects in this section were roots fine at joints (RFJ) and deposits attached ragging (DAR). Most structural defects were surface damage spalling of coating (SSC) and surface damage roughness increased (SRI). The primary defects in Interceptor 7 are several medium roots and structural defects (fractures, one instance of broken pipe) in the downstream 780-ft section of the interceptor.

Photograph 13: Interceptor 7 36-inch RCP
Multiple Fractures

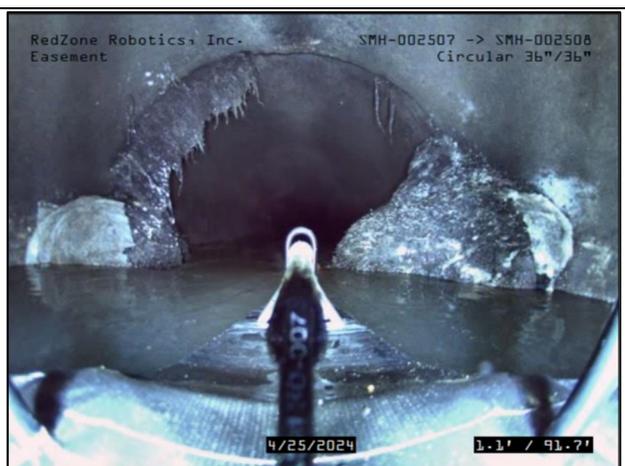
Photograph 14: Interceptor 7 36-inch RCP
Medium Root at Joint

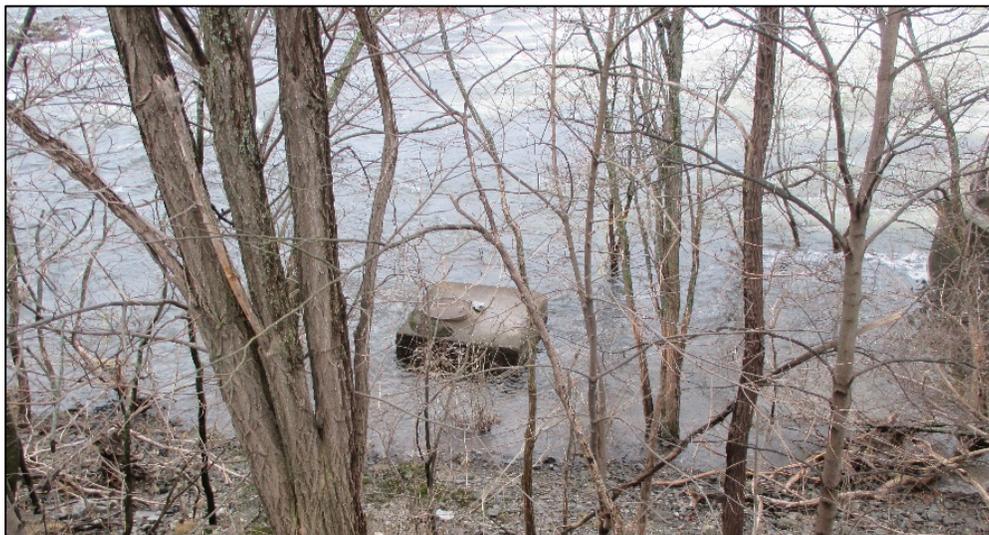
Photograph 21: Pill Box Manhole, Interceptor 2

This portion of Interceptor 2 manholes are located within the river or its banks. Therefore, they are affected by river stages and likely susceptible to submersion.

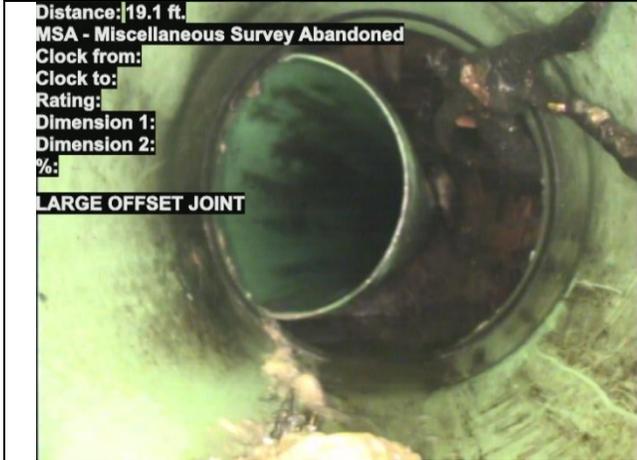
Photograph 15: Hanover Street – Joint Offset Large

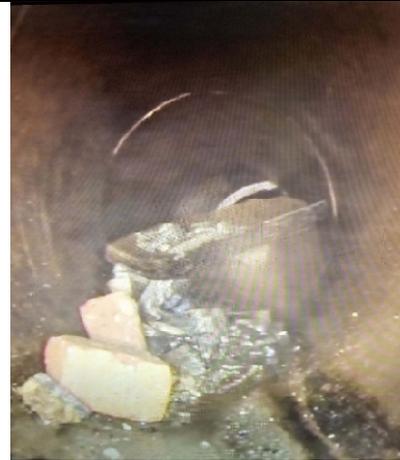
Photograph 16: Hall Street – Collapsed Pipe

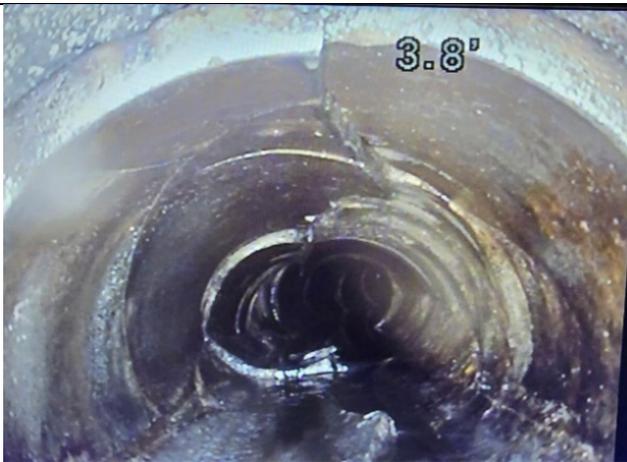
Photograph 17: Church Street – Severe Hinge Fracture

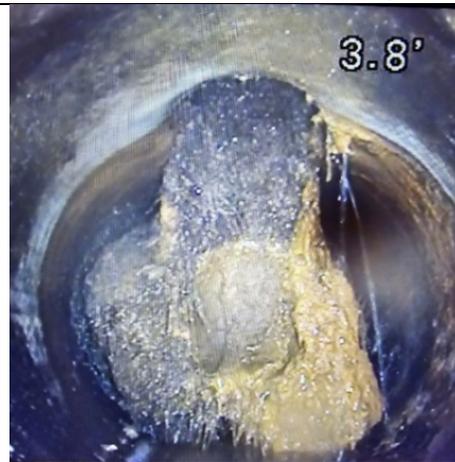
Photograph 18: George Street – Rootball Removed

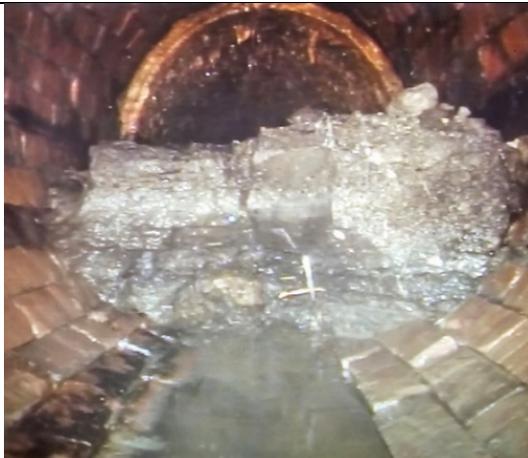
Photograph 19: Lewis Street – Heavy Cleaning

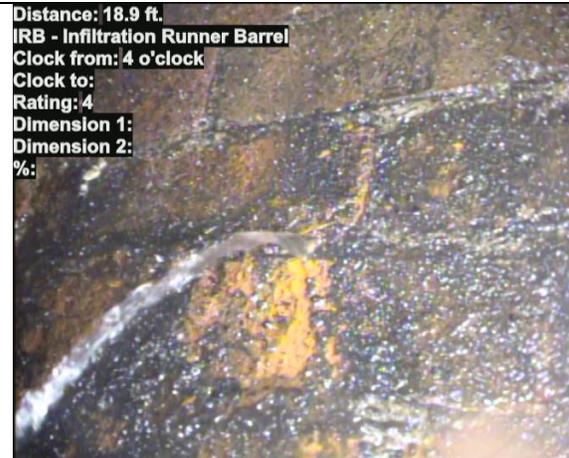
Photograph 20: Dutton Street – Infiltration Runner
