**LOWELL REGIONAL WASTEWATER UTILITY  
CITY OF LOWELL, MA  
2023 INFILTRATION AND INFLOW ANALYSIS REPORT  
KLEINFELDER PROJECT #20220166.003A**

**January 31, 2024**

**LOWELL INFILTRATION AND INFLOW ANALYSIS REPORT  
CITY OF LOWELL, MA**

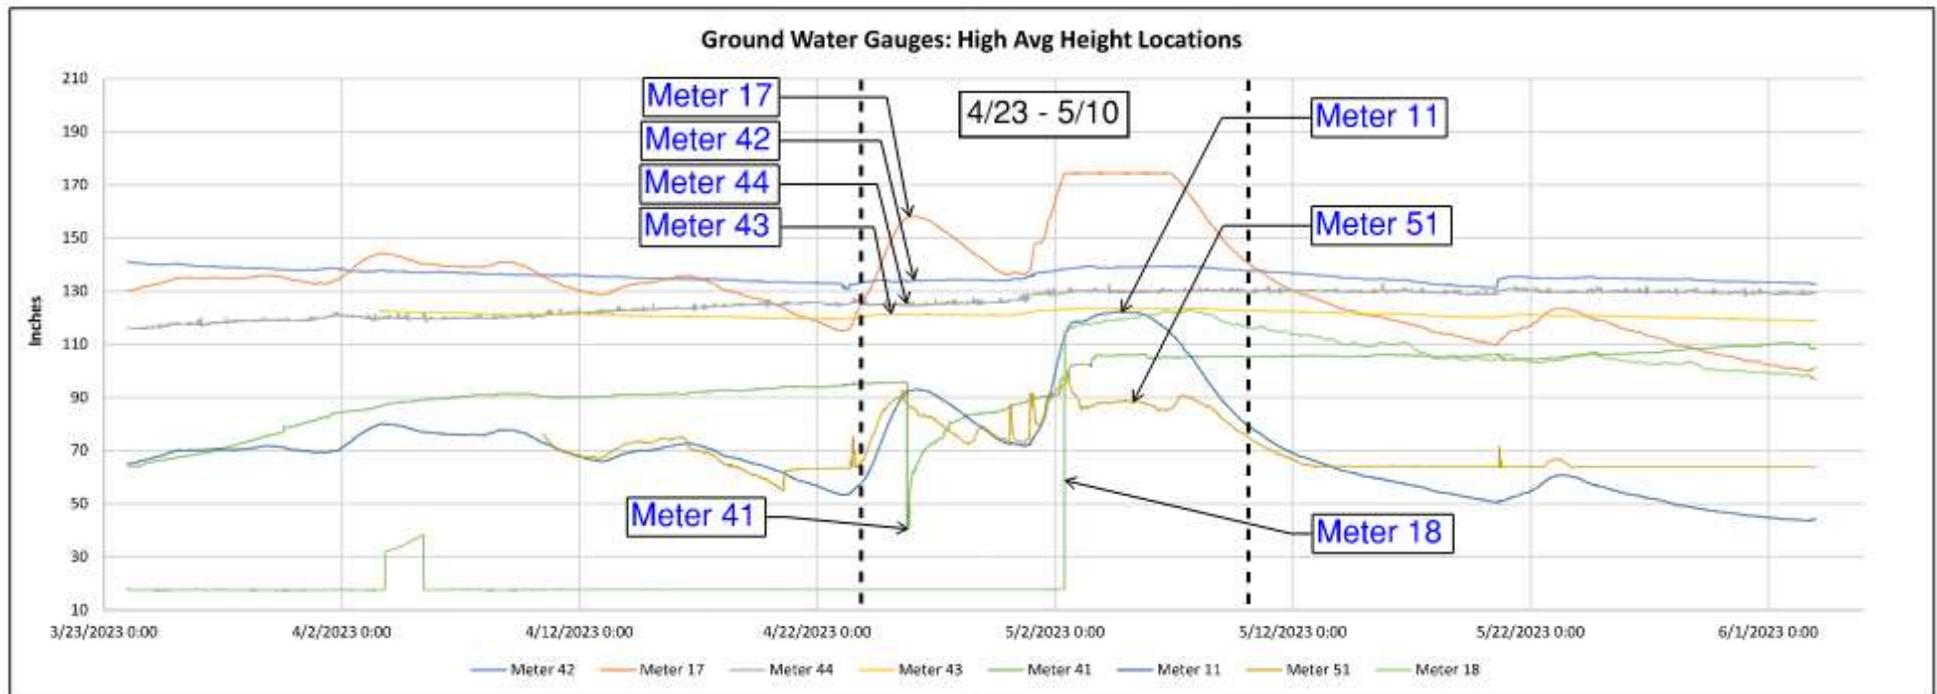
**Figure 6: Highest Average Groundwater Gauge Readings (inches above gauge location)**

**Figure 6** depicts some of the groundwater gauges with the highest average groundwater depths, measured in inches above the gauge install location, that also display peak responses to the wettest portion of the program or remain consistently at a high level throughout the duration of the program. A summary of average depths for all groundwater gauges is included in **Appendix A**. **Figure 7** includes the automatic groundwater gauge locations and displays the average value throughout the metering period associated with its meter area to show relative saturation. These groundwater gauge readings confirm the metering program was conducted during a high groundwater period which, in turn, accurately represents infiltration results from the analysis. This also validates the higher groundwater portions of the City are near waterbodies and validates inspection of pipe adjacent waterbodies or cross-country easement pipe as part of future inspections. During the metering period, the highest groundwater was observed from April 23, 2023 to May 10, 2023. **Figure 8** shows the United States Geological Survey's (USGS) "Merrimack River B: Concord River at Lowell, MA – 01100000" river gauge levels from September 2021 to December 2023, with some of the highest river levels recorded in a similar period of late April/early May 2023. Historically higher levels of the Merrimack River have corresponded to higher treatment flows recorded at Duck Island. **Figure 8** also includes the comparison of Merrimack River levels with Duck Island effluent flow and illustrates the trends in WWTF flows with river levels.

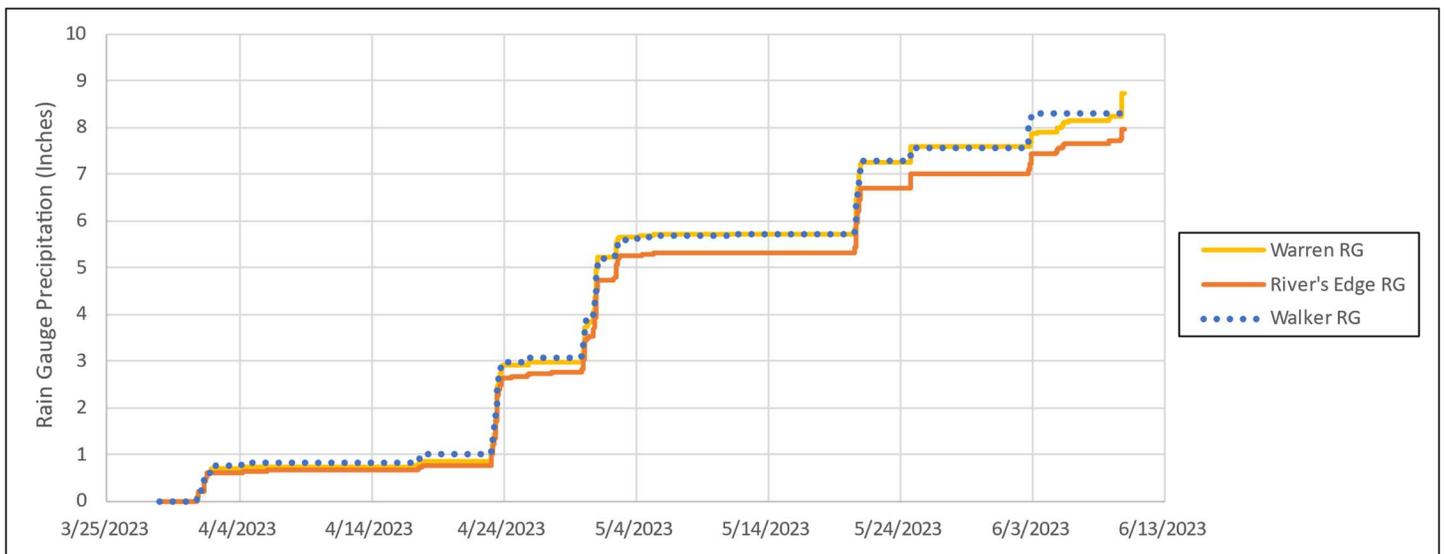
**Figure 9: Rain Gauge Precipitation**

The flow meter program included the installation of three (3) rain gauges evenly distributed throughout the City. The MassDEP Guidelines call for a minimum of 2 rain gauges within the study area as well as preferably one gauge located every 3 to 4 square miles. The City consists of 14.5 square miles and the flow monitoring program was designed to utilize 3 temporary rain gauges and the City’s Duck Island permanent rain gauge. The gauges were installed on March 29, 2023, at the Warren Diversion Structure, Walker Diversion Structure, and River’s Edge Pump Station, shown in **Figure 4** in Section 3.1. The gauges were Rain Alert III with TB-6 tipping bucket and were placed on flat surfaces clear of encroaching trees or building structures. Precipitation readings were recorded in 5-minute intervals. The Utility’s rain gauge at Duck Island had minor maintenance issues during a portion of the metering period and therefore was not used for the analysis due to loss of data. Since then, the gauge has had maintenance performed to restore its typical functionality. Precipitation is recorded to illustrate the impact of rainfall on groundwater levels and to determine inflow rates during different storm events for conversion to designated standard design storms. **Figure 9** presents the cumulative precipitation recorded during the flow metering period for all three (3) rain gauges. During this time, frequent short duration storms were recorded digitally in 5-minute intervals and monitored weekly. Three (3) rain events that exceeded one inch of precipitation were identified during the monitoring period. Of the three storm events that exceeded one inch of precipitation, April 23<sup>rd</sup> and May 20<sup>th</sup> were selected for inflow analysis. The remaining storm selected is the May 24<sup>th</sup> storm event. Dry weather and wet weather distinctions from the average of all three rain gauges are displayed in **Table 3**.

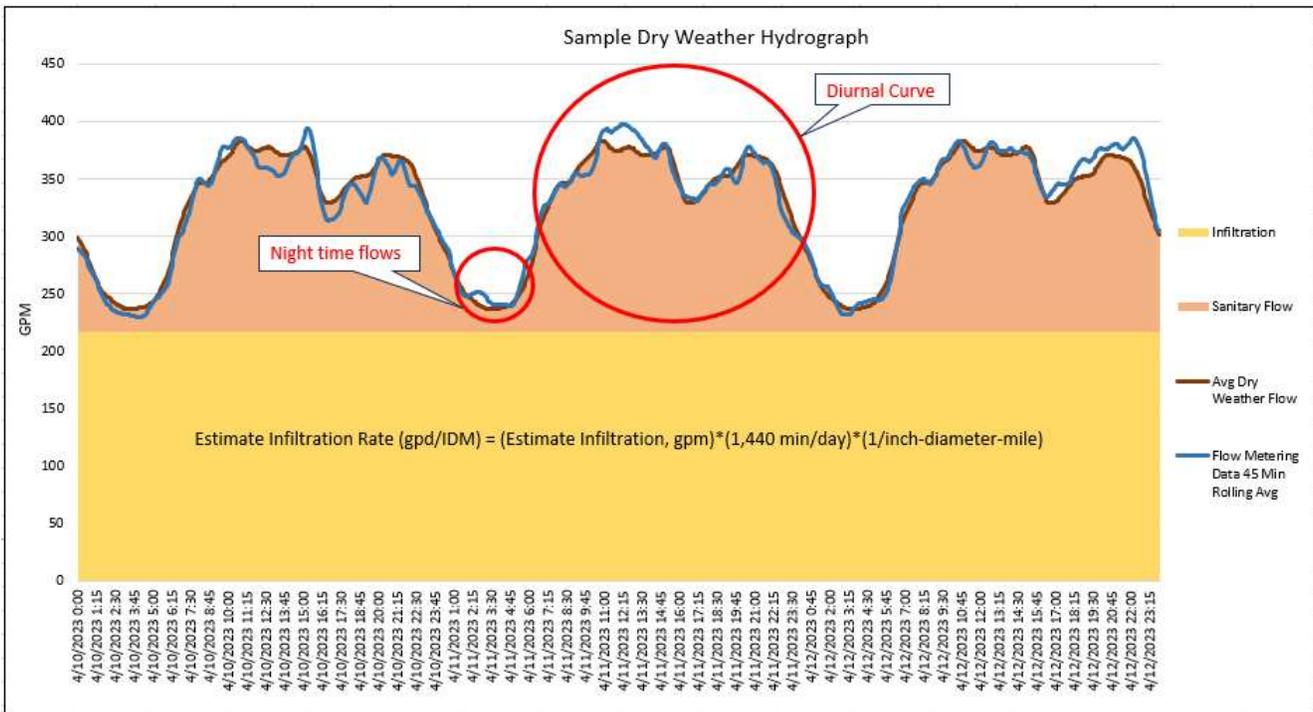
**Figure 10: Sample Dry Weather Hydrograph**

Sanitary flow is defined as the component of wastewater which includes domestic, commercial, institutional, and industrial sewage, and specifically excludes infiltration and inflow. For each metered area, nighttime minimum flows were analyzed to determine the infiltration rate as described above. Sanitary flow is estimated by subtracting the base infiltration rate from metered wastewater flow during dry weather. **Figure 10** illustrates the diurnal sanitary flow curve and the baseflow attributed to infiltration, during dry weather conditions, taken from Meter 1. The corresponding dry weather hydrograph for each metered area is included in **Appendix B**.

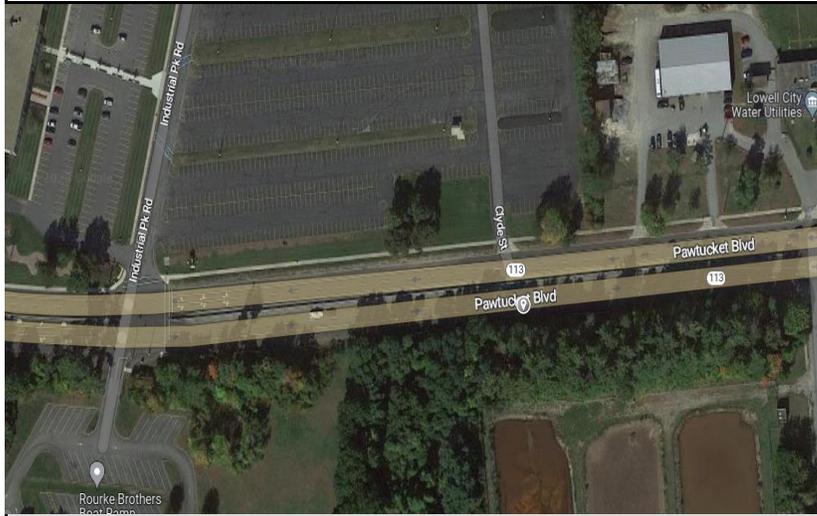
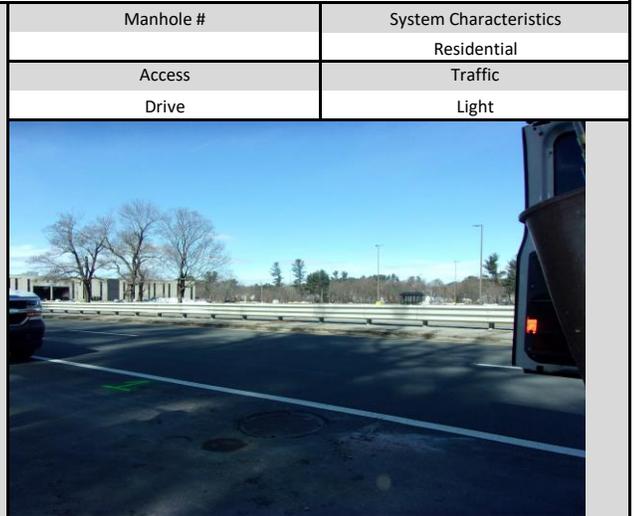
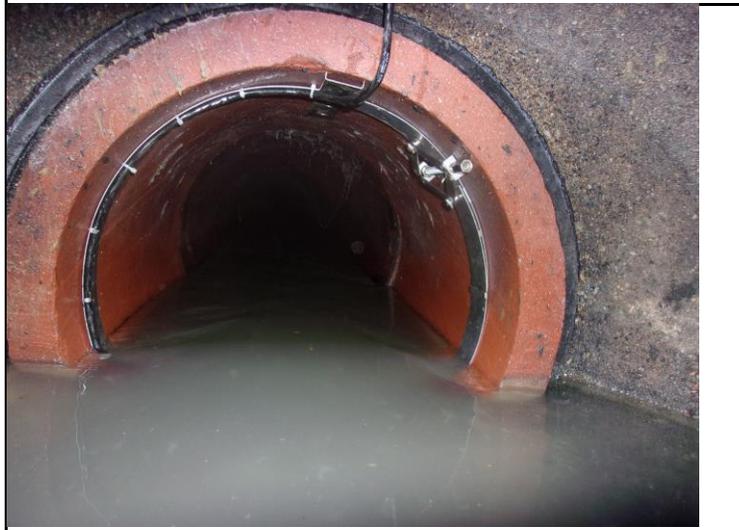
# Meter-1

Site Address / Location:	Coburn St and Lakeview Ave. 42.639879, -71.366122	Monitor Series	TRITON+	Location Type	Temporary
Site Access:	Drive	Pipe Size (H x W)	18.00x18.00	Pipe Shape	Circular

Installation Information	
Installation Date:	Thursday, March 9, 2023
Installation Type:	Doppler Standard Ring and Crank
Monitoring Location (Sensors):	Upstream 0-5 FT
Monitor Location:	Manhole
Sensors / Devices:	AV Max/Peak Combo (CS9)
Pressure Sensor Range (psi)	0 - 5 psi
Installation Confirmation:	
Confirmation Time:	10:24:00 AM
Pipe Size (HxW)	18.00x18.00
Depth of Flow (Wet DOF) (in)	5.77
Range (Air DOF) (in)	12.3
Downlooker Physical Offset (in)	0
Measurement Confidence (in)	0.25"
Peak Velocity (fps)	1.97
Velocity Sensor Offset (in)	0
Silt (in)	0
Silt Type	0
Hydraulic Comments:	
Manhole / Pipe Information:	
Manhole Depth (Approx. inches):	164
Manhole Configuration:	Common Trench
Manhole Material:	Brick
Manhole Condition:	Good
Manhole Opening Diameter (in)	18
Manhole Diameter (Approx.):	18
Manhole Cover:	Concealed
Manhole Frame:	Normal
Active Drop Connections:	No
Air Quality:	Good
Pipe Material:	Brick
Pipe Condition:	Good

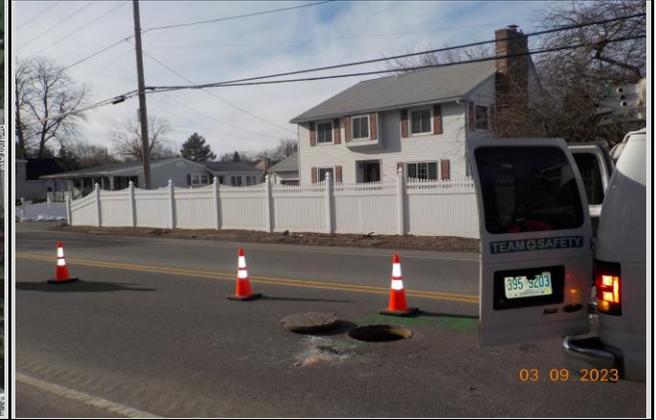
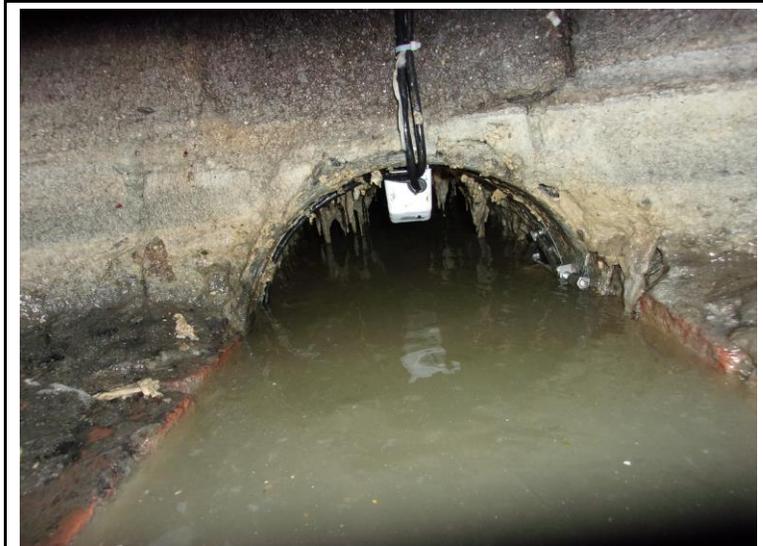
Manhole #	2	System Characteristics	Residential
Access	Drive		Traffic
			Medium

Installation Information	
Installation Date:	Thursday, March 9, 2023
Installation Type:	Doppler Standard Ring and Crank
Monitoring Location (Sensors):	Downstream 0-5 FT
Monitor Location:	Manhole
Sensors / Devices:	AV   Max/Peak Combo (CS9)
Pressure Sensor Range (psi)	0 -5 psi

Installation Confirmation:	
Confirmation Time:	10:39:00 AM
Pipe Size (HxW)	14.00x14.00
Depth of Flow (Wet DOF) (in)	7.33
Range (Air DOF) (in)	4.67
Downlooker Physical Offset (in)	0
Measurement Confidence (in)	0.25"
Peak Velocity (fps)	1
Velocity Sensor Offset (in)	0
Silt (in)	0
Silt Type	0

Manhole / Pipe Information:	
Manhole Depth (Approx. inches):	163.5
Manhole Configuration	Common Trench
Manhole Material:	Brick
Manhole Condition:	Good
Manhole Opening Diameter (in)	28
Manhole Diameter (Approx.):	28
Manhole Cover	Concealed
Manhole Frame	Normal
Active Drop Connections	No
Air Quality:	Good
Pipe Material	
Pipe Condition:	Good

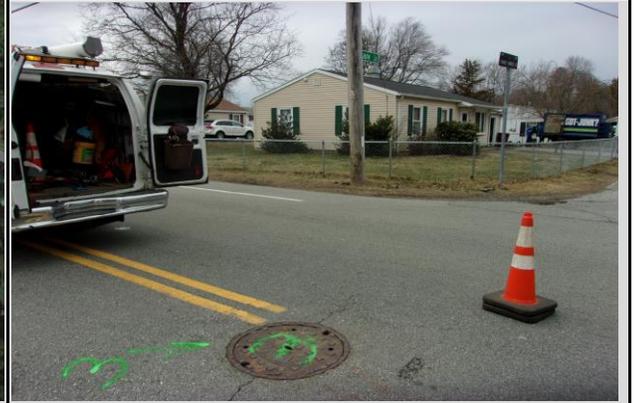
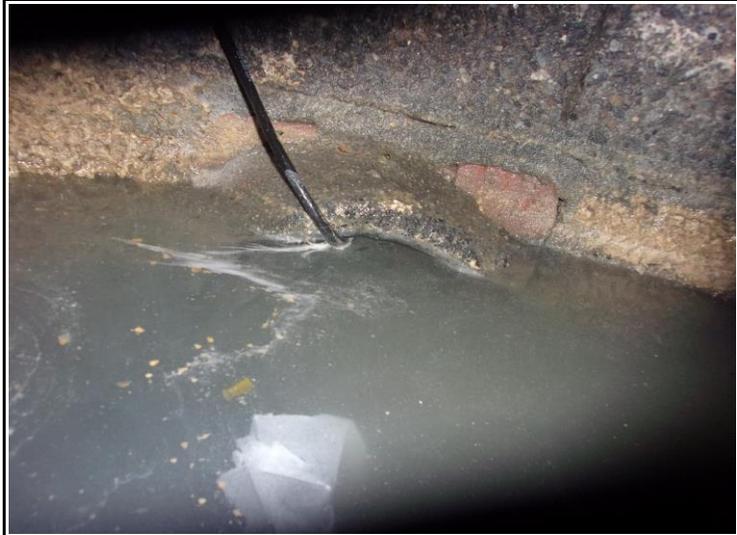
Manhole #	3	System Characteristics	Residential
Access	Drive		Traffic
			Light

Installation Information	
Installation Date:	Monday, March 27, 2023
Installation Type:	Doppler Standard Ring and Crank
Monitoring Location (Sensors):	Upstream 0-5 FT
Sensors / Devices:	AV MAX/Peak Combo (CS9)
Monitor Location:	Manhole
Pressure Sensor Range (psi)	0 - 5 psi
Installation Confirmation:	
Confirmation Time:	3:30:00 PM
Pipe Size (HxW)	15.00x15.00
Depth of Flow (Wet DOF) (in)	13.52
Range (Air DOF) (in)	1.48
Downlooker Physical Offset (in)	0
Measurement Confidence (in)	0.25"
Peak Velocity (fps)	0.82
Velocity Sensor Offset (in)	0
Silt (in)	0
Silt Type	0
Hydraulic Comments:	
Manhole / Pipe Information:	
Manhole Depth (Approx. Inches):	168.13
Manhole Configuration	Common Trench
Manhole Material:	Brick
Manhole Condition:	Good
Manhole Opening Diameter (in)	28
Manhole Diameter (Approx.):	28
Manhole Cover	Concealed
Manhole Frame	Normal
Active Drop Connections	No
Air Quality:	Good
Pipe Material	Concrete
Pipe Condition:	Good

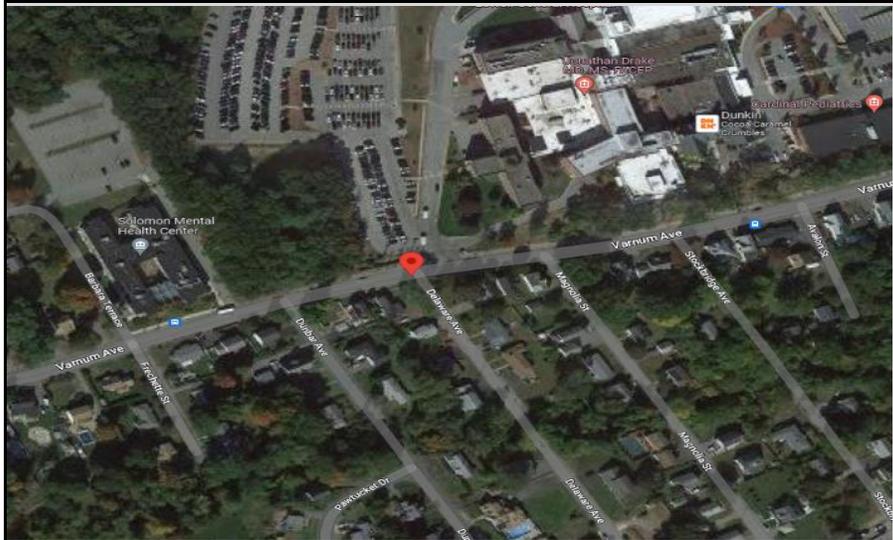
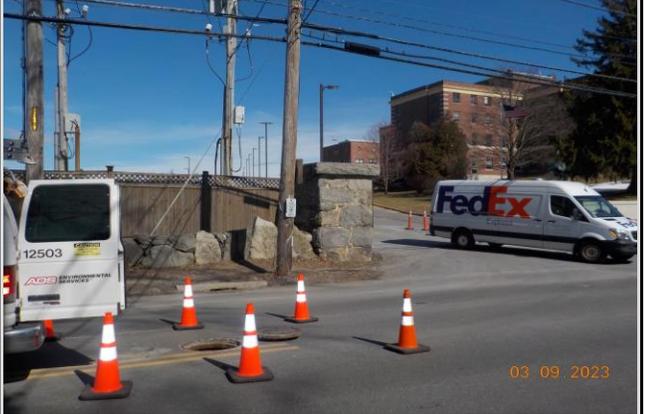
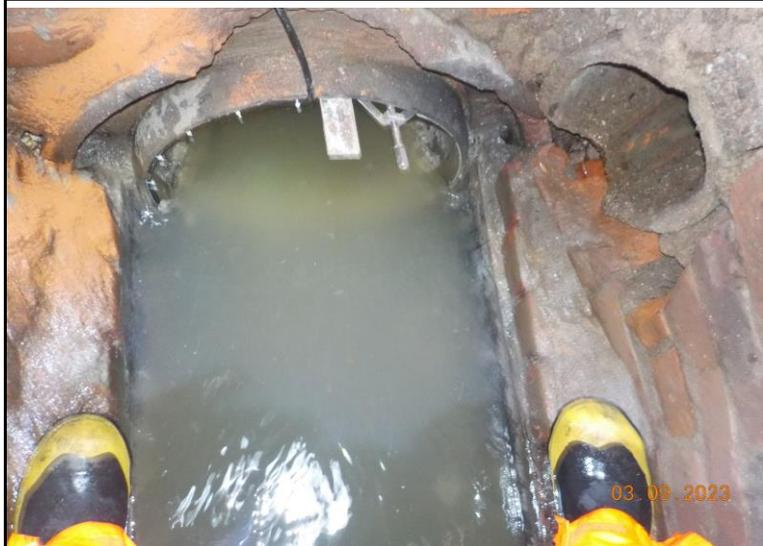
## Meter-4

Site Address / Location:	360 Varnum Ave	Monitor Series	TRITON+	Location Type	Temporary
Site Access:	Drive	Pipe Size (H x W)	17.50x17.510	Pipe Shape	Circular

Installation Information	
Installation Date:	Thursday, March 9, 2023
Installation Type:	Doppler Standard Ring and Crank
Monitoring Location (Sensors):	Upstream 0-5 FT
Monitor Location:	Manhole
Sensors / Devices:	AV   Max/Peak Combo (CS9)
Pressure Sensor Range (psi)	0 - 5 psi
Installation Confirmation:	
Confirmation Time:	10:10:00 AM
Pipe Size (HxW)	17.50x17.50
Depth of Flow (Wet DOF) (in)	9.1
Range (Air DOF) (in)	8.4
Downlooker Physical Offset (in)	0
Measurement Confidence (in)	0.25"
Peak Velocity (fps)	4.26
Velocity Sensor Offset (in)	0
Silt (in)	0
Silt Type	0
Hydraulic Comments:

Manhole / Pipe Information:	
Manhole Depth (Approx. inches):	180.5
Manhole Configuration	Common Trench
Manhole Material:	Brick
Manhole Condition:	Good
Manhole Opening Diameter (in)	28
Manhole Diameter (Approx.):	28
Manhole Cover	Concealed
Manhole Frame	Normal
Active Drop Connections	No
Air Quality:	Good
Pipe Material	PVC
Pipe Condition:	Good
Communication Information:	
Communication Type	Wireless
Antenna Location	Drilled Pavement / Concrete

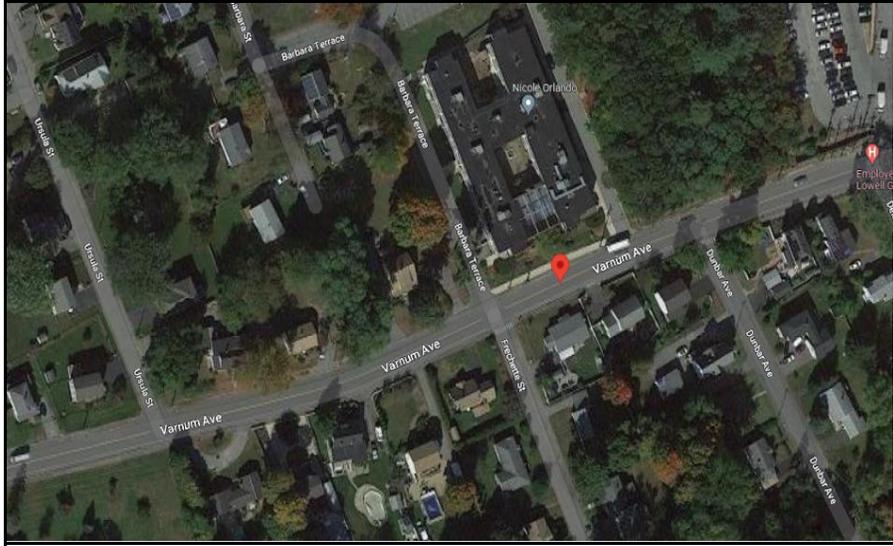
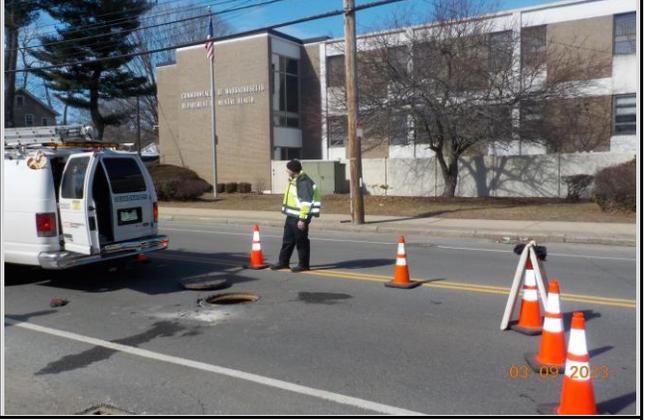
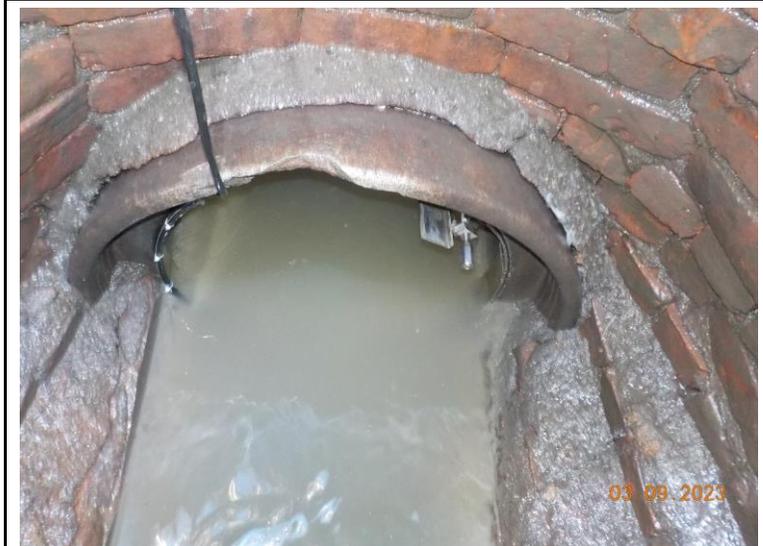
# Meter-5

Site Address / Location:	391 Varnum Ave	Monitor Series	TRITON+	Location Type	Temporary
Site Access:	Drive	Pipe Size (H x W)	17.50x17.50	Pipe Shape	Circular

Installation Date:	Thursday, March 9, 2023	Installation Type:	Doppler Standard Ring and Crank
Monitoring Location (Sensors):	Upstream 0-5 FT	Monitor Location:	Manhole
Sensors / Devices:	AV   Max/Peak Combo (CS9)	Pressure Sensor Range (psi)	0 - 5 psi

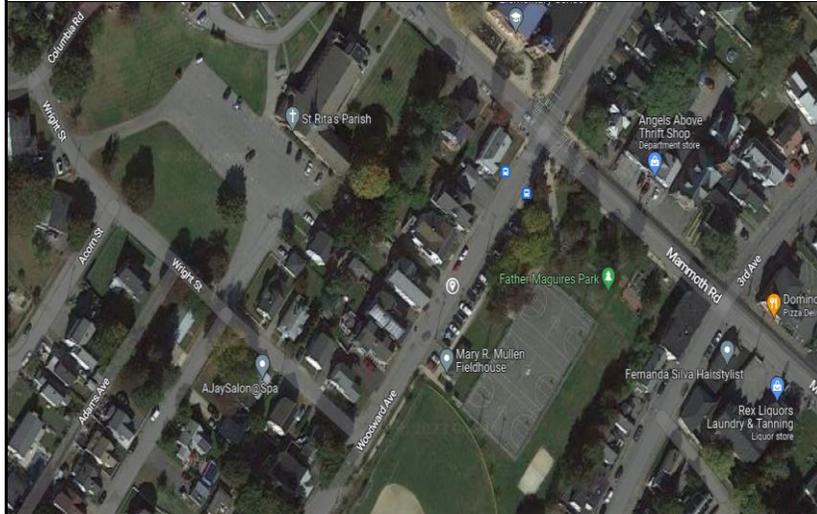
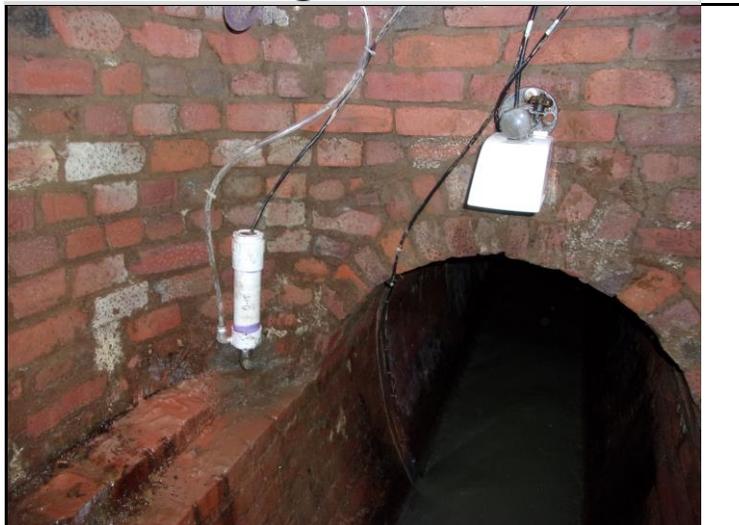
# Meter-6

Site Address / Location:	15 Woodward Ave, Lowell, MA/ 42.651474, -71.335103	Monitor Series	TRITON+	Location Type	Temporary
Site Access:	Drive	Pipe Size (H x W)	50.00x34.50	Pipe Shape	Elliptical

Installation Information	
Installation Date:	Wednesday, March 8, 2023
Installation Type:	Doppler Special Installation
Monitoring Location (Sensors):	Upstream 0-5 FT
Sensors / Devices:	Manhole
	Pressure Sensor Range (psi)
	0 - 5 psi

Installation Confirmation:	
Confirmation Time:	12:42:00 PM
Pipe Size (HxW)	50.00x34.50
Depth of Flow (Wet DOF) (in)	9.92
Range (Air DOF) (in)	40.08
Downlooker Physical Offset (in)	154
Measurement Confidence (in)	0.25"
Peak Velocity (fps)	4.07
Velocity Sensor Offset (in)	3.38
Silt (in)	0
Silt Type	0

Manhole / Pipe Information:	
Manhole Depth (Approx. inches):	210.5
Manhole Configuration	Common Trench
Manhole Material:	Brick
Manhole Condition:	Good
Manhole Opening Diameter (in)	18
Manhole Diameter (Approx.):	18
Manhole Cover	Concealed
Manhole Frame	Normal
Active Drop Connections	No
Air Quality:	Good
Pipe Material	Brick
Pipe Condition:	Good

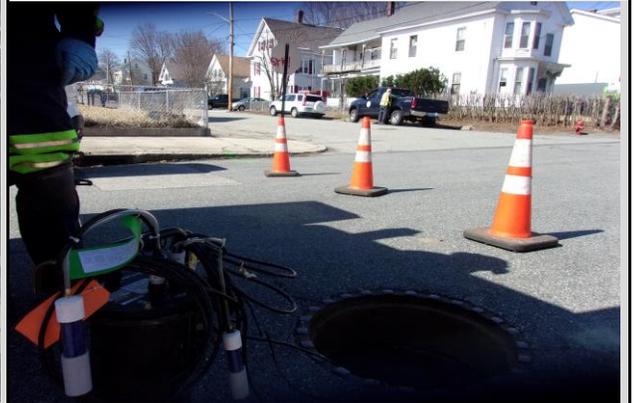
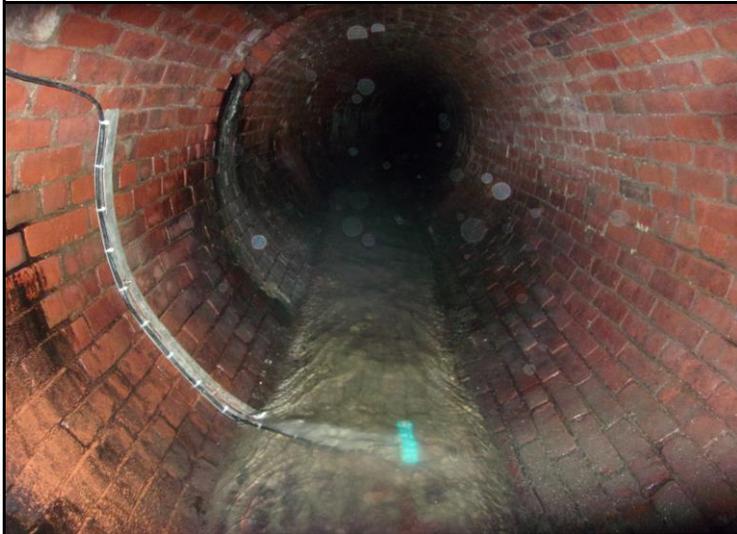
Manhole #	7	System Characteristics	Residential
Access	Drive		Traffic
			Medium

Installation Information	
Installation Date:	Wednesday, March 29, 2023
Installation Type:	Doppler Special Installation
Monitoring Location (Sensors):	Upstream 0-5 FT
Monitor Location:	Manhole
Sensors / Devices:	AV MAX/Peak Combo (CS9)
Pressure Sensor Range (psi)	0 - 5 psi

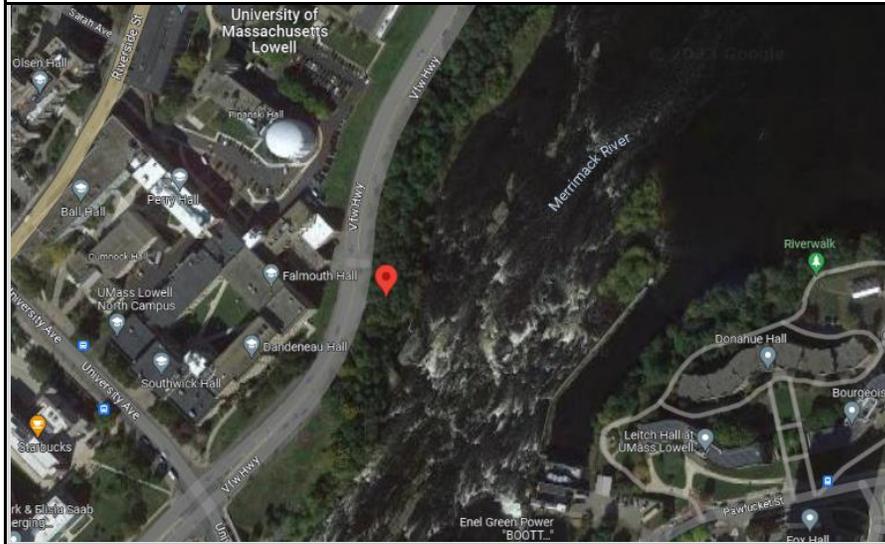
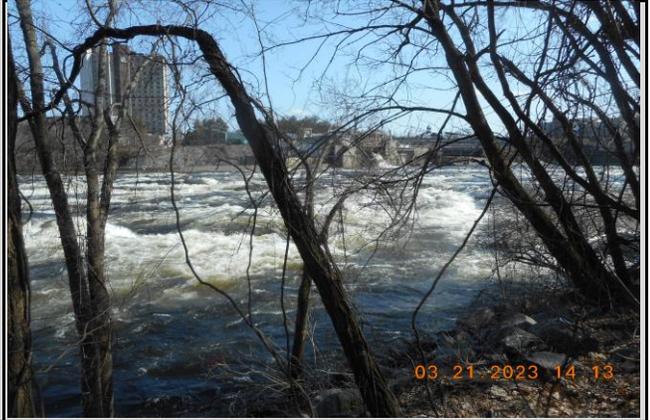
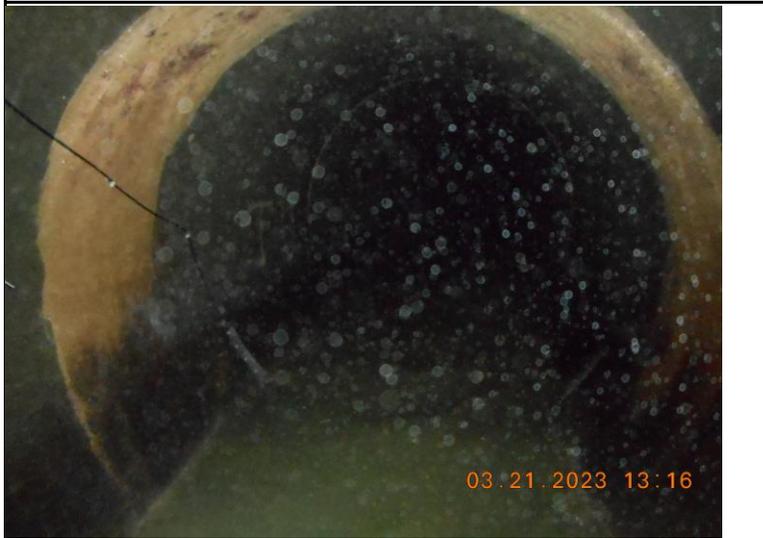
**Meter-8**

Site Address / Location:	Off of VFW highway (42.653674,-71.323815)	Monitor Series	Location Type
Site Access:	Drive	TRITON+	Temporary
		Pipe Size (H x W)	Pipe Shape
		84.00x84.00	Circular

Installation Information	
Installation Date:	Installation Type:
Tuesday, March 21, 2023	Doppler Special Installation
Monitoring Location (Sensors):	Monitor Location:
Upstream 0-5 FT	Manhole
Sensors / Devices:	Pressure Sensor Range (psi)
AV   Max/Peak Combo (CS9)	0 -5 psi
Installation Confirmation:	
Confirmation Time:	Pipe Size (HxW)

2:22:00 PM	84.00x84.00
Depth of Flow (Wet DOF) (in)	Range (Air DOF) (in)
13.11	70.89
Downlooker Physical Offset (in)	Measurement Confidence (in)
0	0.25"
Peak Velocity (fps)	Velocity Sensor Offset (in)

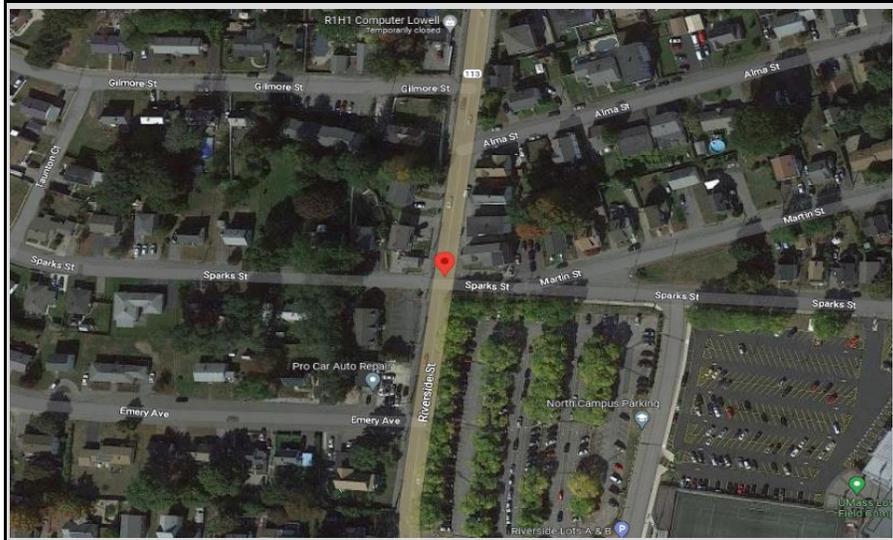
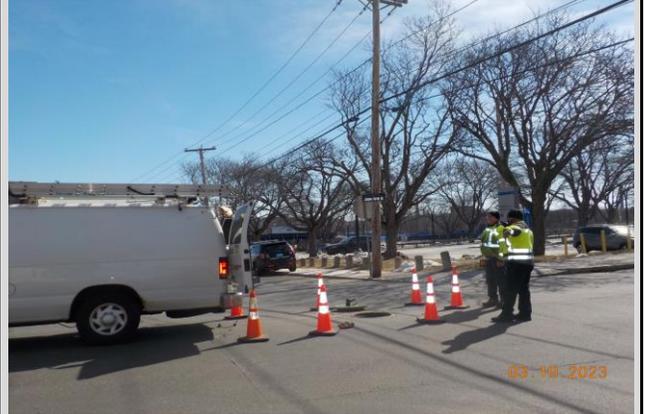
**Meter-9**

Site Address / Location:	Riverside St at Sparks St	Monitor Series	TRITON+	Location Type	Temporary
Site Access:	Drive	Pipe Size (H x W)	49.50x45.75	Pipe Shape	Elliptical

Installation Information	
Installation Date:	Friday, March 10, 2023
Installation Type:	Doppler Special Installation
Monitoring Location (Sensors):	Upstream 0-5 FT
Monitor Location:	Manhole
Sensors / Devices:	AV   Max/Peak Combo (CS9)
Pressure Sensor Range (psi)	0 -5 psi
Installation Confirmation:	
Confirmation Time:	10:04:00 AM
Pipe Size (HxW)	49.50x45.75
Depth of Flow (Wet DOF) (in)	1.2
Range (Air DOF) (in)	48.3
Downlooker Physical Offset (in)	0
Measurement Confidence (in)	0.25"
Peak Velocity (fps)	2.73
Velocity Sensor Offset (in)	0
Silt (in)	0
Silt Type	0
Hydraulic Comments:	
Manhole / Pipe Information:	
Manhole Depth (Approx. inches):	120.25
Manhole Configuration	Common Trench
Manhole Material:	Brick
Manhole Condition:	Good
Manhole Opening Diameter (in)	28
Manhole Diameter (Approx.):	28
Manhole Cover	Concealed
Manhole Frame	Normal
Active Drop Connections	No
Air Quality:	Good
Pipe Material	Brick
Pipe Condition:	Good
Communication Information:

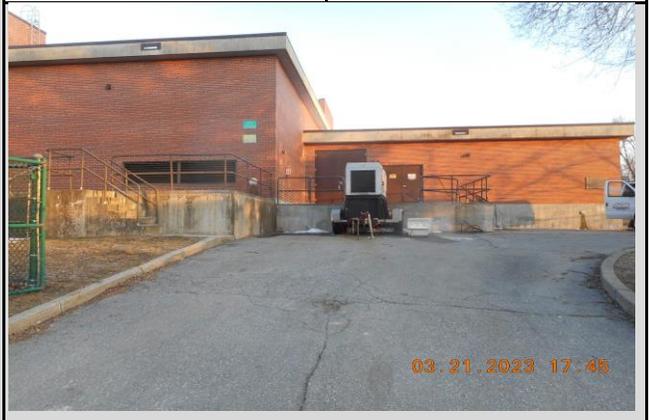
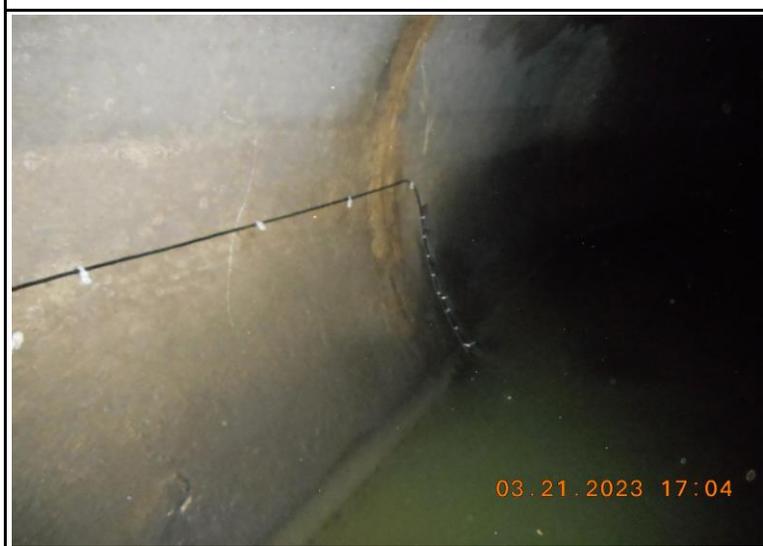
Manhole #	10	System Characteristics	Residential
Access	Drive		Traffic
			None

Installation Information	
Installation Date:	Tuesday, March 21, 2023
Installation Type:	Doppler Special Installation
Monitoring Location (Sensors):	Upstream 0-5 FT
Monitor Location:	Manhole
Sensors / Devices:	AV   Max/Peak Combo (CS9)
Pressure Sensor Range (psi)	0 -5 psi
Installation Confirmation:	
Confirmation Time:	6:20:00 PM
Pipe Size (HxW)	96.00x96.00
Depth of Flow (Wet DOF) (in)	17.98
Range (Air DOF) (in)	78.02
Downlooker Physical Offset (in)	0
Measurement Confidence (in)	0.25"
Peak Velocity (fps)	2.21
Velocity Sensor Offset (in)	0
Silt (in)	0
Silt Type	0
Hydraulic Comments:

Manhole / Pipe Information:	
Manhole Depth (Approx. inches):	144
Manhole Configuration	Common Trench
Manhole Material:	Concrete
Manhole Condition:	Good
Manhole Opening Diameter (in)	28
Manhole Diameter (Approx.):	28
Manhole Cover	
Manhole Frame	
Active Drop Connections	No
Air Quality:	Good
Pipe Material	Concrete
Pipe Condition:	Good

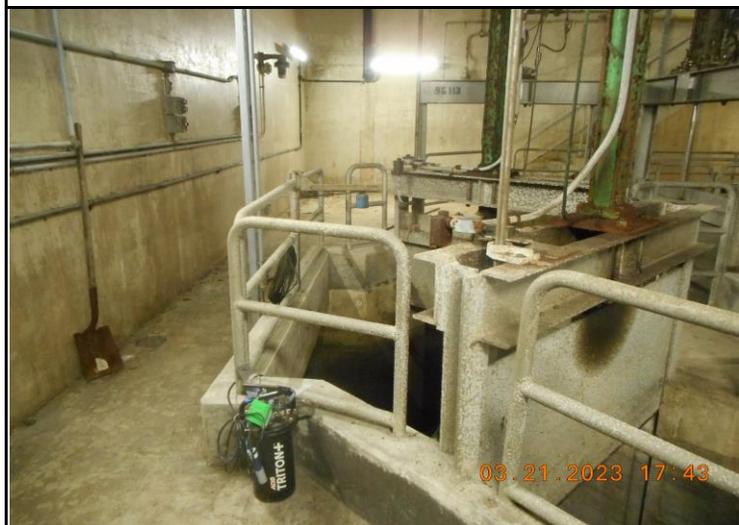
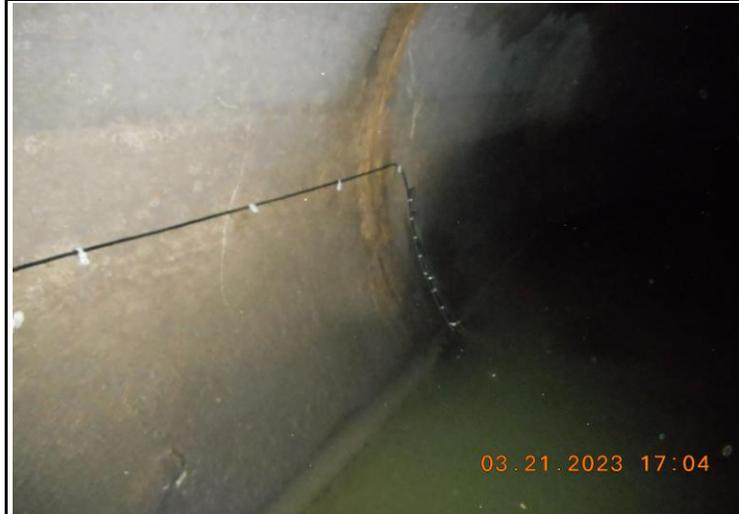
Manhole #	10	System Characteristics	Residential
Access	Drive		
			None

Installation Information	
Installation Date:	Tuesday, March 21, 2023
Installation Type:	Doppler Special Installation
Monitoring Location (Sensors):	Upstream 0-5 FT
Monitor Location:	Manhole
Sensors / Devices:	AV Max/Peak Combo (CS9)
Pressure Sensor Range (psi)	0 - 5 psi
Installation Confirmation:	
Confirmation Time:	6:20:00 PM
Pipe Size (HxW)	96.00x96.00
Depth of Flow (Wet DOF) (in)	17.98
Range (Air DOF) (in)	78.02
Downlooker Physical Offset (in)	0
Measurement Confidence (in)	0.25"
Peak Velocity (fps)	2.21
Velocity Sensor Offset (in)	0
Silt (in)	0
Silt Type	0
Hydraulic Comments:

Manhole / Pipe Information:	
Manhole Depth (Approx. inches):	144
Manhole Configuration	Common Trench
Manhole Material:	Concrete
Manhole Condition:	Good
Manhole Opening Diameter (in)	28
Manhole Diameter (Approx.):	28
Manhole Cover	Manhole Frame
Active Drop Connections	No
Air Quality:	Good
Pipe Material	Concrete
Pipe Condition:	Good
Communication Information:	
Communication Type	Wireless
Antenna Location	
Additional Site Info. / Comments:	
Meter is located in PS- No ground water gauge installed

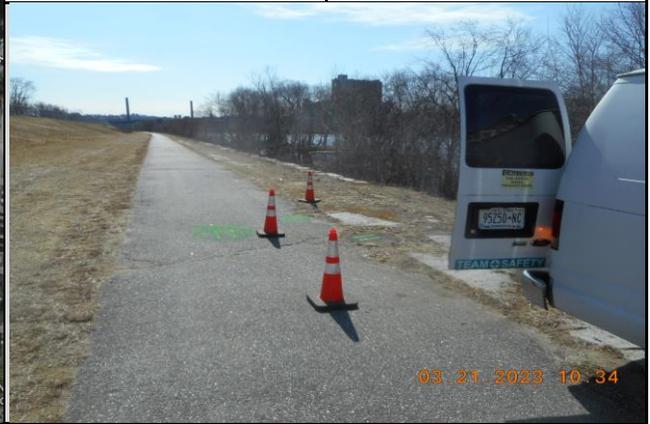
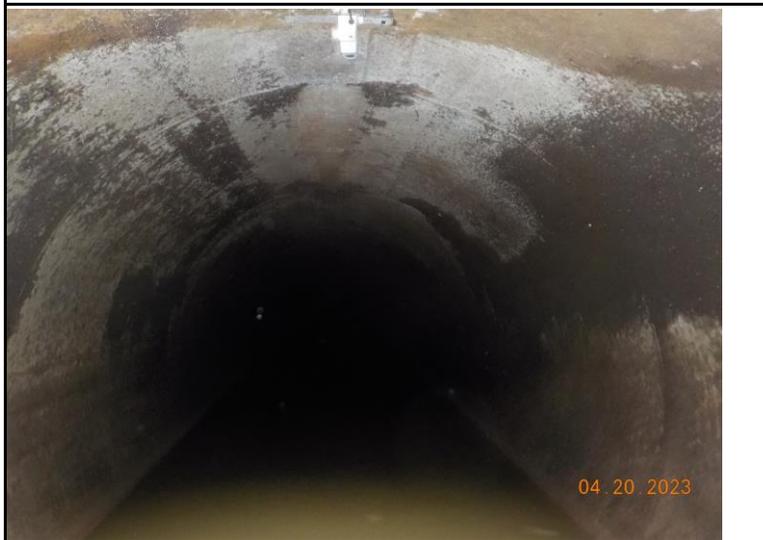
Manhole #	System Characteristics
11	Residential
Access	Traffic
Drive	None

Installation Information	
Installation Date:	Installation Type:
Tuesday, March 21, 2023	Doppler Special Installation
Monitoring Location (Sensors):	Monitor Location:
Upstream 0-5 FT	Manhole
Sensors / Devices:	Pressure Sensor Range (psi)
AV   Max/Peak Combo (CS9)-Smart Depth (CSS)	0 - 5 psi
Installation Confirmation:	
Confirmation Time:	Pipe Size (HxW)

3:55:00 PM	95.50x96.00
Depth of Flow (Wet DOF) (in)	Range (Air DOF) (in)
26.66	68.34
Downlooker Physical Offset (in)	Measurement Confidence (in)
1.5	0.25"
Peak Velocity (fps)	Velocity Sensor Offset (in)

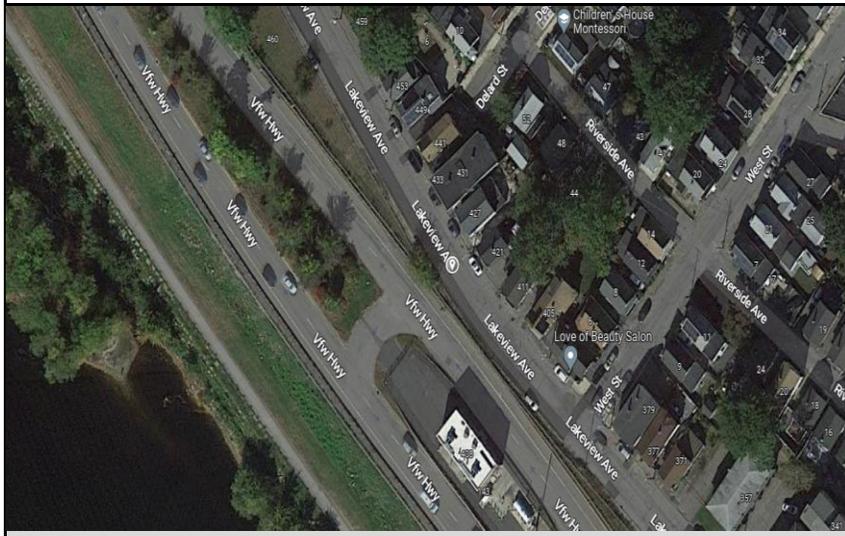
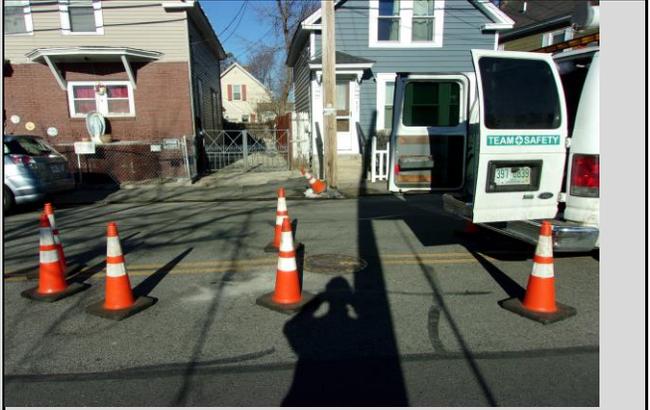
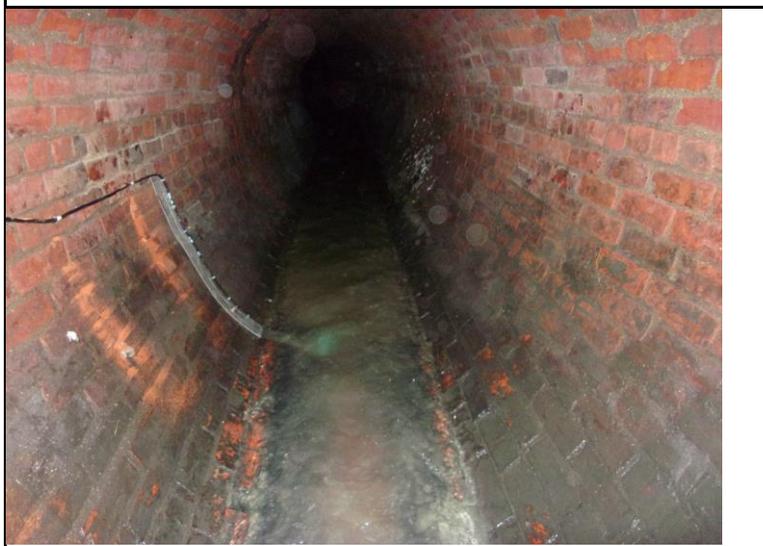
## Meter-12

Site Address / Location:	427 Lakeview Ave, Lowell, MA/ 42.653022, -71.310484	Monitor Series	Location Type
Site Access:	Drive	TRITON+	Temporary
		Pipe Size (H x W)	Pipe Shape
		54.75x47.00	Elliptical

Installation Date:	Installation Type:
Wednesday, March 8, 2023	Doppler Special Installation
Monitoring Location (Sensors):	Monitor Location:
Downstream 0-5 FT	Manhole
Sensors / Devices:	Pressure Sensor Range (psi)
AV   Max/Peak Combo (CS9)	0 -5 psi

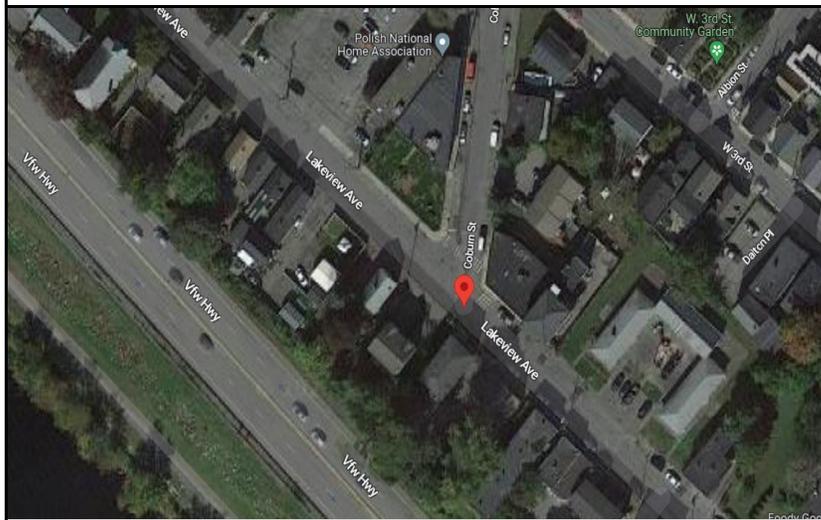
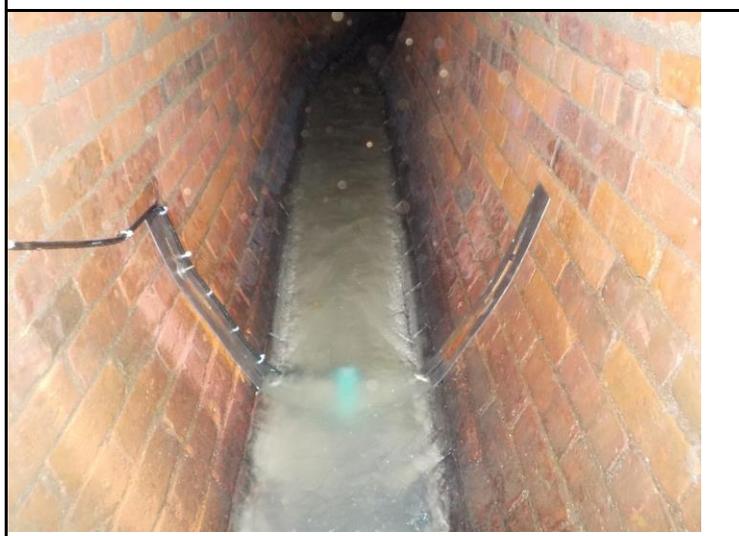
# Meter-15

Site Address / Location:	Coburn St and Lakeview Ave. 42.650665, -71.306919	Monitor Series	TRITON+	Location Type	Temporary
Site Access:	Drive	Pipe Size (H x W)	41.00x27.50	Pipe Shape	Standard Egg

Installation Information	
Installation Date:	Wednesday, March 8, 2023
Installation Type:	Doppler Special Installation
Monitoring Location (Sensors):	Upstream 0-5 FT
Monitor Location:	Manhole
Sensors / Devices:	AV   Max/Peak Combo (CS9)
Pressure Sensor Range (psi)	0 - 5 psi
Installation Confirmation:	
Confirmation Time:	4:44:00 PM
Pipe Size (HxW)	41.00x27.50
Depth of Flow (Wet DOF) (in)	3.2
Range (Air DOF) (in)	37.8
Downlooker Physical Offset (in)	0
Measurement Confidence (in)	0.25"
Peak Velocity (fps)	2.99
Velocity Sensor Offset (in)	0
Silt (in)	0
Silt Type	0
Hydraulic Comments:	
Manhole / Pipe Information:	
Manhole Depth (Approx. FT):	Manhole Configuration
	Common Trench
Manhole Material:	Manhole Condition:
Brick	Good
Manhole Opening Diameter (in)	Manhole Diameter (Approx.):
Manhole Cover	Manhole Frame
Concealed	Normal
Active Drop Connections	Air Quality:
No	Good
Pipe Material	Pipe Condition:
Brick	Good
Communication Information:

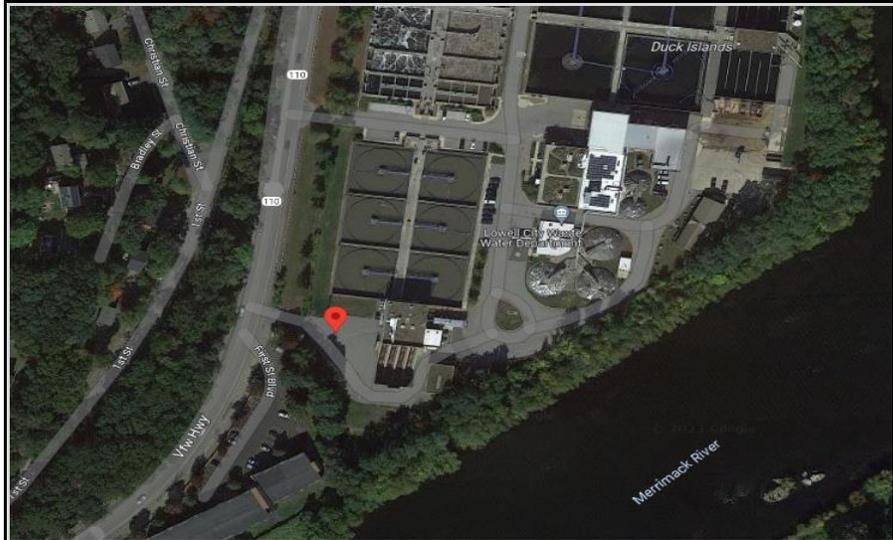
## Meter-18

Site Address / Location:	Lowell City Waste Water Department	Monitor Series	TRITON+	Location Type	Temporary
Site Access:	Drive	Pipe Size (H x W)	18.00x18.00	Pipe Shape	Circular

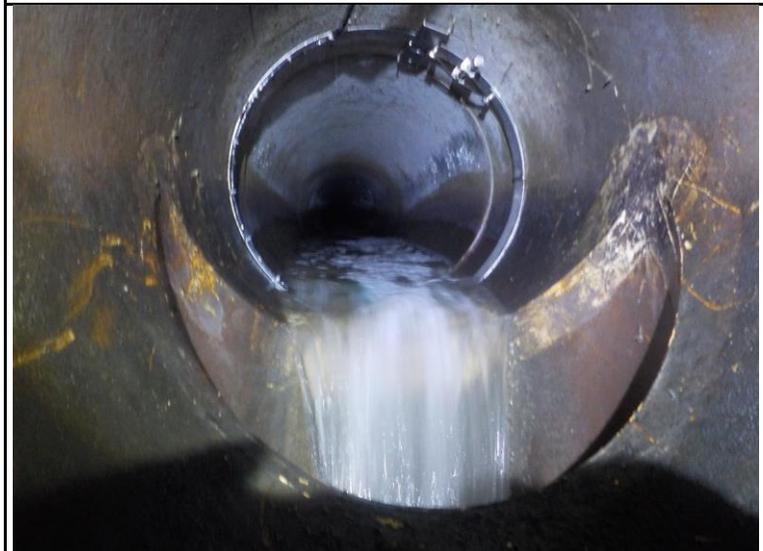
Confirmation Time:	12:08:00 PM	Pipe Size (HxW)	18.00x18.00
Depth of Flow (Wet DOF) (in)	2.5	Range (Air DOF) (in)	15.5
Downlooker Physical Offset (in)	0	Measurement Confidence (in)	0.25"
Peak Velocity (fps)	2.28	Velocity Sensor Offset (in)	0
Silt (in)	0	Silt Type	0

Manhole Depth (Approx. inches):	339	Manhole Configuration	Common Trench
Manhole Material:	Concrete	Manhole Condition:	Good
Manhole Opening Diameter (in)	28	Manhole Diameter (Approx.):	28
Manhole Cover	Concealed	Manhole Frame	Normal
Active Drop Connections	Yes, Inside	Air Quality:	Good
Pipe Material	PVC	Pipe Condition:	Good

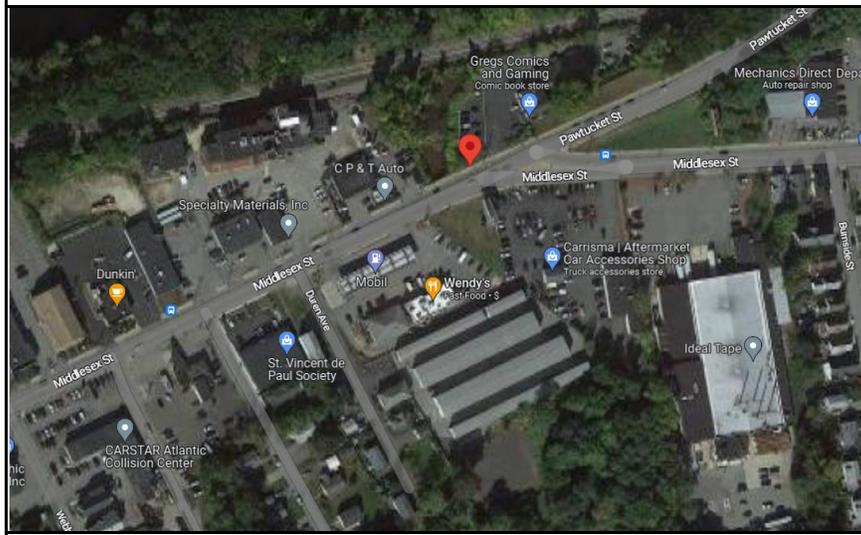
# Meter-20

Site Address / Location:	915 Pawtucket Street, Lowell, MA	Monitor Series	TRITON+	Location Type	Temporary
Site Access:	Drive	Pipe Size (H x W)	47.50x47.50	Pipe Shape	Circular

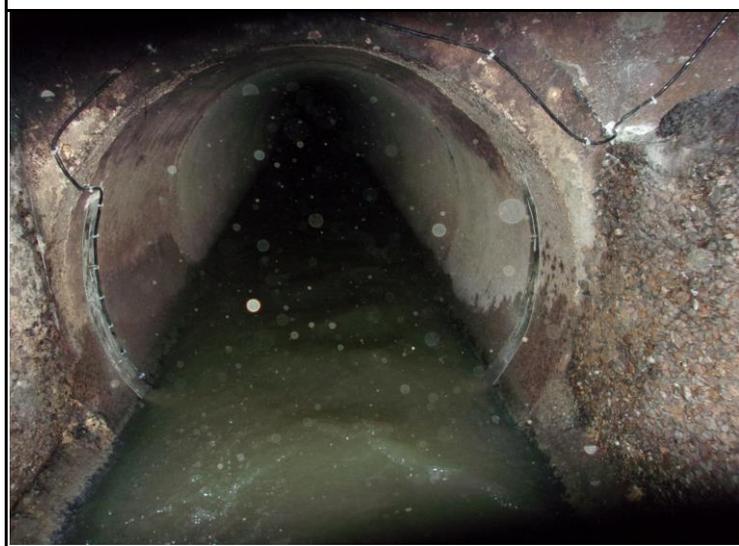
Installation Information	
Installation Date:	Tuesday, March 21, 2023
Installation Type:	Doppler Special Installation
Monitoring Location (Sensors):	Upstream 0-5 FT
Monitor Location:	Manhole
Sensors / Devices:	AV MAX/Peak Combo (CS9)
Pressure Sensor Range (psi)	0 - 5 psi
Installation Confirmation:	
Confirmation Time:	12:37:00 PM
Pipe Size (HxW)	47.50x47.50
Depth of Flow (Wet DOF) (in)	10.52
Range (Air DOF) (in)	36.98
Downlooker Physical Offset (in)	0
Measurement Confidence (in)	0.25"
Peak Velocity (fps)	2.75
Velocity Sensor Offset (in)	0
Silt (in)	0
Silt Type	0
Hydraulic Comments:

Manhole / Pipe Information:	
Manhole Depth (Approx. Inches):	206.75
Manhole Configuration	Common Trench
Manhole Material:	Concrete
Manhole Condition:	Good
Manhole Opening Diameter (in)	28
Manhole Diameter (Approx.):	28
Manhole Cover	Concealed
Manhole Frame	Normal
Active Drop Connections	No
Air Quality:	Good
Pipe Material	Concrete
Pipe Condition:	Good
