**LOWELL REGIONAL WASTEWATER UTILITY  
CITY OF LOWELL, MA  
2023 INFILTRATION AND INFLOW ANALYSIS REPORT  
KLEINFELDER PROJECT #20220166.003A**

**January 31, 2024**

**LOWELL INFILTRATION AND INFLOW ANALYSIS REPORT  
CITY OF LOWELL, MA**

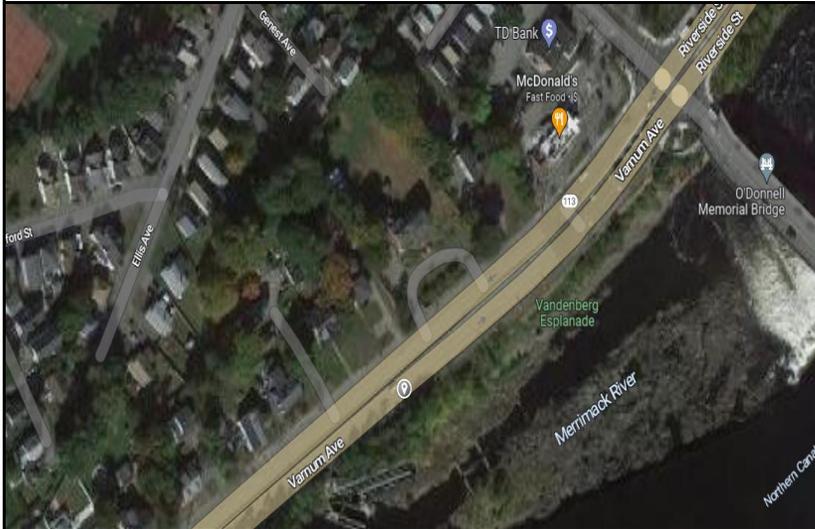
# Meter-21

Site Address / Location:	42.648948, -71.333508	Monitor Series	TRITON+	Location Type	Temporary
Site Access:	Drive	Pipe Size (H x W)	36.006x36.00	Pipe Shape	Circular

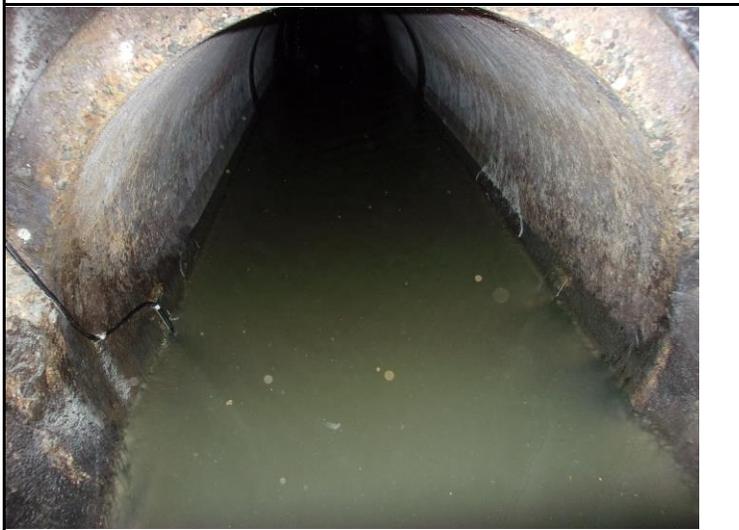
Installation Information	
Installation Date:	Thursday, March 9, 2023
Installation Type:	Doppler Special Installation
Monitoring Location (Sensors):	Upstream 0-5 FT
Monitor Location:	Manhole
Sensors / Devices:	AV Max/Peak Combo (CS9)
Pressure Sensor Range (psi)	0 - 5 psi
Installation Confirmation:	
Confirmation Time:	11:59:00 AM
Pipe Size (HxW)	36.00x36.00
Depth of Flow (Wet DOF) (in)	11.15
Range (Air DOF) (in)	24.85
Downlooker Physical Offset (in)	0
Measurement Confidence (in)	0.25"
Peak Velocity (fps)	2.27
Velocity Sensor Offset (in)	0
Silt (in)	0
Silt Type	0
Hydraulic Comments:

Manhole / Pipe Information:	
Manhole Depth (Approx. Inches):	411.5
Manhole Configuration	Common Trench
Manhole Material:	Concrete
Manhole Condition:	Good
Manhole Opening Diameter (in)	24
Manhole Diameter (Approx.):	24
Manhole Cover	Concealed
Manhole Frame	Normal
Active Drop Connections	No
Air Quality:	Good
Pipe Material	Concrete
Pipe Condition:	Good

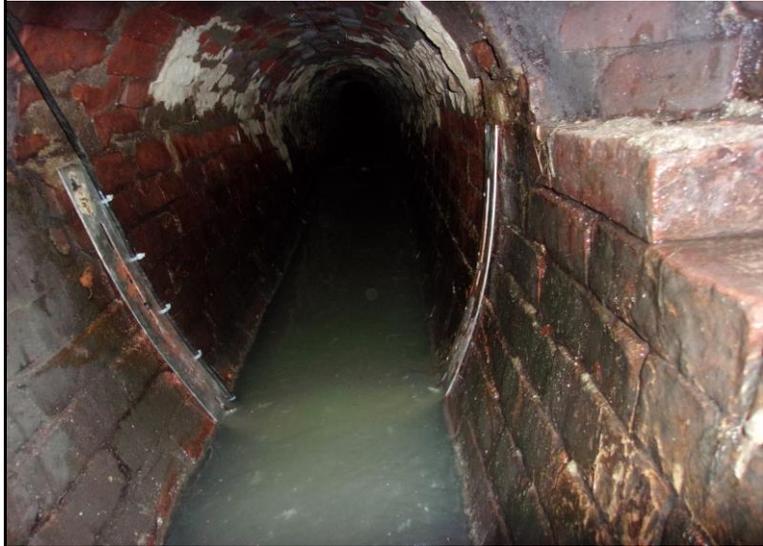
Installation Information	
Installation Date:	Installation Type:
Friday, March 10, 2023	Doppler Special Installation
Monitoring Location (Sensors):	Monitor Location:
Downstream 0-5 FT	Manhole
Sensors / Devices:	Pressure Sensor Range (psi)
AV MAX/Peak Combo (CS9)	0 -5 psi
Installation Confirmation:	
Confirmation Time:	Pipe Size (HxW)
10:01:00 AM	30.00x21.00
Depth of Flow (Wet DOF) (in)	Range (Air DOF) (in)
4.19	24.81
Downlooker Physical Offset (in)	Measurement Confidence (in)
0	0.25"
Peak Velocity (fps)	Velocity Sensor Offset (in)
0.79	0
Silt (in)	Silt Type
0	0
Hydraulic Comments:

Manhole / Pipe Information:	
Manhole Depth (Approx. Inches):	Manhole Configuration
164.25	Common Trench
Manhole Material:	Manhole Condition:
Brick	Good
Manhole Opening Diameter (in)	Manhole Diameter (Approx.):
28	28
Manhole Cover	Manhole Frame
Concealed	Normal
Active Drop Connections	Air Quality:
No	Good
Pipe Material	Pipe Condition:
Brick	Good
Communication Information:	
Communication Type	Antenna Location
Wireless	Drilled Pavement / Concrete

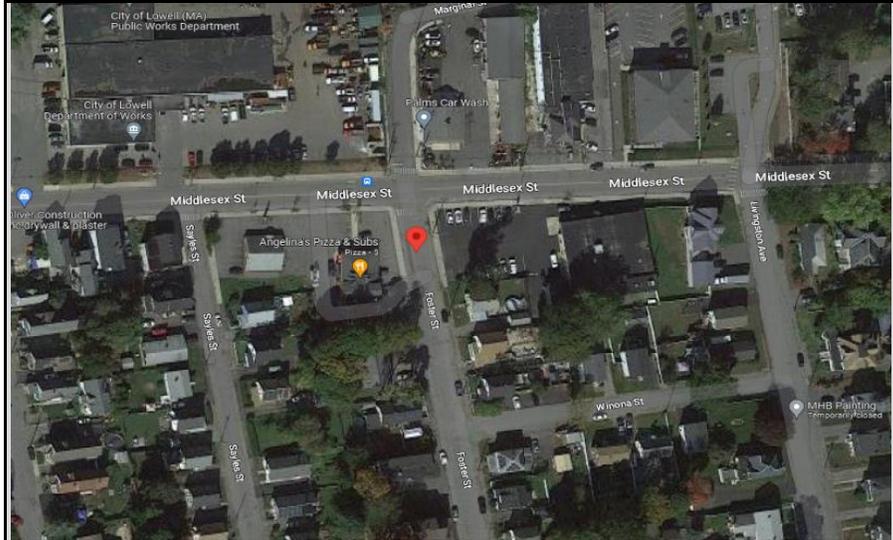
Site Address / Location:	34-24 Foster St
Site Access:	Drive

Monitor Series	Location Type
TRITON+	Temporary
Pipe Size (H x W)	Pipe Shape
18.00x18.00	Circular

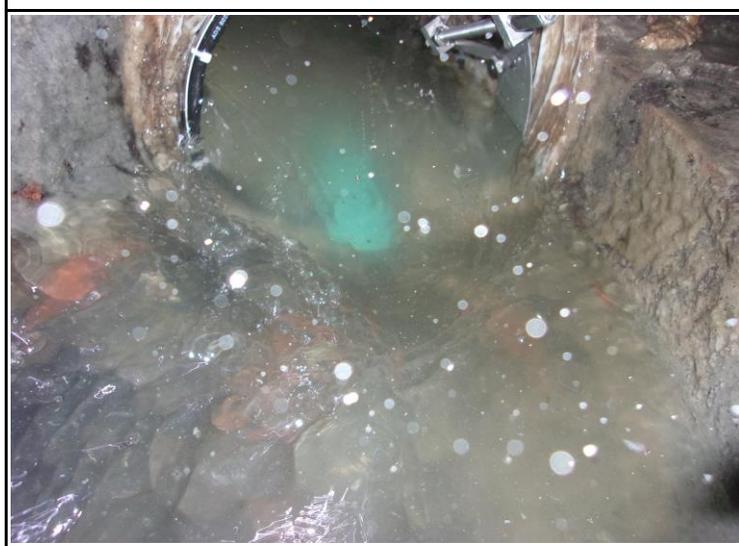
Installation Information	
Installation Date:	Wednesday, March 8, 2023
Installation Type:	Doppler Standard Ring and Crank
Monitoring Location (Sensors):	Upstream 0-5 FT
Sensors / Devices:	AV MAX/Peak Combo (CS9)
Monitor Location:	Manhole
	Pressure Sensor Range (psi)
	0 - 5 psi
Installation Confirmation:	
Confirmation Time:	9:48:00 AM
Pipe Size (HxW)	9.13x9.13
Depth of Flow (Wet DOF) (in)	4.92
Range (Air DOF) (in)	4.21
Downlooker Physical Offset (in)	0
Confidence	0.25"
Peak Velocity (fps)	2.14
Velocity Sensor Offset (in)	0
Silt (in)	0
Silt Type	0
Hydraulic Comments:

Manhole / Pipe Information:	
Manhole Depth (Approx. Inches):	208
Manhole Configuration	Common Trench
Manhole Material:	Brick
Manhole Condition:	Good
Manhole Opening Diameter (in)	28
Manhole Diameter (Approx.):	28
Manhole Cover	Concealed
Manhole Frame	Normal
Active Drop Connections	No
Air Quality:	Good
Pipe Material	Cast Iron Pipe
Pipe Condition:	Good

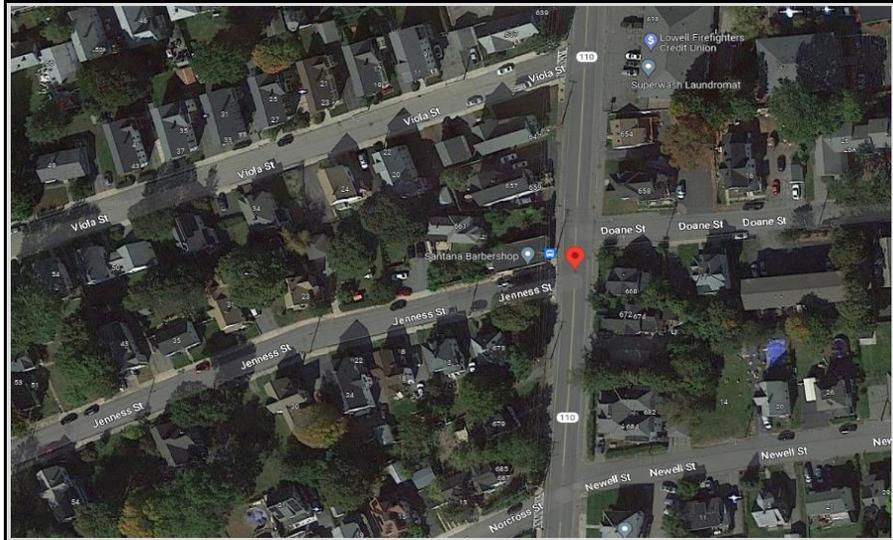
## Meter-25

Site Address / Location:	Chelmsford St at Jenness St	Monitor Series	TRITON+	Location Type	Temporary
Site Access:	Drive	Pipe Size (H x W)	36.00x36.00	Pipe Shape	Circular

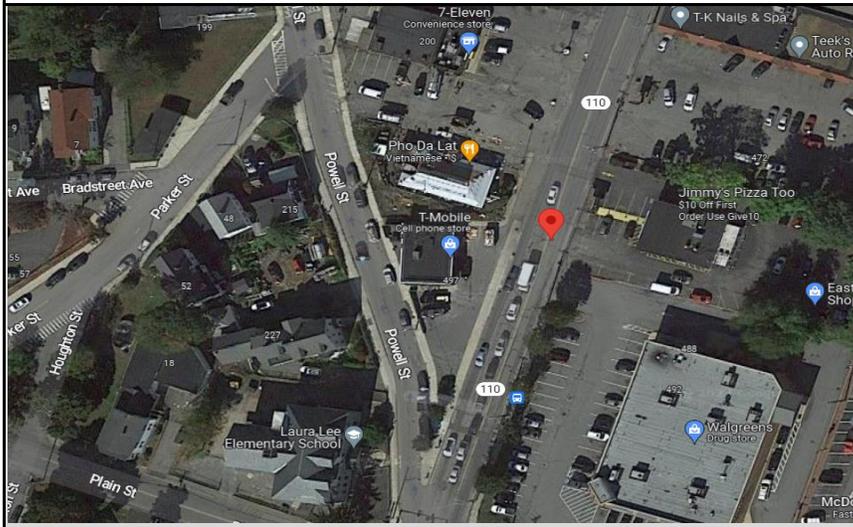
# Meter-27

Site Address / Location:	480 Chelmsford St, Lowell, Ma	Monitor Series	TRITON+	Location Type	Temporary
Site Access:	Drive	Pipe Size (H x W)	56.00x52.00	Pipe Shape	Elliptical

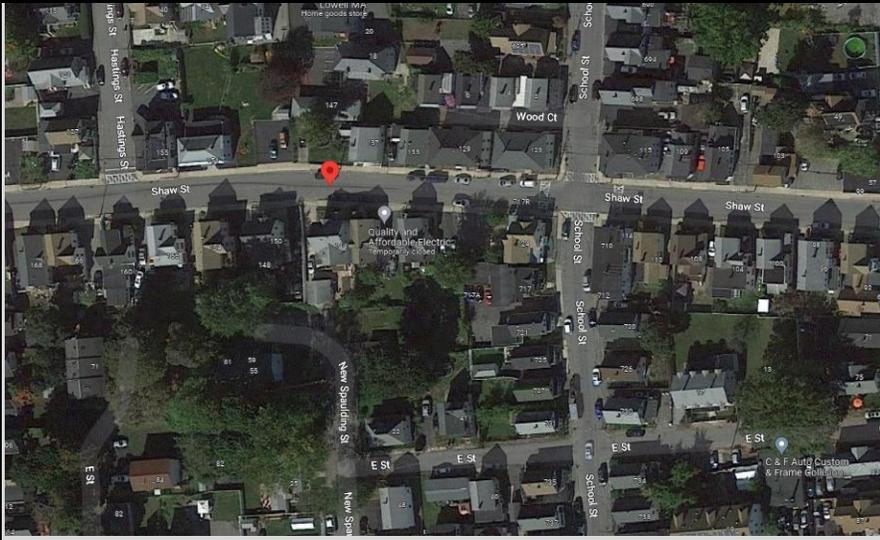
**Meter-28**

Site Address / Location:	144 Shaw St	Monitor Series	TRITON+	Location Type	Temporary
Site Access:	Drive	Pipe Size (H x W)	51.50x36.83	Pipe Shape	Standard Egg

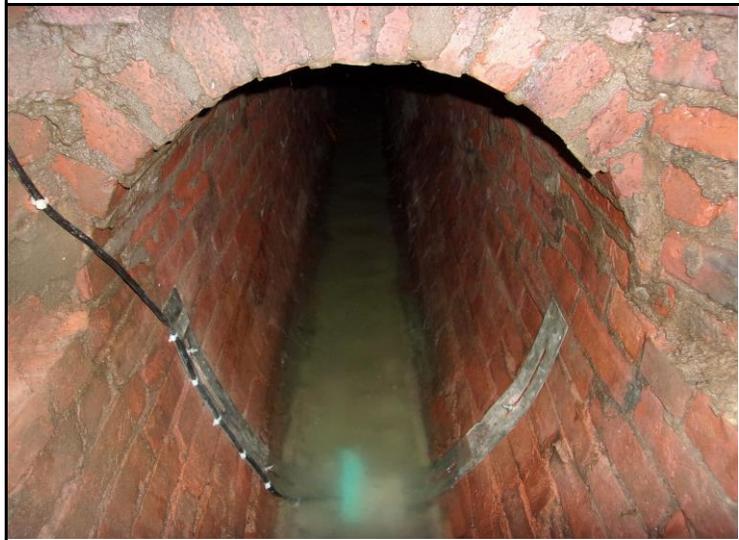
Installation Information	
Installation Date:	Wednesday, March 22, 2023
Installation Type:	Doppler Special Installation
Monitoring Location (Sensors):	Upstream 0-5 FT
Monitor Location:	Manhole
Sensors / Devices:	AV MAX/Peak Combo (CS9)
Pressure Sensor Range (psi)	0 - 5 psi
Installation Confirmation:	
Confirmation Time:	1:16:00 PM
Pipe Size (HxW)	34.00x24.25
Depth of Flow (Wet DOF) (in)	4.2
Range (Air DOF) (in)	29.8
Downlooker Physical Offset (in)	0
Measurement Confidence (in)	0.38"
Peak Velocity (fps)	1.16
Velocity Sensor Offset (in)	0
Silt (in)	0
Silt Type	0
Hydraulic Comments:

Manhole / Pipe Information:	
Manhole Depth (Approx. Inches):	139
Manhole Configuration	Common Trench
Manhole Material:	Brick
Manhole Condition:	Good
Manhole Opening Diameter (in)	28
Manhole Diameter (Approx.):	28
Manhole Cover	Concealed
Manhole Frame	Normal
Active Drop Connections	No
Air Quality:	Good
Pipe Material	Brick
Pipe Condition:	Good

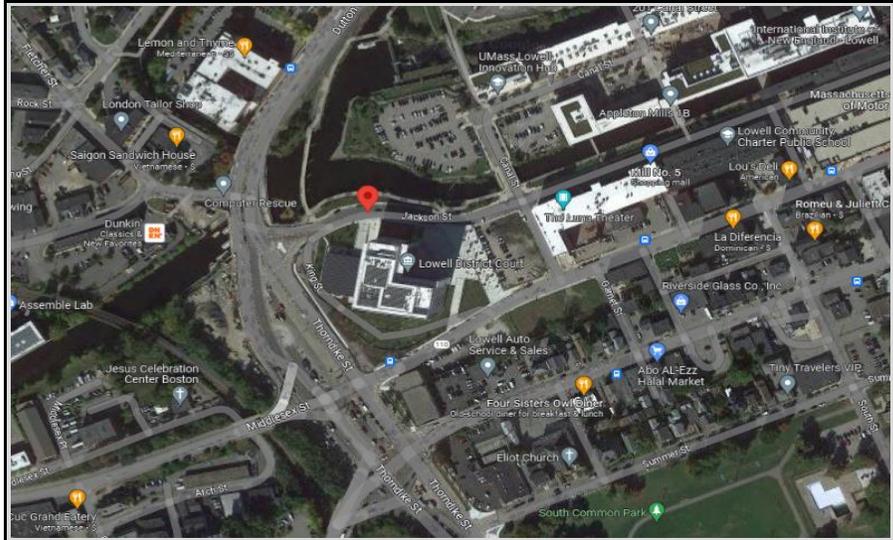
## Meter-33

Site Address / Location:	355 Jackson St	Monitor Series	TRITON+	Location Type	Temporary
Site Access:	Drive	Pipe Size (H x W)	48.00x48.00	Pipe Shape	Circular

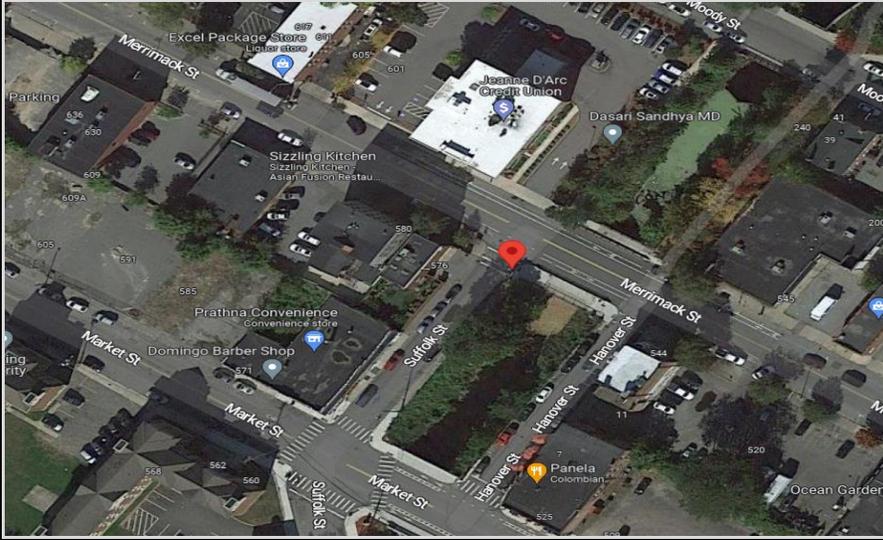
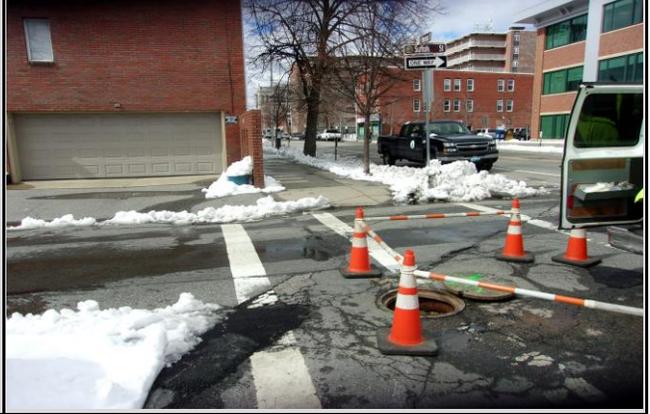
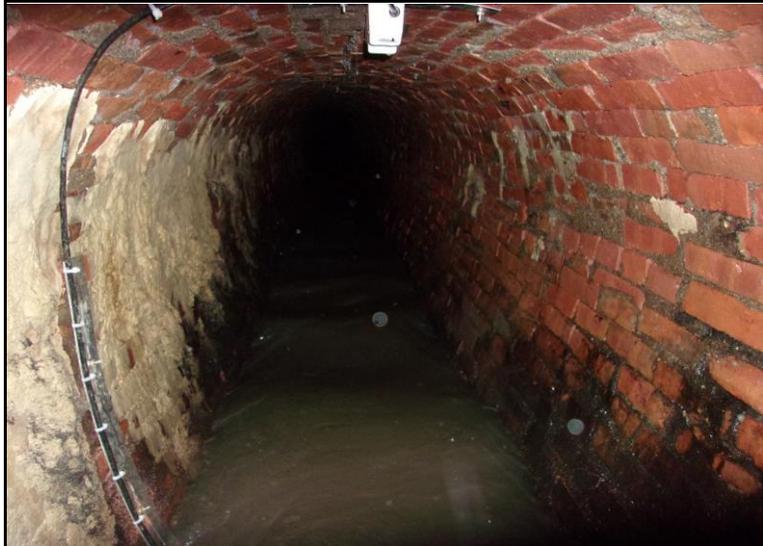
## Meter-35

Site Address / Location:	432 Suffolk St Lowell, Ma	Monitor Series	TRITON+	Location Type	Temporary
Site Access:	Drive	Pipe Size (H x W)	52.00x37.5	Pipe Shape	Standard Egg

Manhole #	35	System Characteristics	Residential
Access	Drive		Traffic
			Light

Installation Information	
Installation Date:	Wednesday, March 15, 2023
Monitoring Location (Sensors):	Downstream 0-5 FT
Sensors / Devices:	AV   MAX/Peak Combo (CS9), Smart Depth (CS5)
Installation Type:	Doppler Standard Ring and Crank
Monitor Location:	Manhole
Pressure Sensor Range (psi)	0 -5 psi

Installation Confirmation:	
Confirmation Time:	12:33:00 PM
Depth of Flow (Wet DOF) (in)	14.3
Downlooker Physical Offset (in)	0
Peak Velocity (fps)	2.04
Silt (in)	0
Pipe Size (HxW)	52.00x37.5
Range (Air DOF) (in)	38.7
Measurement Confidence (in)	0.25"
Velocity Sensor Offset (in)	0
Silt Type	0

Manhole / Pipe Information:	
Manhole Depth (Approx. Inches):	198
Manhole Material:	Brick
Manhole Opening Diameter (in)	28
Manhole Cover	Concealed
Active Drop Connections	No
Pipe Material	Brick
Manhole Configuration	Common Trench
Manhole Condition:	Good
Manhole Diameter (Approx.):	28
Manhole Frame	Normal
Air Quality:	Good
Pipe Condition:	Good

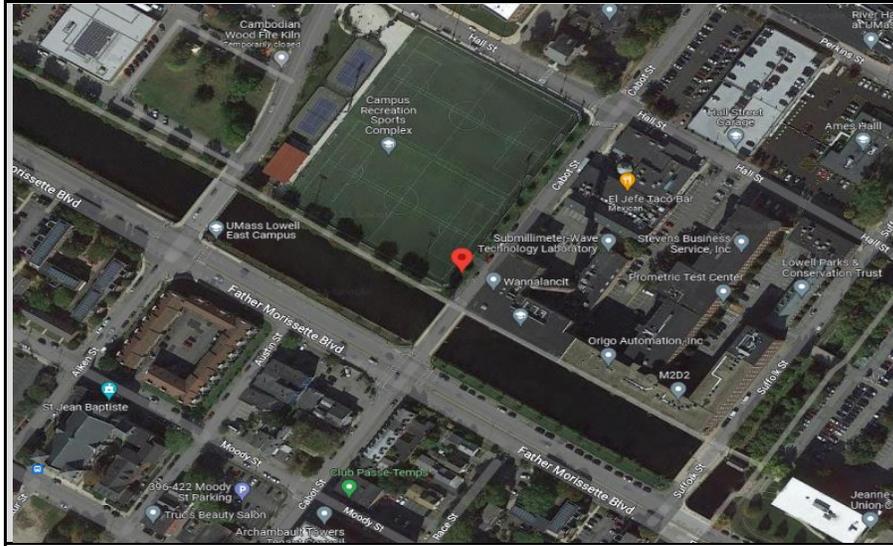
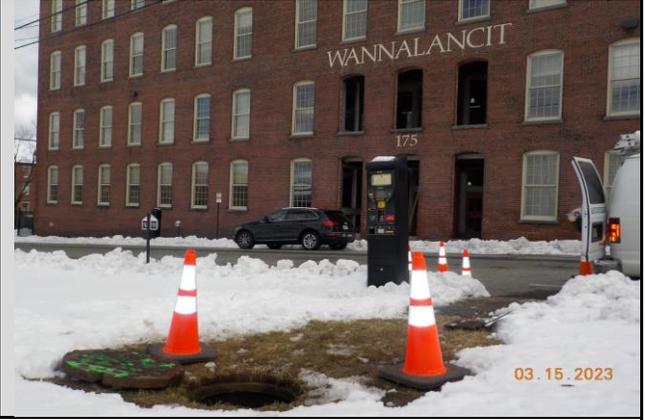
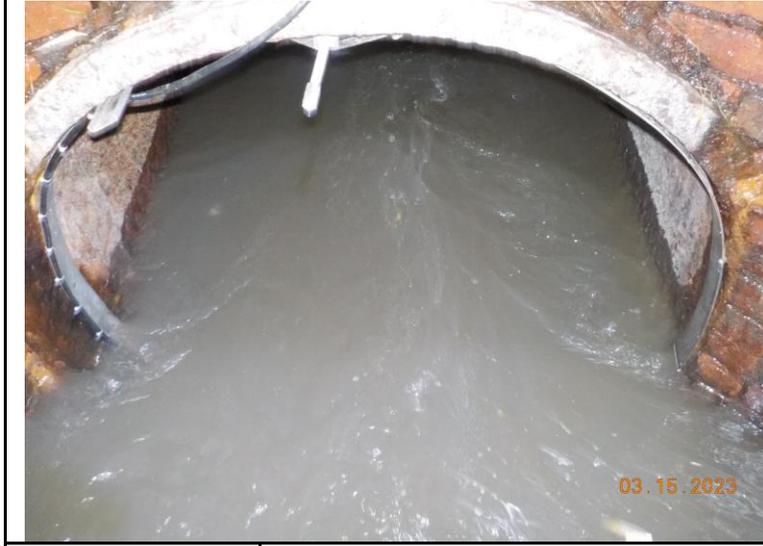
**Meter-36**

Site Address / Location:	Cabot St in grass, use coordinates 42.649998, -71.317590	Monitor Series	TRITON+	Location Type	Temporary
Site Access:	Drive	Pipe Size (H x W)	40.50x40.50	Pipe Shape	Circular

Manhole #	36	System Characteristics	Residential
Access	Drive		Traffic
			Medium

Installation Information	
Installation Date:	Wednesday, March 15, 2023
Installation Type:	Doppler Special Installation
Monitoring Location (Sensors):	Upstream 0-5 FT
Monitor Location:	Manhole
Sensors / Devices:	AV   Max/Peak Combo (CS9)
Pressure Sensor Range (psi)	0 - 5 psi
Installation Confirmation:	
Confirmation Time:	12:53:00 PM
Pipe Size (HxW)	40.50x40.50
Depth of Flow (Wet DOF) (in)	16.16
Range (Air DOF) (in)	24.34
Downlooker Physical Offset (in)	0
Measurement Confidence (in)	0.25"
Peak Velocity (fps)	2.57
Velocity Sensor Offset (in)	0
Silt (in)	0
Silt Type	0
Hydraulic Comments:

Manhole / Pipe Information:	
Manhole Depth (Approx. inches):	281
Manhole Configuration	Common Trench
Manhole Material:	Brick
Manhole Condition:	Good
Manhole Opening Diameter (in)	28
Manhole Diameter (Approx.):	28
Manhole Cover	Concealed
Manhole Frame	Normal
Active Drop Connections	No
Air Quality:	Good
Pipe Material	Cast Iron Pipe
Pipe Condition:	Good
Communication Information:	
Communication Type	Wireless
Antenna Location	Drilled Pavement / Concrete
Additional Site Info. / Comments:

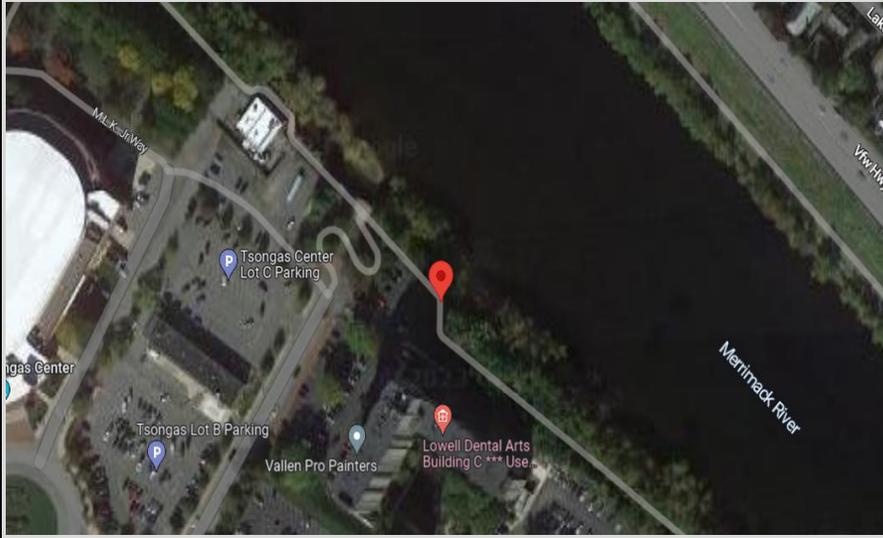
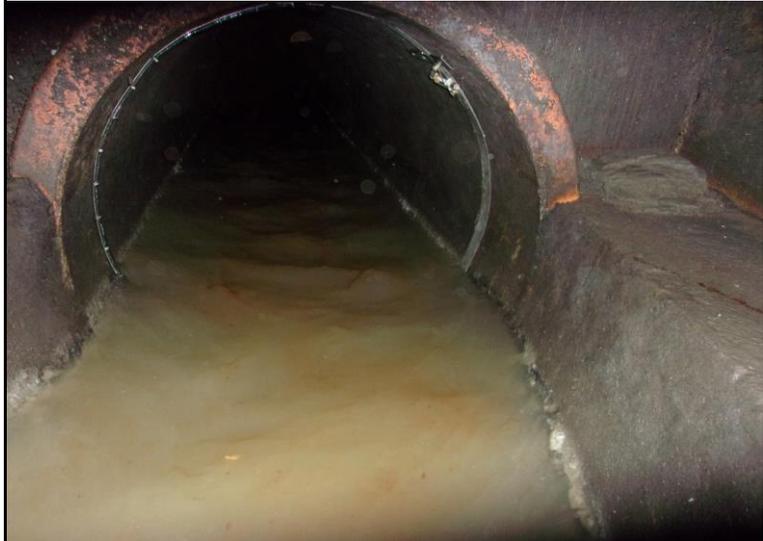
## Meter-37

Site Address / Location:	1 River PI Building C, Lowell, Ma (42.650112, -71.310496)	Monitor Series	Location Type
Site Access:	Walk	TRITON+	Temporary
		Pipe Size (H x W)	Pipe Shape
		36.00x36.00	Circular

Manhole #	System Characteristics
37	Residential
Access	Traffic
Walk (Commercial)	Light

Manhole Depth (Approx. Inches):	Manhole Configuration
60	Common Trench
Manhole Material:	Manhole Condition:
Concrete	Good
Manhole Opening Diameter (in)	Manhole Diameter (Approx.):
28	28
Manhole Cover	Manhole Frame
Concealed	Normal
Active Drop Connections	Air Quality:
No	Good
Pipe Material	Pipe Condition:
Concrete	Good

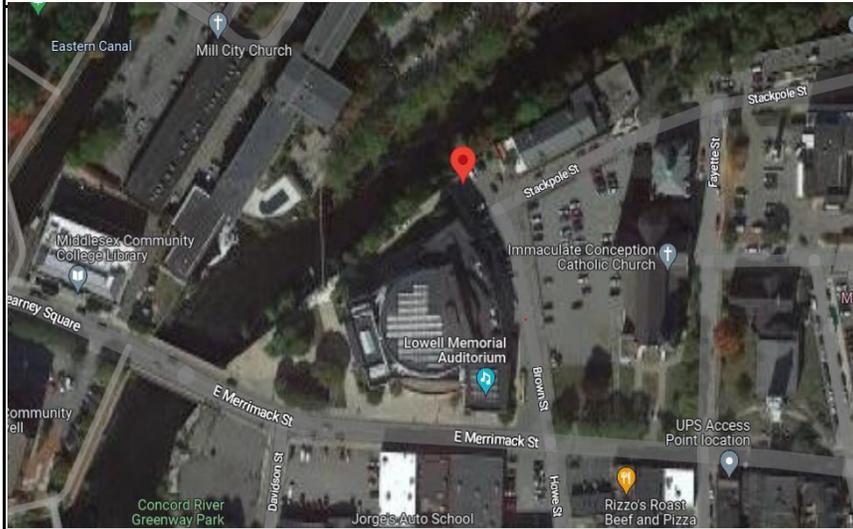
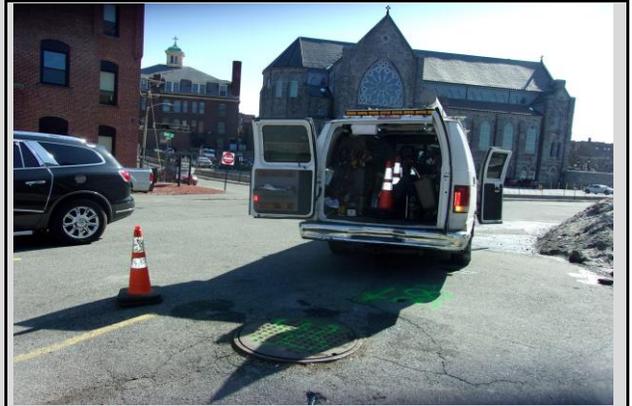
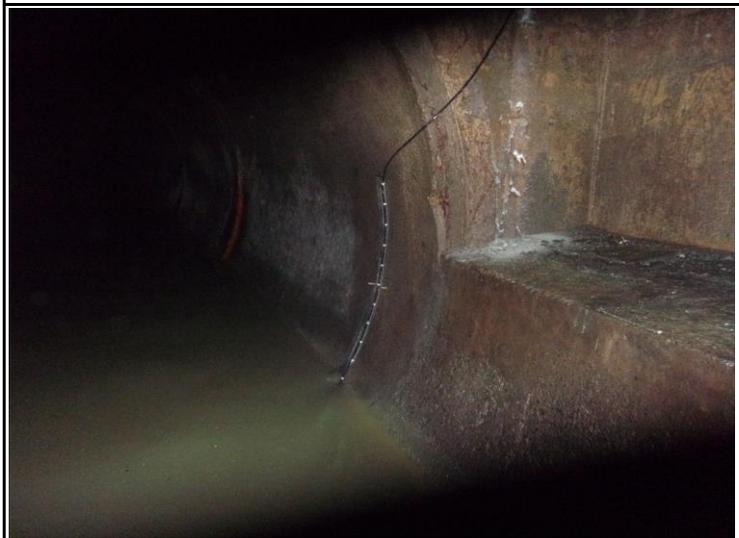
# Meter-38

Site Address / Location:	50 Stackpole St, Lowell, Ma	Monitor Series	TRITON+	Location Type	Temporary
Site Access:	Drive	Pipe Size (H x W)	96.00x96.00	Pipe Shape	Circular

Manhole #	38	System Characteristics	Residential
Access	Drive		Traffic
			Light

Installation Information	
Installation Date:	Tuesday, March 21, 2023
Installation Type:	Doppler Special Installation
Monitoring Location (Sensors):	Upstream 0-5 FT
Monitor Location:	Manhole
Sensors / Devices:	AV   MAX/Peak Combo (CS9), Smart Depth (CS5)
Pressure Sensor Range (psi)	0 - 5 psi

Installation Confirmation:	
Confirmation Time:	10:34:00 AM
Pipe Size (HxW)	96.00x96.00
Depth of Flow (Wet DOF) (in)	21.86
Range (Air DOF) (in)	74.14
Downlooker Physical Offset (in)	1.5
Measurement Confidence (in)	0.25"
Peak Velocity (fps)	2.81
Velocity Sensor Offset (in)	14.5
Silt (in)	0
Silt Type	Gravel

Manhole / Pipe Information:	
Manhole Depth (Approx. Inches):	269.25
Manhole Configuration	Common Trench
Manhole Material:	Concrete
Manhole Condition:	Good
Manhole Opening Diameter (in)	28
Manhole Diameter (Approx.):	28
Manhole Cover	Concealed
Manhole Frame	Normal
Active Drop Connections	No
Air Quality:	Good
Pipe Material	Concrete
Pipe Condition:	Good

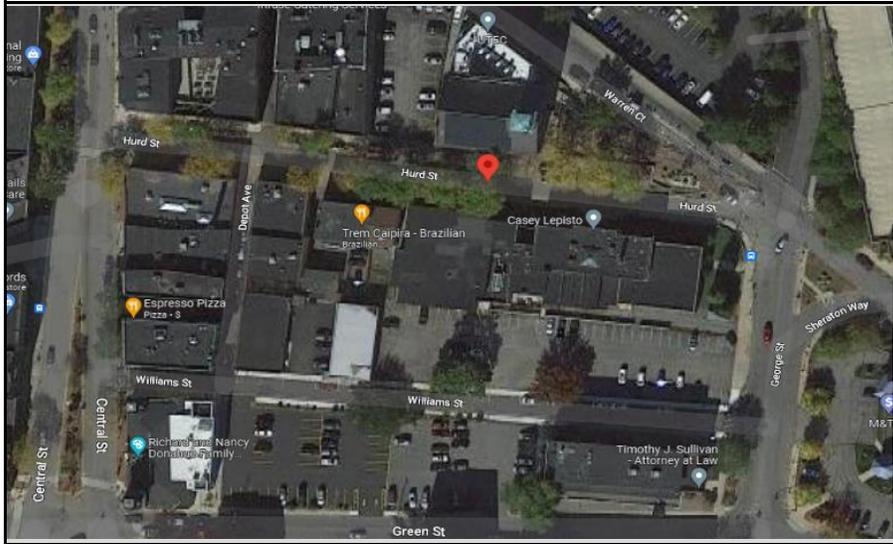
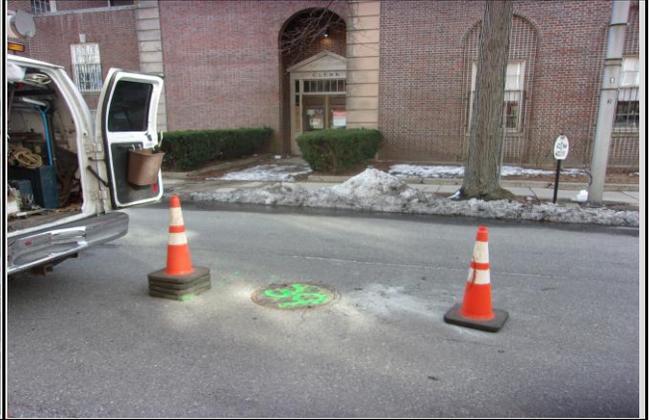
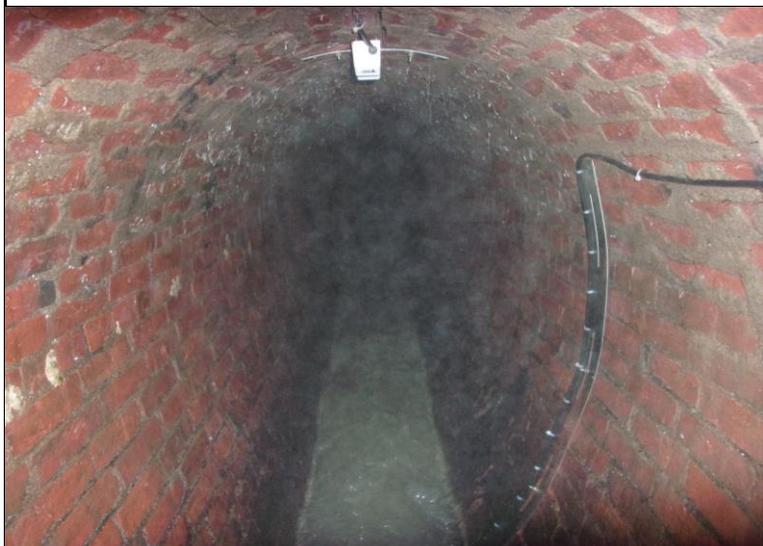
## Meter-39

Site Address / Location:	34 Hurd St, Lowell, Ma	Monitor Series	TRITON+	Location Type	Temporary
Site Access:	Drive	Pipe Size (H x W)	54.00x37.00	Pipe Shape	Standard Egg

Manhole #		System Characteristics	Residential
Access	Drive	Traffic	Light

Installation Information	
Installation Date:	Thursday, March 9, 2023
Installation Type:	Doppler Standard Ring and Crank
Monitoring Location (Sensors):	Downstream 0-5 FT
Sensors / Devices:	AV  Max/Peak Combo (CS9)/Smart Depth (CS5)
Monitor Location:	Manhole
Pressure Sensor Range (psi)	0 -5 psi

Installation Confirmation:	
Confirmation Time:	2:45:00 PM
Pipe Size (HxW)	54.00x37.00
Depth of Flow (Wet DOF) (in)	4.04
Range (Air DOF) (in)	48.46
Downlooker Physical Offset (in)	1.5
Measurement Confidence (in)	0.25"
Peak Velocity (fps)	5.12
Velocity Sensor Offset (in)	0.5
Silt (in)	0
Silt Type	0

Manhole / Pipe Information:	
Manhole Depth (Approx. FT):	178.75
Manhole Configuration	Common Trench
Manhole Material:	Brick
Manhole Condition:	Good
Manhole Opening Diameter (in)	18
Manhole Diameter (Approx.):	18
Manhole Cover	Concealed
Manhole Frame	Normal
Active Drop Connections	No
Air Quality:	Good
Pipe Material	Brick
Pipe Condition:	Good

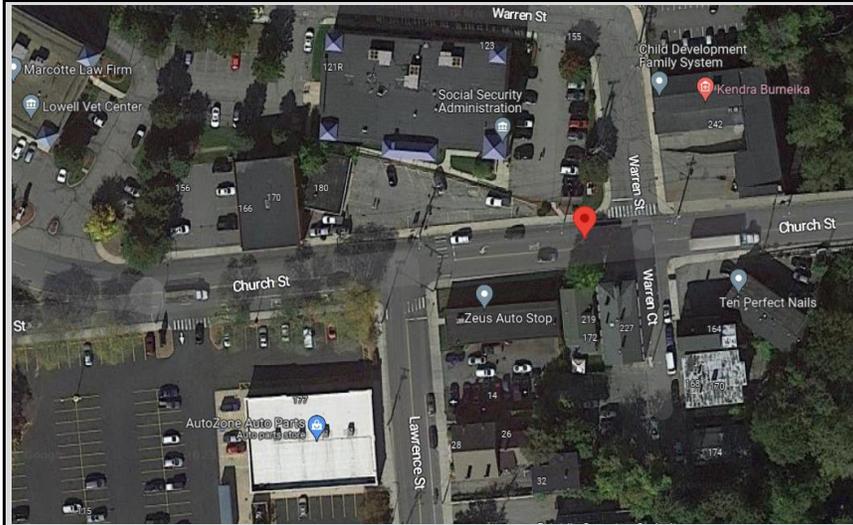
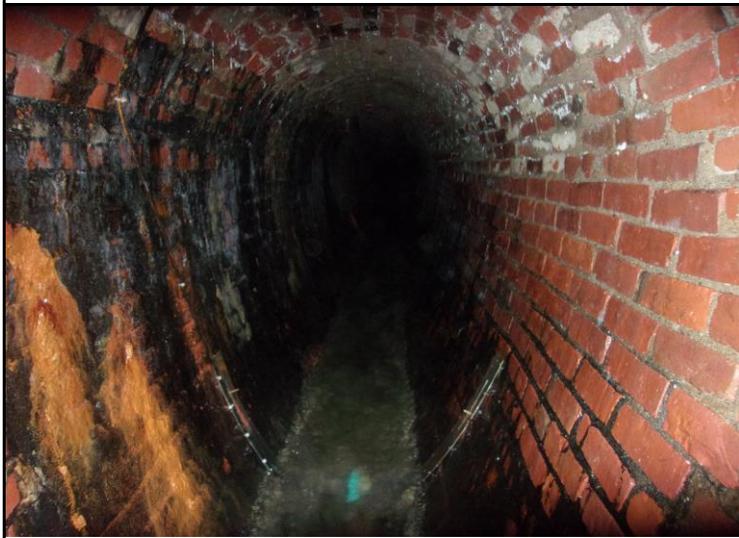
# Meter-40

Site Address / Location:	219 Church St, Lowell, Ma	Monitor Series	TRITON+	Location Type	Temporary
Site Access:	Drive	Pipe Size (H x W)	54.63x36.63	Pipe Shape	Standard Egg

Installation Information	
Installation Date:	Thursday, March 16, 2023
Installation Type:	Doppler Special Installation
Monitoring Location (Sensors):	Upstream 0-5 FT
Monitor Location:	Manhole
Sensors / Devices:	Peak Combo (CS4)
Pressure Sensor Range (psi)	0 - 5 psi
Installation Confirmation:	
Confirmation Time:	3:29:00 PM
Pipe Size (HxW)	54.63x36.63
Depth of Flow (Wet DOF) (in)	3.74
Range (Air DOF) (in)	50.85
Downlooker Physical Offset (in)	0
Measurement Confidence (in)	0.38"
Peak Velocity (fps)	5.3
Velocity Sensor Offset (in)	0
Silt (in)	0
Silt Type	0
Hydraulic Comments:

Manhole / Pipe Information:	
Manhole Depth (Approx. Inches)	160
Manhole Configuration	Common Trench
Manhole Material:	Brick
Manhole Condition:	Good
Manhole Opening Diameter (in)	28
Manhole Diameter (Approx.):	28
Manhole Cover	Concealed
Manhole Frame	Normal
Active Drop Connections	No
Air Quality:	Good
Pipe Material	Brick
Pipe Condition:	Good
Communication Information:	
Communication Type	Wireless
Antenna Location	Drilled Pavement / Concrete
Additional Site Info. / Comments:

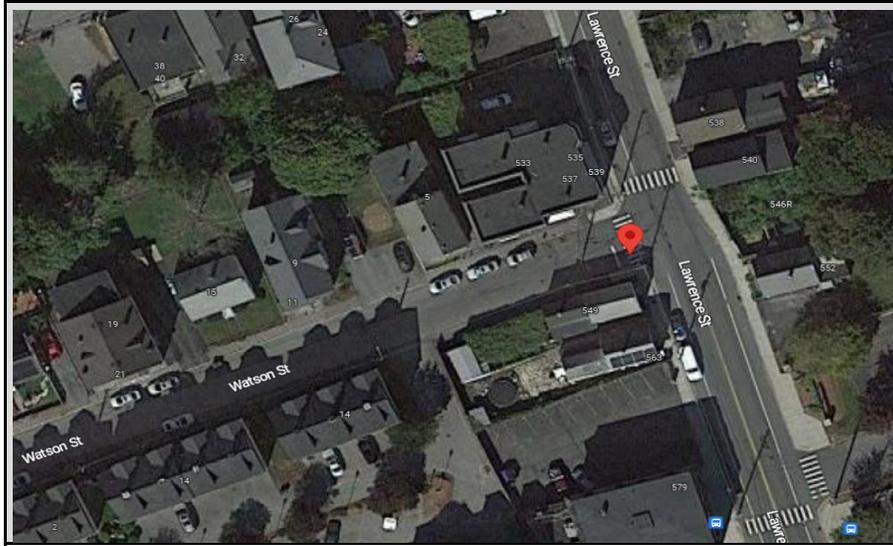
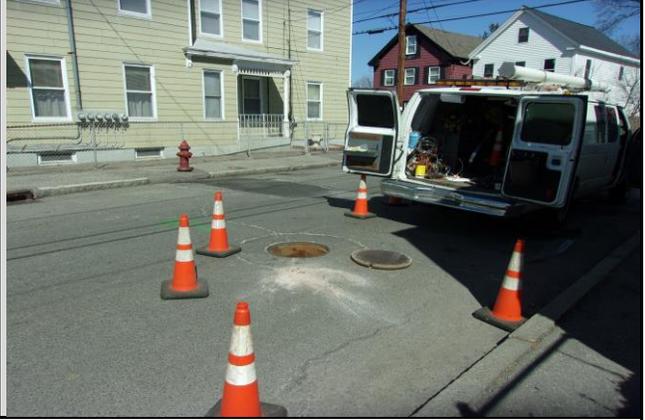
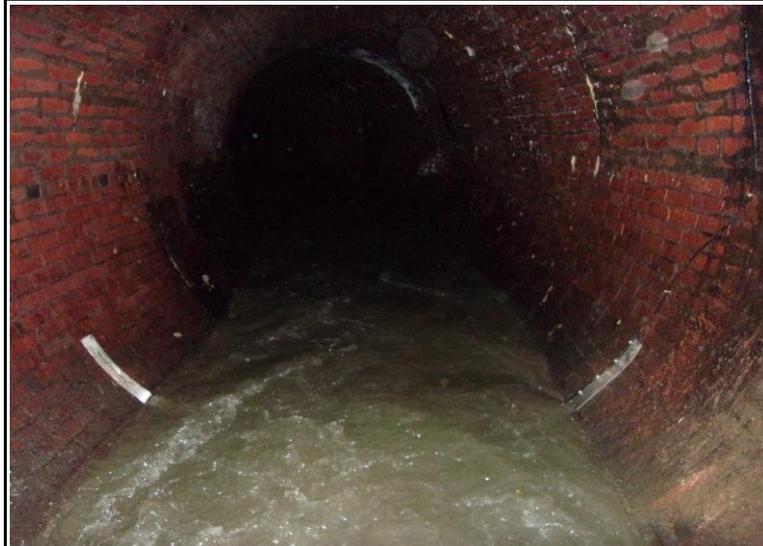
# Meter-42

Site Address / Location:	549 Lawrence Street, Lowell, MA	Monitor Series	TRITON+	Location Type	Temporary
Site Access:	Drive	Pipe Size (H x W)	92.00x92.00	Pipe Shape	Circular

Manhole #	41	System Characteristics	Residential
Access	Drive		Traffic
			Light

Installation Information	
Installation Date:	Monday, March 20, 2023
Installation Type:	Doppler Special Installation
Monitoring Location (Sensors):	Upstream 0-5 FT
Monitor Location:	Manhole
Sensors / Devices:	AV MAX/Peak Combo (CS9)
Pressure Sensor Range (psi)	0 -5 psi
Installation Confirmation:	
Confirmation Time:	1:15:00 PM
Pipe Size (HxW)	92.00x92.00
Depth of Flow (Wet DOF) (in)	12.03
Range (Air DOF) (in)	79.97
Downlooker Physical Offset (in)	0
Measurement Confidence (in)	0.25"
Peak Velocity (fps)	5.13
Velocity Sensor Offset (in)	0
Silt (in)	0
Silt Type	0
Hydraulic Comments:

Manhole / Pipe Information:	
Manhole Depth (Approx. Inches):	253
Manhole Configuration	Common Trench
Manhole Material:	Brick
Manhole Condition:	Good
Manhole Opening Diameter (in)	28
Manhole Diameter (Approx.):	28
Manhole Cover	Concealed
Manhole Frame	Normal
Active Drop Connections	No
Air Quality:	Good
Pipe Material	Brick
Pipe Condition:	Good
Communication Information:	
Communication Type	Wireless
Antenna Location	Drilled Pavement / Concrete

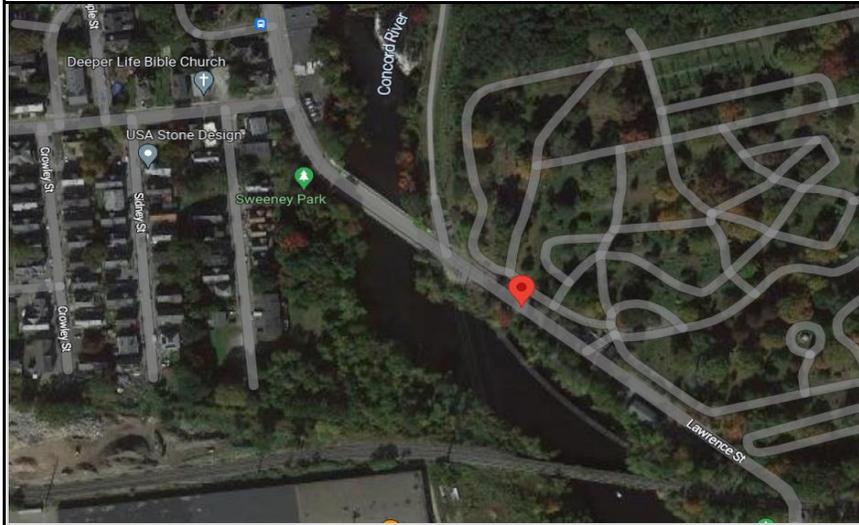
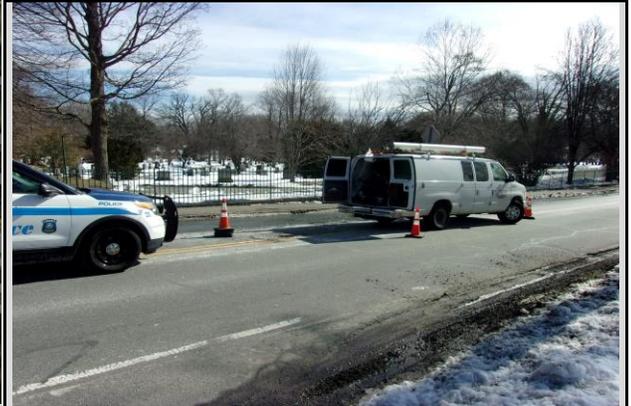
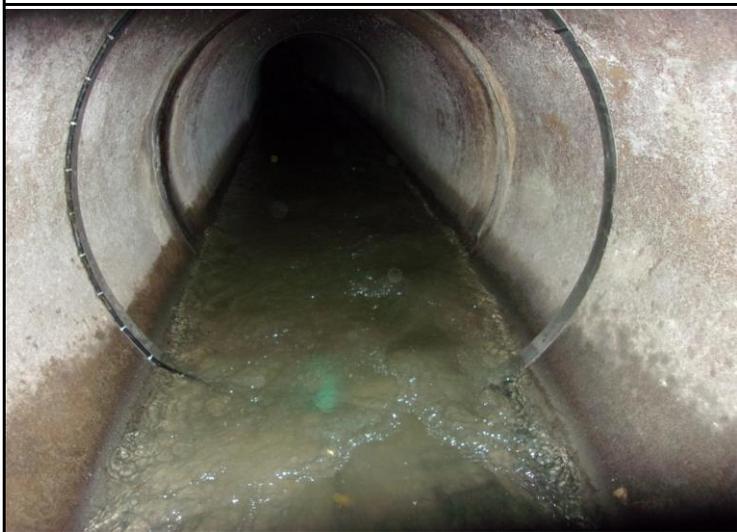
# Meter-47

Site Address / Location:	42.627471,-71.297308- Near Lowell Cemetery	Monitor Series	TRITON+	Location Type	Temporary
Site Access:	Drive	Pipe Size (H x W)	36.00x36.00	Pipe Shape	Circular

Manhole #	47	System Characteristics	Residential
Access	Drive		
			Medium

Installation Information	
Installation Date:	Thursday, March 16, 2023
Installation Type:	Doppler Standard Ring and Crank
Monitoring Location (Sensors):	Upstream 0-5 FT
Monitor Location:	Manhole
Sensors / Devices:	AV MAX/Peak Combo (CS9)
Pressure Sensor Range (psi)	0 -5 psi

Installation Confirmation:	
Confirmation Time:	10:12:00 AM
Pipe Size (HxW)	36.00x36.00
Depth of Flow (Wet DOF) (in)	6.32
Range (Air DOF) (in)	29.68
Downlooker Physical Offset (in)	0
Measurement Confidence (in)	0.25"
Peak Velocity (fps)	2.7
Velocity Sensor Offset (in)	0
Silt (in)	0
Silt Type	0

Manhole / Pipe Information:	
Manhole Depth (Approx. Inches):	193
Manhole Configuration	Common Trench
Manhole Material:	Concrete
Manhole Condition:	Good
Manhole Opening Diameter (in)	28
Manhole Diameter (Approx.):	28
Manhole Cover	Concealed
Manhole Frame	Normal
Active Drop Connections	No
Air Quality:	Good
Pipe Material	Concrete
Pipe Condition:	Good

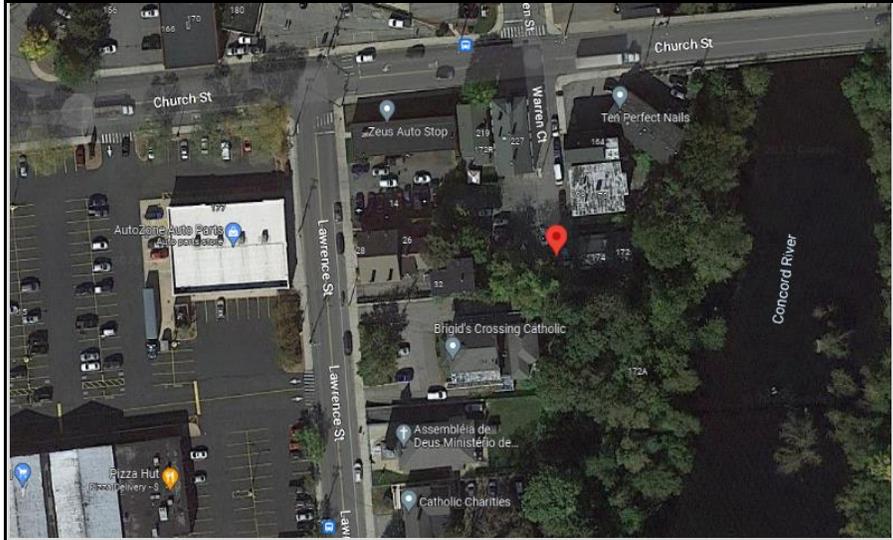
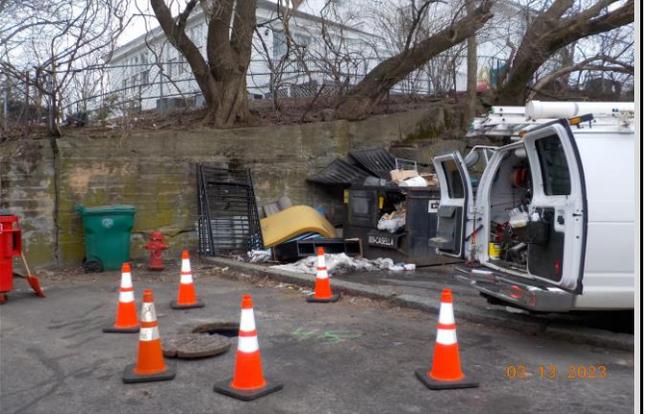
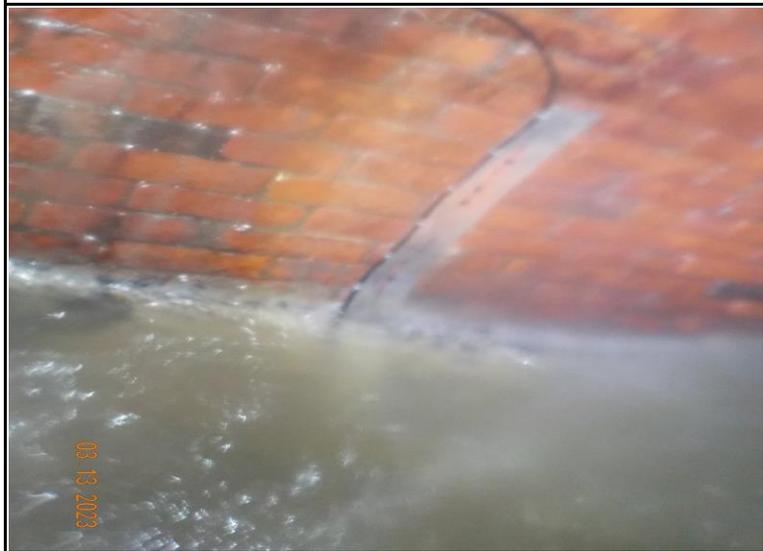
## Meter-48

Site Address / Location:	174 Warren Ct	Monitor Series	TRITON+	Location Type	Temporary
Site Access:	Drive	Pipe Size (H x W)	84.00x84.00	Pipe Shape	Circular

Manhole #	48	System Characteristics	Residential
Access	Drive		Traffic
			Medium

Installation Information	
Installation Date:	Monday, March 13, 2023
Installation Type:	Doppler Special Installation
Monitoring Location (Sensors):	Upstream 0-5 FT
Monitor Location:	Manhole
Sensors / Devices:	AV   Max/Peak Combo (CS9)
Pressure Sensor Range (psi)	0 - 5 psi
Installation Confirmation:	
Confirmation Time:	2:49:00 PM
Pipe Size (HxW)	84.00x84.00
Depth of Flow (Wet DOF) (in)	7.16
Range (Air DOF) (in)	76.84
Downlooker Physical Offset (in)	0
Measurement Confidence (in)	0.25"
Peak Velocity (fps)	6.1
Velocity Sensor Offset (in)	0
Silt (in)	0
Silt Type	0
Hydraulic Comments:	
Manhole / Pipe Information:	
Manhole Depth (Approx. inches):	366
Manhole Configuration	Common Trench
Manhole Material:	Brick
Manhole Condition:	Good
Manhole Opening Diameter (in)	28
Manhole Diameter (Approx.):	28
Manhole Cover	Concealed
Manhole Frame	Normal
Active Drop Connections	No
Air Quality:	Good
Pipe Material	Brick
Pipe Condition:	Good
Communication Information:

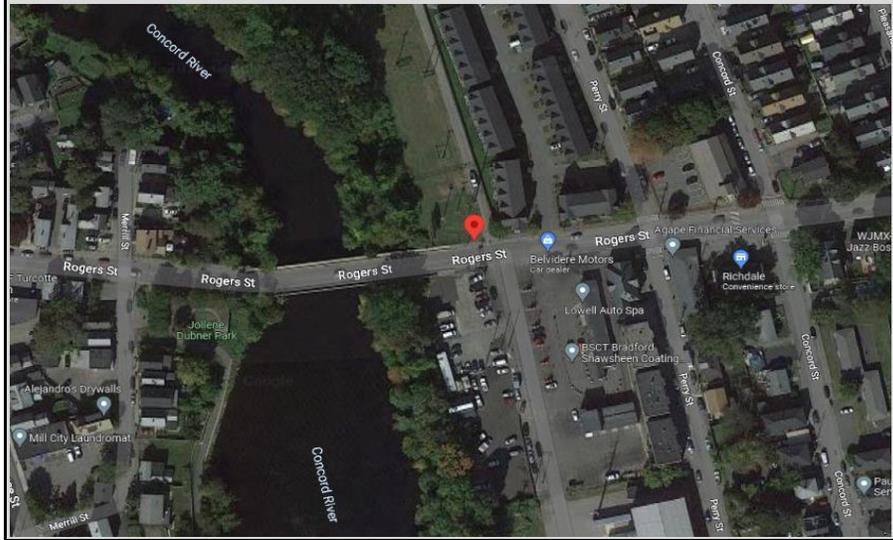
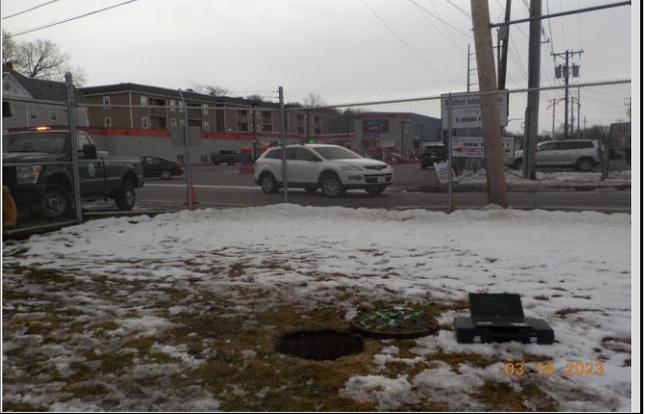
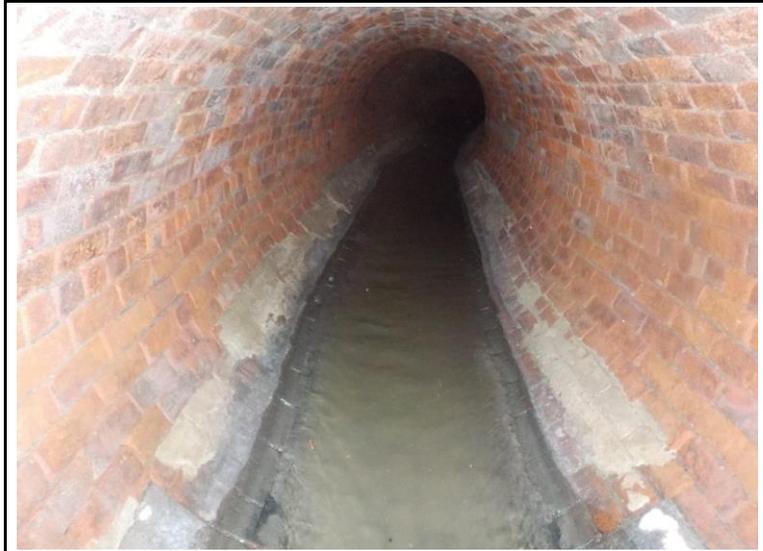
## Meter-50

Installation Confirmation:	
Confirmation Time:	3:48:00 PM
Pipe Size (HxW)	46.00x46.00
Depth of Flow (Wet DOF) (in)	4.95
Range (Air DOF) (in)	43.05
Downlooker Physical Offset (in)	0
Measurement Confidence (in)	0.25"
Peak Velocity (fps)	2.93
Velocity Sensor Offset (in)	0
Silt (in)	0
Silt Type	0

Manhole / Pipe Information:	
Manhole Depth (Approx. inches):	181
Manhole Configuration	Common Trench
Manhole Material:	Brick
Manhole Condition:	Good
Manhole Opening Diameter (in)	28
Manhole Diameter (Approx.):	28
Manhole Cover	Concealed
Manhole Frame	Normal
Active Drop Connections	No
Air Quality:	Good
Pipe Material	Brick
Pipe Condition:	Good

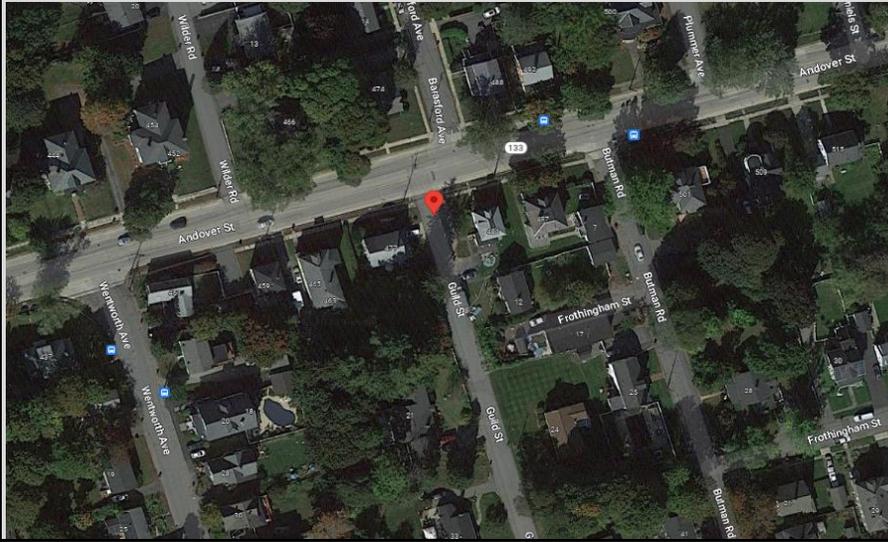
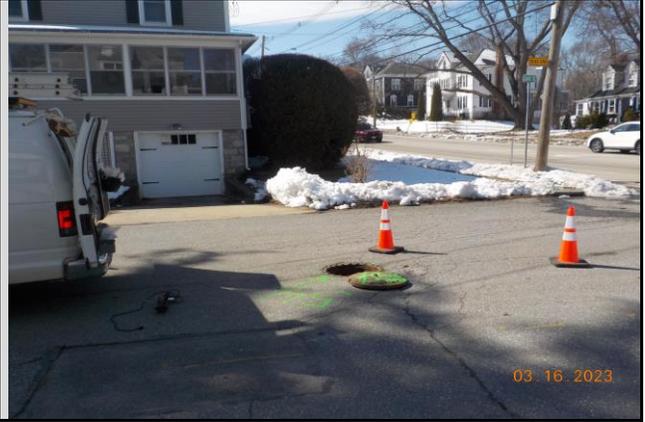
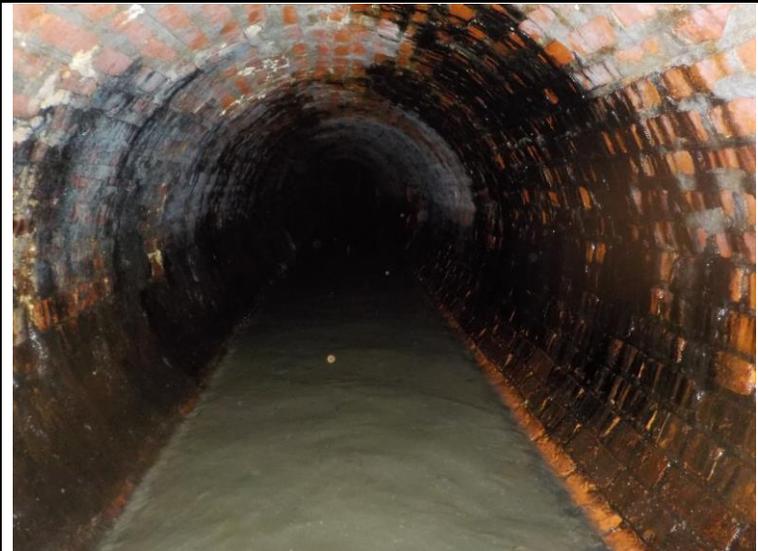
## Meter-54

Installation Confirmation:	
Confirmation Time:	1:51:00 PM
Pipe Size (HxW)	48.00x49.00
Depth of Flow (Wet DOF) (in)	10.16
Range (Air DOF) (in)	38.16
Downlooker Physical Offset (in)	0
Measurement Confidence (in)	0.25"
Peak Velocity (fps)	2.94
Velocity Sensor Offset (in)	0
Silt (in)	0
Silt Type	0

Manhole / Pipe Information:	
Manhole Depth (Approx. inches):	301
Manhole Configuration	Common Trench
Manhole Material:	Brick
Manhole Condition:	Good
Manhole Opening Diameter (in)	28
Manhole Diameter (Approx.):	28
Manhole Cover	Concealed
Manhole Frame	Normal
Active Drop Connections	No
Air Quality:	Good
Pipe Material	Brick
Pipe Condition:	Good

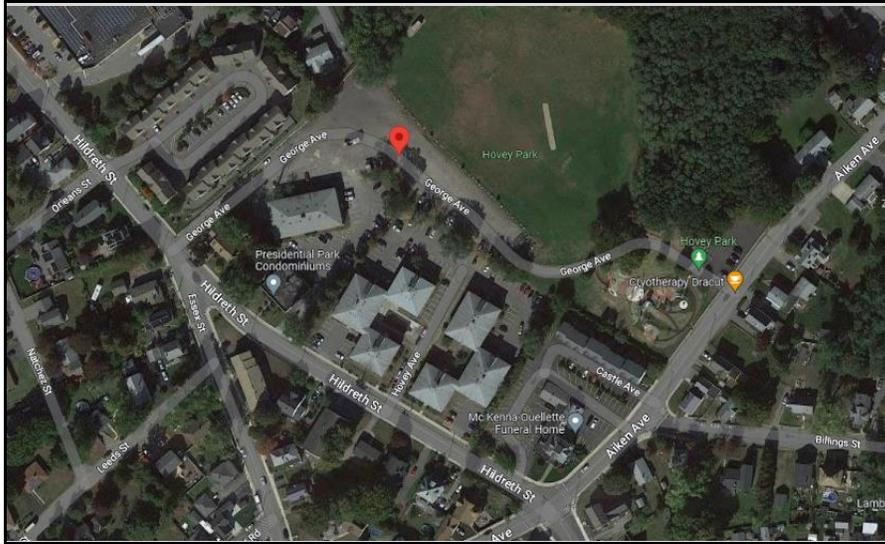
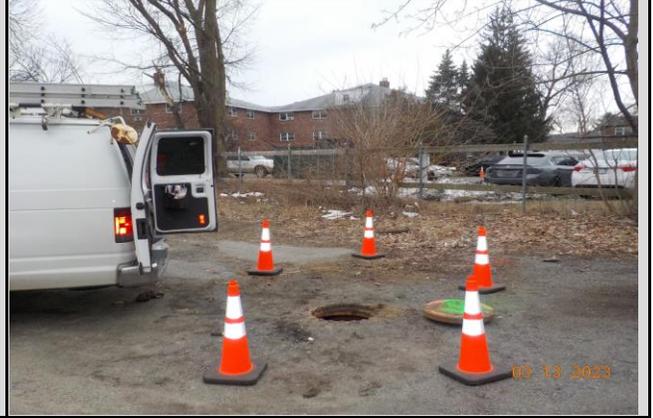
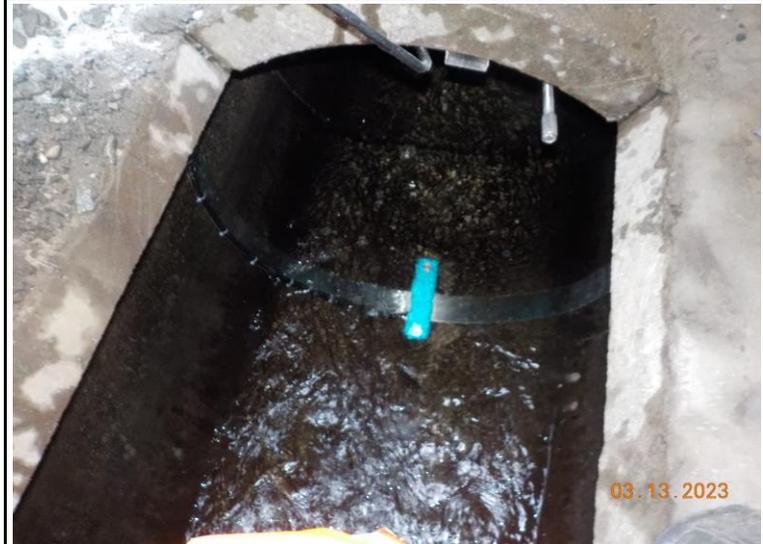
## Meter-60

Manhole / Pipe Information:	
Manhole Depth (Approx. inches):	Manhole Configuration
104.85	Common Trench
Manhole Material:	Manhole Condition:
Concrete	Good
Manhole Opening Diameter (in)	Manhole Diameter (Approx.):
28	28
Manhole Cover	Manhole Frame
Concealed	Normal
Active Drop Connections	Air Quality:
No	Good
Pipe Material	Pipe Condition:
Concrete	Good
Communication Information:	
Communication Type	Antenna Location
Wireless	Drilled Pavement / Concrete
