**LOWELL REGIONAL WASTEWATER UTILITY  
CITY OF LOWELL, MA  
2023 INFILTRATION AND INFLOW ANALYSIS REPORT  
KLEINFELDER PROJECT #20220166.003A**

**January 31, 2024**

**LOWELL INFILTRATION AND INFLOW ANALYSIS REPORT  
CITY OF LOWELL, MA**

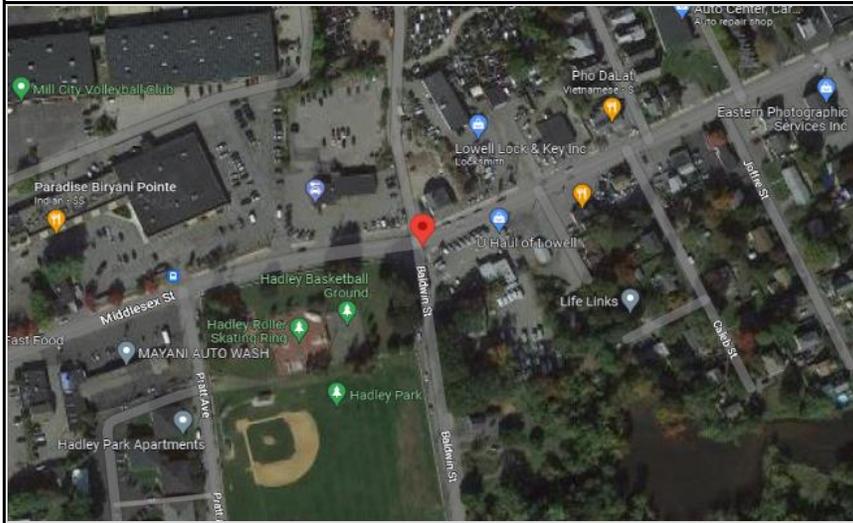
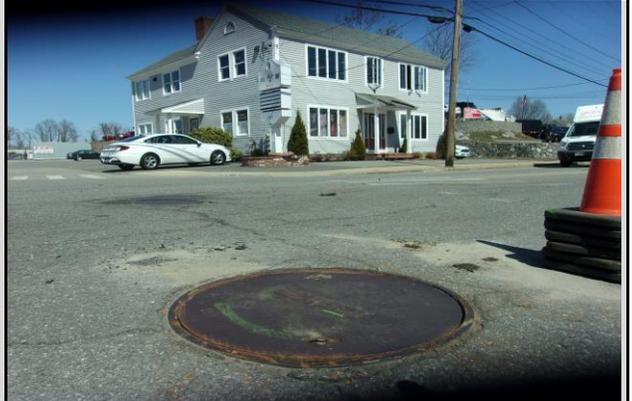
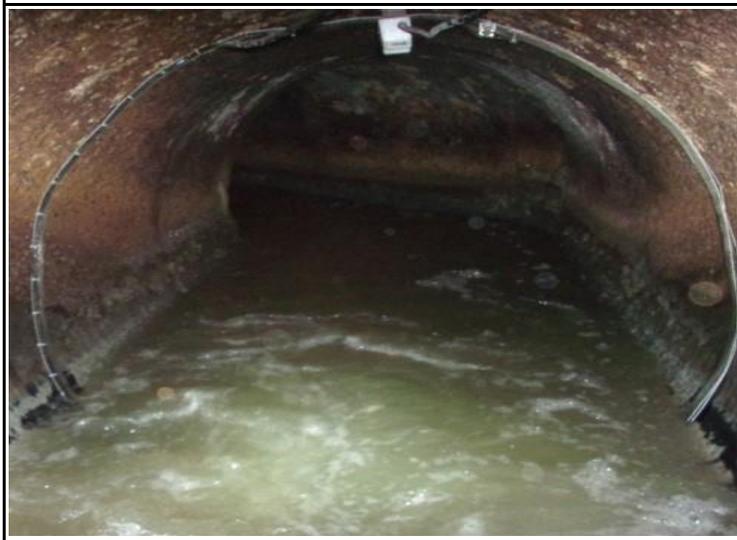
# Meter-62

Installation Confirmation:	
Confirmation Time:	11:26:00 AM
Pipe Size (HxW)	48.00x48.00
Depth of Flow (Wet DOF) (in)	15.34
Range (Air DOF) (in)	32.66
Downlooker Physical Offset (in)	1.5
Measurement Confidence (in)	0.38"
Peak Velocity (fps)	1.89
Velocity Sensor Offset (in)	0
Silt (in)	0
Silt Type	0

Manhole / Pipe Information:	
Manhole Depth (Approx. Inches):	203.25
Manhole Configuration	Common Trench
Manhole Material:	Concrete
Manhole Condition:	Good
Manhole Opening Diameter (in)	28
Manhole Diameter (Approx.):	28
Manhole Cover	Concealed
Manhole Frame	Normal
Active Drop Connections	No
Air Quality:	Good
Pipe Material	Concrete
Pipe Condition:	Good

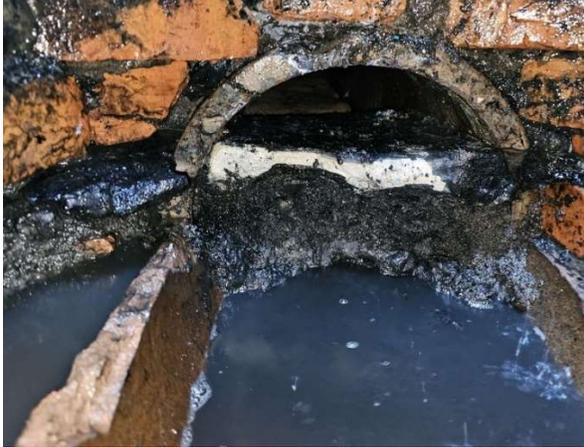
<p style="text-align: center;"><b>Moody Street – Canal Inflow</b></p>

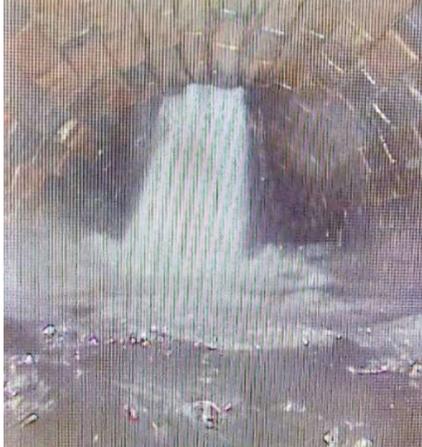
<p style="text-align: center;"><b>John Street – Hinge Fractures</b></p>

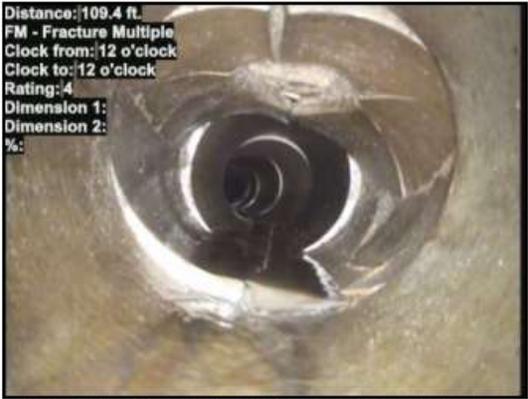
<p>Distance: 109.4 ft. FM - Fracture Multiple Clock from: 12 o'clock Clock to: 12 o'clock Rating: 4 Dimension 1: Dimension 2: %:</p> <p>Photo: AMH 'SMH-004116'__FM at 109.4 ft._5_2_2023_9_03 AM.JPG At: 109.4 ft. FM - Fracture Multiple 12/12</p>	<p style="text-align: center;"><b>Nesmith Street – Missing Bricks</b></p>

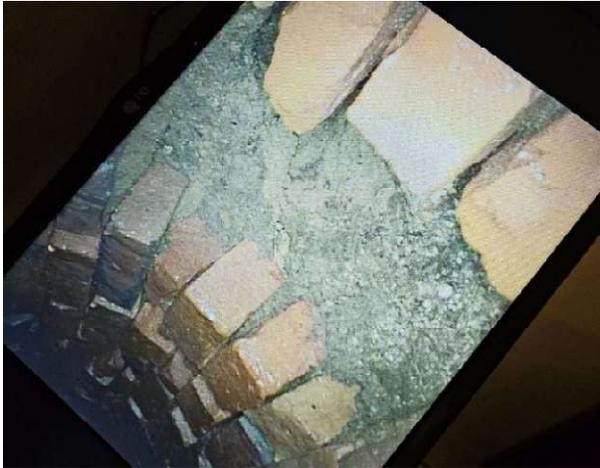
<p style="text-align: center;"><b>Lee Street – Holes</b></p>

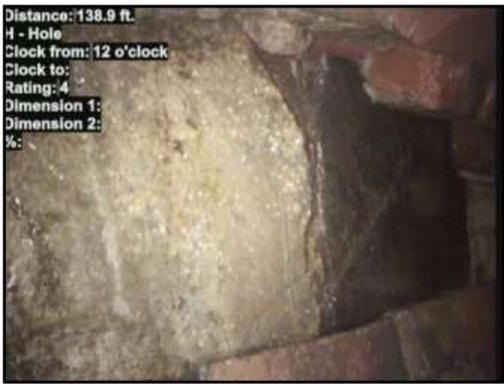
<p>Distance: 138.9 ft. H - Hole Clock from: 12 o'clock Clock to: Rating: 4 Dimension 1: Dimension 2: %:</p> <p>Photo: AMH 'SMH-004107'__H at 138.9 ft._4_20_2023_9_53 AM.JPG At: 138.9 ft. 12/ H - Hole</p>	<p style="text-align: center;"><b>Bartlett – Roots, Holes, Displaced Bricks</b></p>

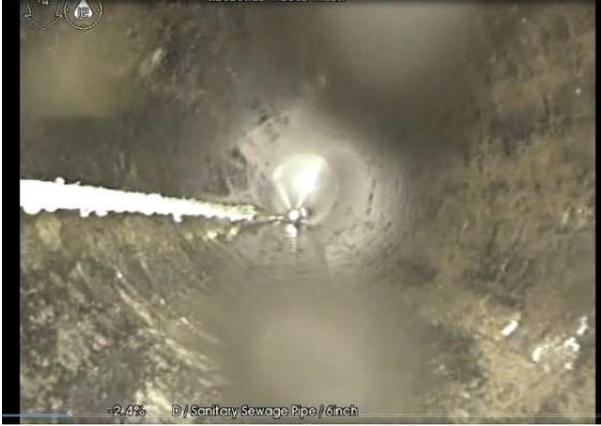
<p>Distance: 0.0 ft. AMH - Manhole Clock from: Clock to: Rating: Dimension 1: Dimension 2: %: SIPHON INLET STRUCTURE</p>

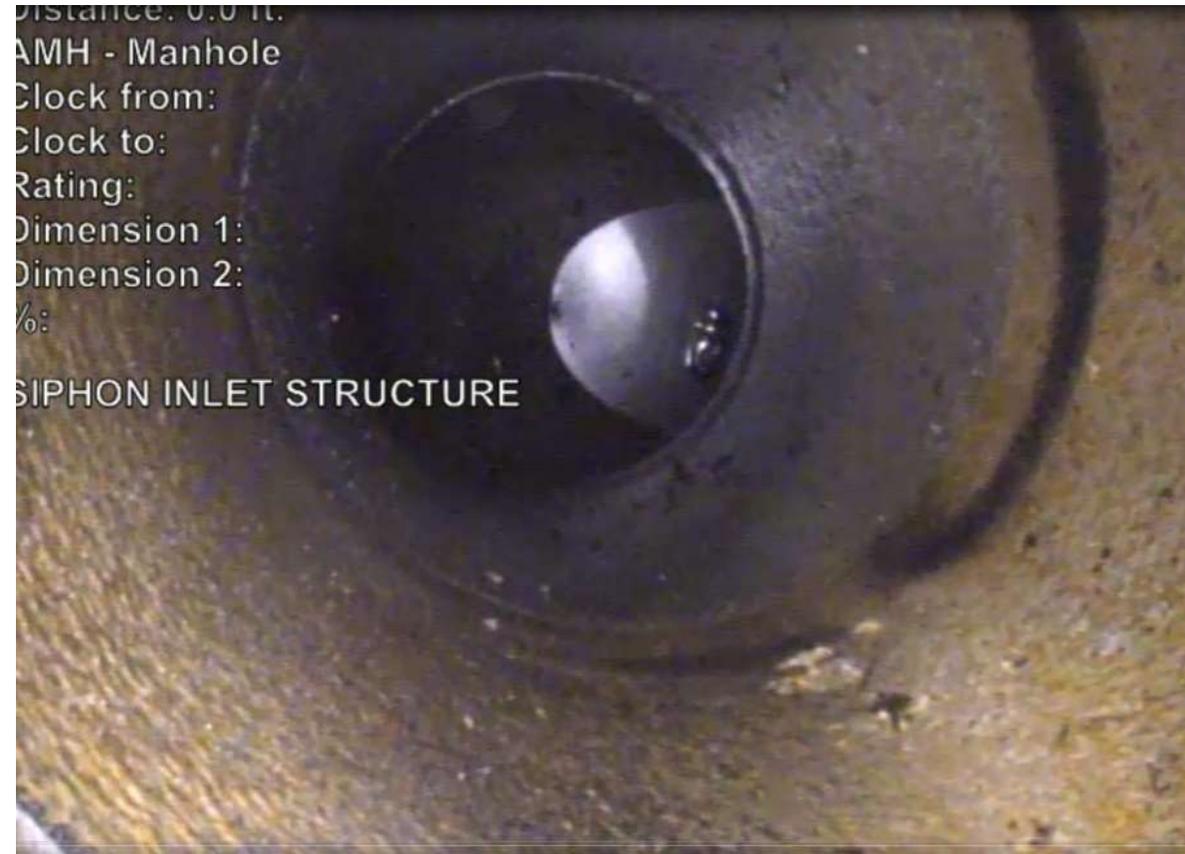
<p>30-inch Barrel</p>
