Central Street Walk Audit Report

City of Lowell
Department of Planning & Development

Walk Audit

On October 24, 2024, the City conducted its first walk audit on Central Street. The walk included approximately 0.25 miles along Central Street between Middle Street and Middlesex Street. Over the one-hour walk, observations and insights shared by the participants were recorded for formulating short-term and long-term goals for the street.

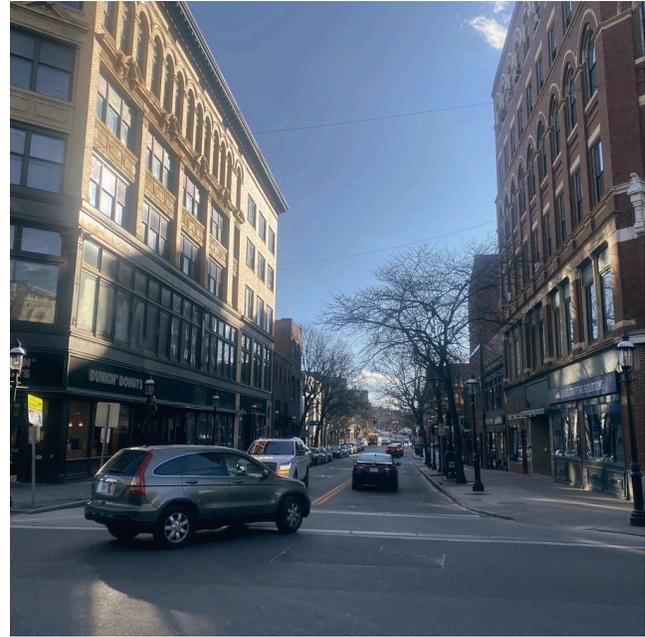
Central Street & Merrimack Street intersection

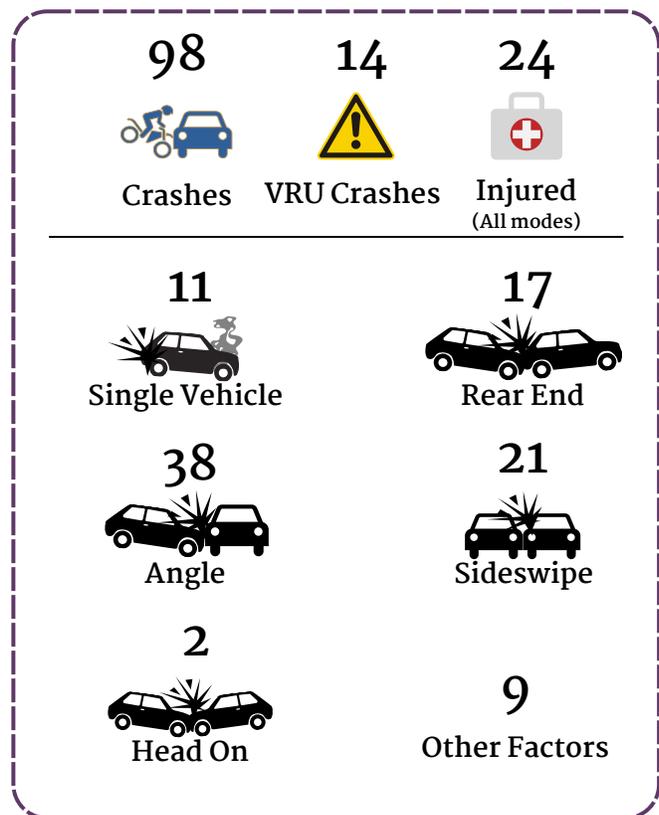
Intersection crashes

57% of the VRU crashes occurred while the pedestrians and bicyclists were entering a crosswalk attempting to cross. The highest number of VRU crashes occurred at the intersections of Central Street with Merrimack Street and with Jackson Street. Turning movements contributed to 50% of crashes and 20% of those occurred in the

dark. Factors contributing to VRU crashes included operation of electronic devices, distracted driving, and visibility conflicts while pedestrians were crossing and vehicles are completing turning movements.

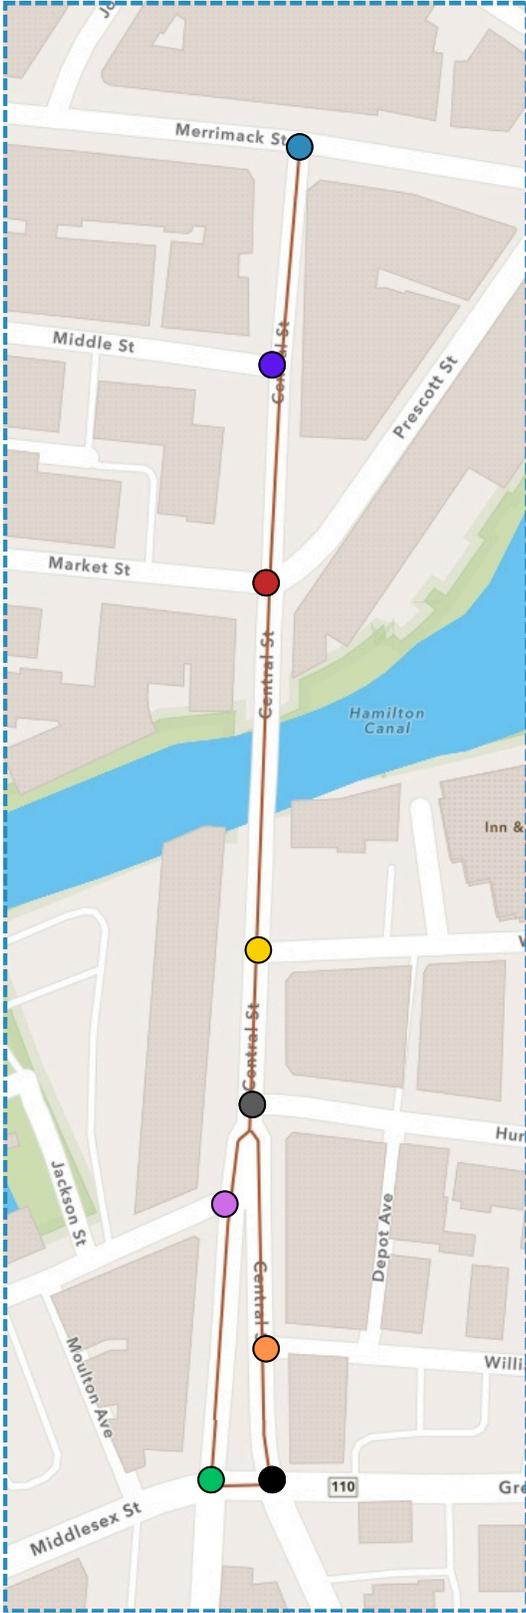
Crash Summary

Intersection of Central Street with	Total Crashes	VRU Crashes	Injury (All modes)	Single Vehicle	Rear End	Angle	Sideswipe	Head On
Merrimack Street	19	3	5	1	2	7	6	
Middle Street	4	1		1	1	1		
Market Street	14	1	3	2	5	3	2	
Warren Street	8	1	2		1	4	2	
Hurd Street	7		2	1	1		5	
Jackson Street	12	4	2	2	2	6	1	1
Williams Street	3	1	1	1	2			
Green Street	10	1	3	2	2	2	2	
Middlesex Street	21	2	6	1	1	15	3	1
Total	98	14	24	11	17	38	21	2

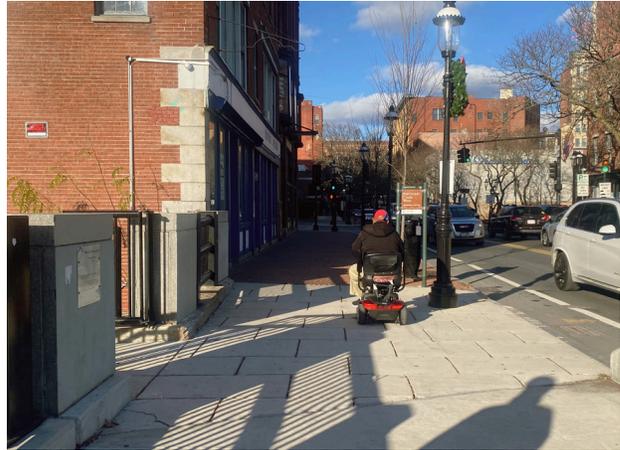
Sidewalk on Central Street

The sidewalk is wide and easy to walk on. Concerns noted cracks in the sidewalks causing difficulty for those needing mobility assistance or pushing strollers. An even surface is easier to traverse for all users. Varying sidewalk treatments, including concrete and brick were noted to be difficult to transition for pedestrians using mobility devices.

Repair sidewalks to create an even surface free of cracks

Short-term recommendations	Long-term recommendations
<ul style="list-style-type: none"> • Repair sidewalk panels or fill gaps and cracks that need immediate attention. • Reset or replace brick areas as necessary. 	<ul style="list-style-type: none"> • Ensure all ramps are in compliance with ADA standards and add tactile warning surfaces. • Raise sidewalks wherever appropriate to create even surface for pedestrians. • Consider removing all brick surfaces.

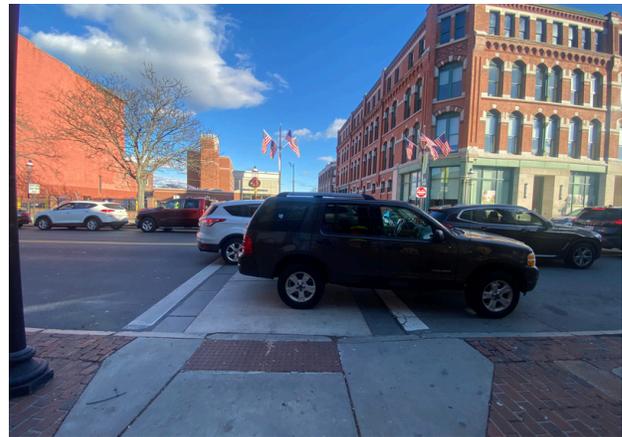
Car parked on crosswalk

The crosswalk color makes them less visible for both the pedestrians and drivers, particularly at night. Vehicles tend to park immediately against the mid-block crosswalks, making pedestrians hard to see after they step off the sidewalk. Between Middlesex Street and Market Street, Central Street transitions from four vehicle travel lanes to two vehicle travel lanes.

Improve pedestrian visibility and daylight crosswalks

Short-term recommendations	Long-term recommendations
<ul style="list-style-type: none"> • Enforce parking regulations and ticket violators. • Mark parking spaces on Central Street between Hurd Street and Green Street and remove parking from within 20 feet of the mid-block crosswalks and the side street intersections. • Enforce right turn on red restrictions at intersections near crosswalks to eliminate conflicts with pedestrians crossing the street. • Daylight crosswalks using flex posts to define no parking zones near crosswalks. 	<ul style="list-style-type: none"> • Install Rectangular Rapid Flashing Beacon (RRFB) at Central Street/Hurd Street and Central Street/Warren Street mid-block crossings. • Install curb bump outs at the mid-block crossings at Hurd Street and Warren Street to improve visibility. • Raise crosswalks to make pedestrians visible especially in the mid-block section of Central Street at Hurd Street and Warren Street intersections.

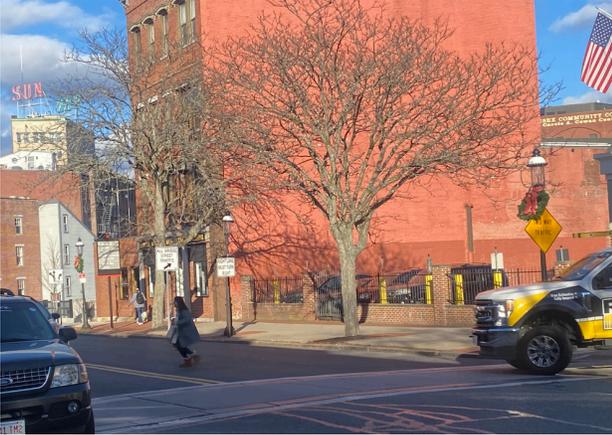
Woman running to cross Central Street

While there is an exclusive pedestrian phase, it was observed that the pedestrian crossing time was inadequate to cross the entire width of Central Street, requiring pedestrians to stop on the median island. This causes pedestrians to cross mid-block through the median island instead of walking to a signalized crossing.

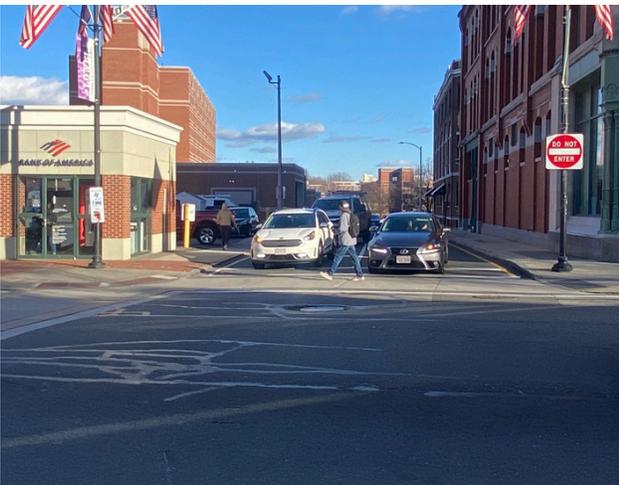
74% of the participants found it difficult to get to their destination by crossing Central Street. The visibility for pedestrians crossing at the mid-block crosswalks at Warran Street and Hurd Street was one of the biggest concerns noted on Central Street. The existing crosswalks along Central Street between Middle Street and Middlesex Street are constructed as concrete panels with slate borders and white stripes on the outside of the slate. This crosswalk construction is only found in the Downtown area, where a more visible striping treatment is used elsewhere in the City.

Cars yielding for pedestrian at Warren Street

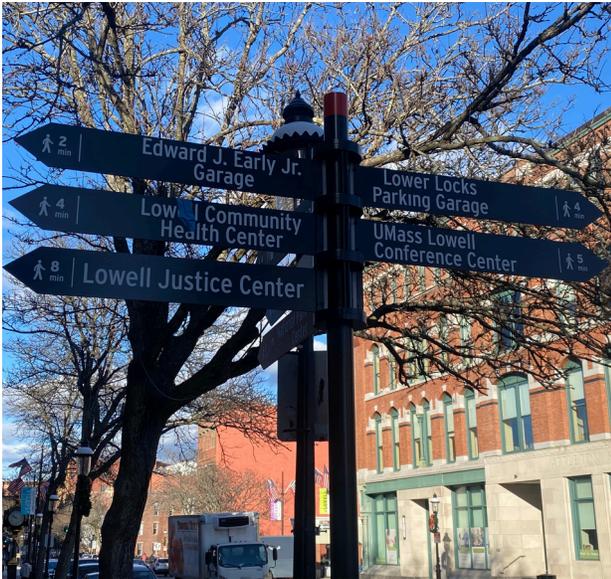
Signage for bus stops were noted to be unclear, limiting the potential to change travel modes if desired.

Existing wayfinding sign

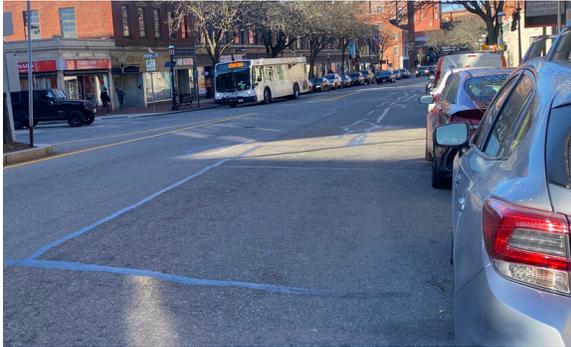
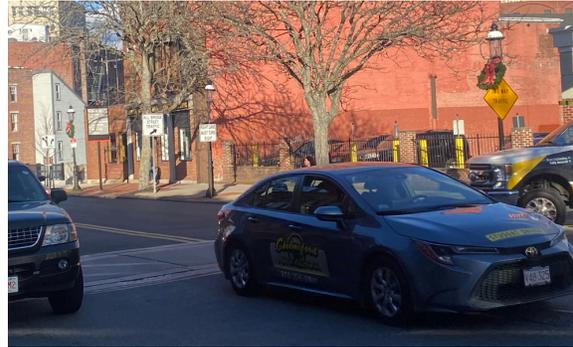
Crosswalks were one of the biggest concerns to the participants as they were not visible to the drivers. Parked cars near intersections and on crosswalks can hinder visibility to both drivers and pedestrians.

Parked cars hinder pedestrian access & visibility

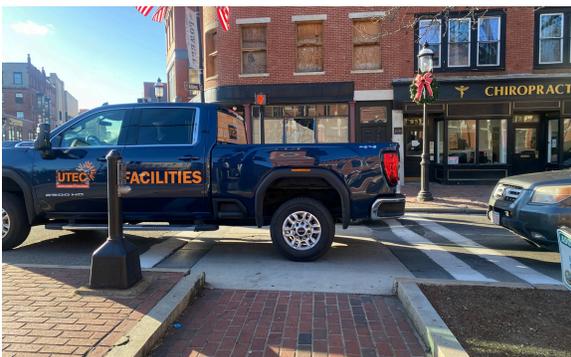
Truck stopped beyond the stop line

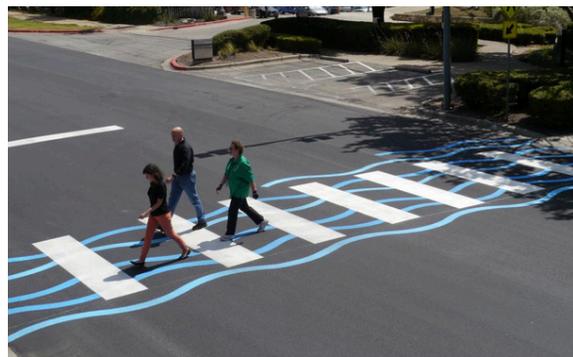
Painted crosswalks; Source: austintexas.gov

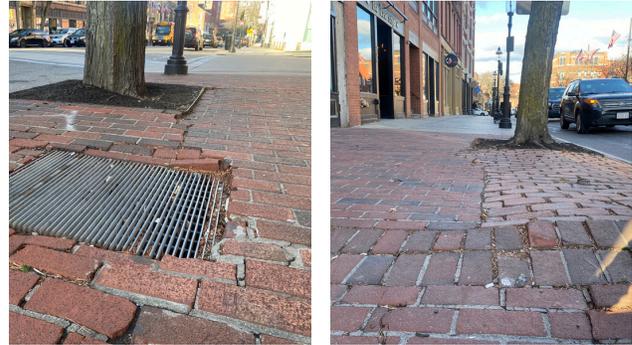
The sidewalk width is generous along the corridor walked and the surface is mostly even. Some sidewalk areas are in need of repair for cracks and non- ADA-compliant cross-slopes that make it uncomfortable for pedestrians using mobility devices and/or strollers. There are sections of the sidewalk that are made of brick that are deteriorating and should be replaced.

Uneven sidewalks on parts of Central Street

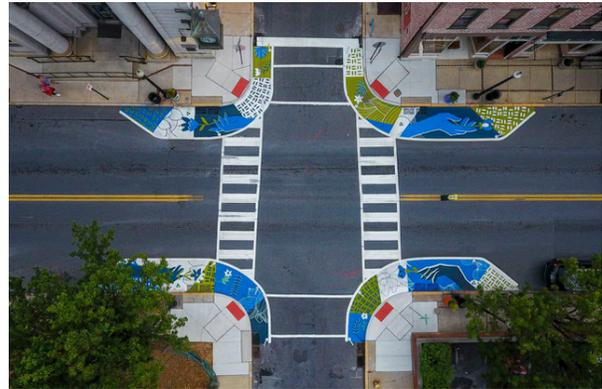
Central Street attracts over 13,000 daily vehicles, including trucks and buses. These vehicles travel along the street with little to no consideration for pedestrians. To forcibly slow down the vehicles and improve pedestrian safety, implementing temporary and eventually adopting permanent traffic calming measures is vital for this street.

Painted bump outs; Source: leighvalleylive.com

Short-term recommendations	Long-term recommendations
<ul style="list-style-type: none"> • Pilot narrow travel lanes by placing temporary bike lanes, extended sidewalks and/or paint curb bump outs to guide traffic. • Identify potential intersections for creative placemaking program such as arts and murals on road and crosswalks by collaborating with local artists and residents. 	<ul style="list-style-type: none"> • Implement successful temporary traffic calming strategies to create permanent installations, such as changing temporary painted bump outs to concrete bump-outs.

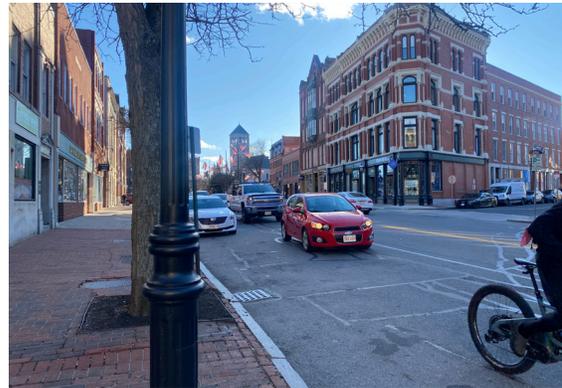
The length of Central Street between Hurd Street and Green Street has wide travel lanes and parking lanes that are under-utilized, and the absence of parked cars encourages drivers to use them as by-pass lanes. On-street parking is desirable for businesses and could aid in filling vacant storefronts. The width of the street outside of the parking lane may be an opportunity to pilot a bicycle lane.

Parking lane being used as travel lane

Short-term recommendations	Long-term recommendations
<ul style="list-style-type: none"> Pilot protected bike lanes along the street to discourage people from driving on parking lanes and to narrow the travel lane. 	<ul style="list-style-type: none"> Implement road diet strategy based on pilot bike lane program results.

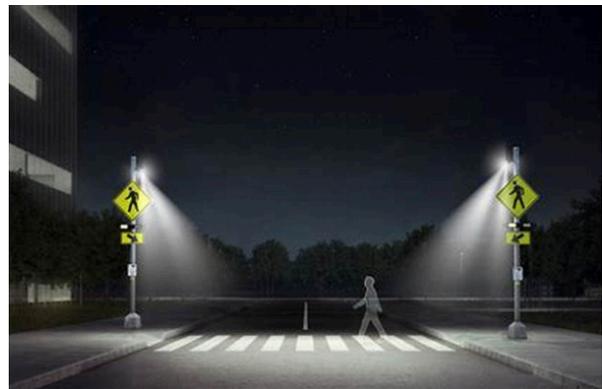
Even though the walk audit took place in daytime hours, many participants expressed their concern about feeling unsafe to cross the road or even walk on the sidewalks due to poor lighting. The current street lighting along the street is not adequate to cover the width of the sidewalk.

Crosswalk lighting; Source: traffictechnologytoday.com

Short-term recommendations	Long-term recommendations
<ul style="list-style-type: none"> Assess lighting conditions at night to find problem areas and to replace the light bulbs/lighting system. 	<ul style="list-style-type: none"> Study light levels and design lighting to improve visibility of crosswalks and for pedestrians walking at night.

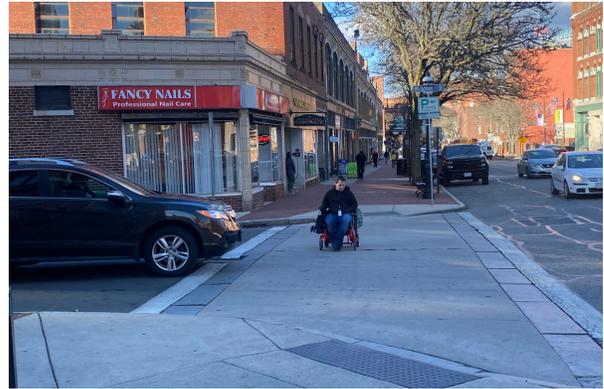
To encourage walking along Central Street, additional safety measures should be implemented. The street has residential, commercial and office land uses with parking on both sides and hosts a high daily traffic volume. While the sidewalks are wide and crosswalks connect curb to curb, additional infrastructure is needed to provide a safe and comfortable walking experience for the pedestrians.

Car stopped too close to sidewalk

Short-term recommendations	Long-term recommendations
<ul style="list-style-type: none"> • Narrow travel lanes between Hurd Street and Green Street by piloting a protected bicycle lane to reduce traffic speeds. • Install Rectangular Rapid Flashing Beacons (RRFB) to indicate mid-block pedestrian crossing locations. • Add benches, resting areas, and trash cans for pedestrians. • Review the traffic signal timing for pedestrian crossings at Central Street/Middlesex Street and Central Street/Market Street intersection. • Study the Central Street/Warren Street intersection for Stop sign/flashing beacon installation. 	<ul style="list-style-type: none"> • Install curb bump outs at mid-block pedestrian crossings to reduce crossing distance. • Install Stop sign/flashing beacon at Central Street/Warren Street if the intersection qualifies. • Raise crosswalks for improving safety while crossing the street.
