**LOWELL REGIONAL WASTEWATER UTILITY
CITY OF LOWELL, MA
PHASE 1 SANITARY SEWER EVALUTION
SURVEYS (SSES) REPORT
KLEINFELDER PROJECT #20220166.003A**

April 11, 2025

PHASE 1 SANITARY SEWER EVALUATION SURVEYS (SSES) REPORT

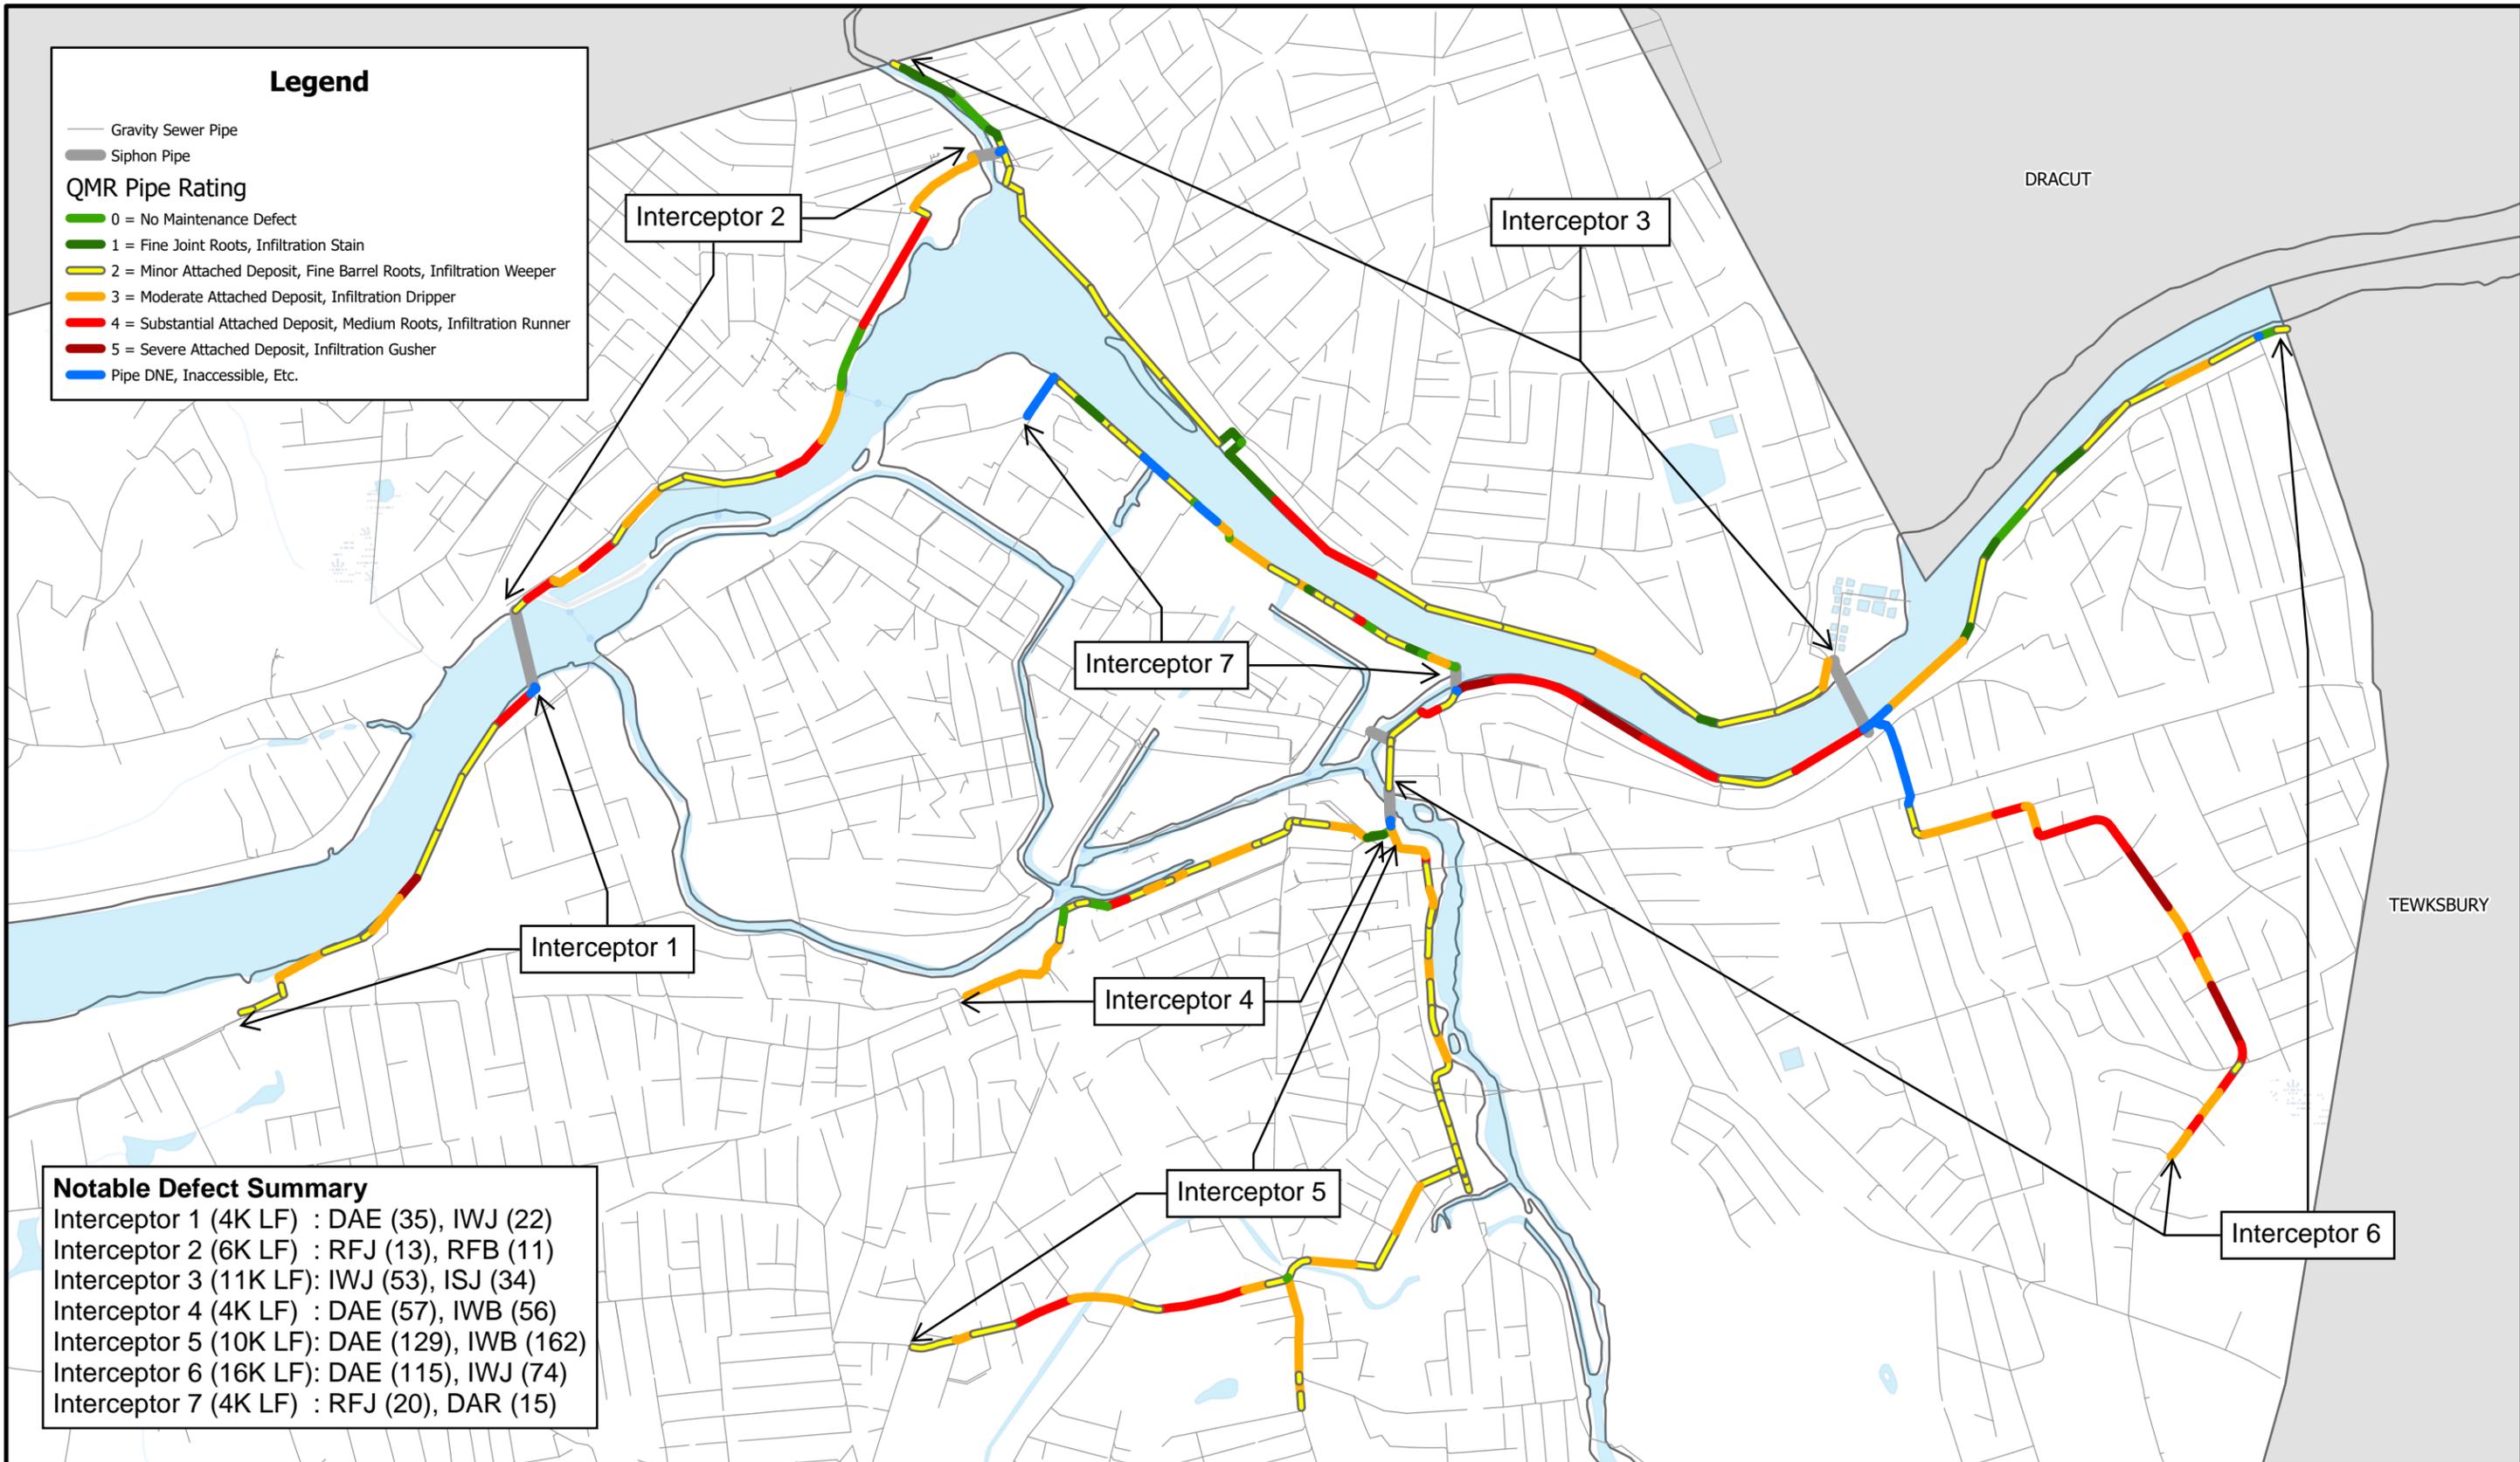
Notable Defect Summary

Interceptor 1 (4K LF)	: DAE (35), IWJ (22)
Interceptor 2 (6K LF)	: RFJ (13), RFB (11)
Interceptor 3 (11K LF)	: IWJ (53), ISJ (34)
Interceptor 4 (4K LF)	: DAE (57), IWB (56)
Interceptor 5 (10K LF)	: DAE (129), IWB (162)
Interceptor 6 (16K LF)	: DAE (115), IWJ (74)
Interceptor 7 (4K LF)	: RFJ (20), DAR (15)

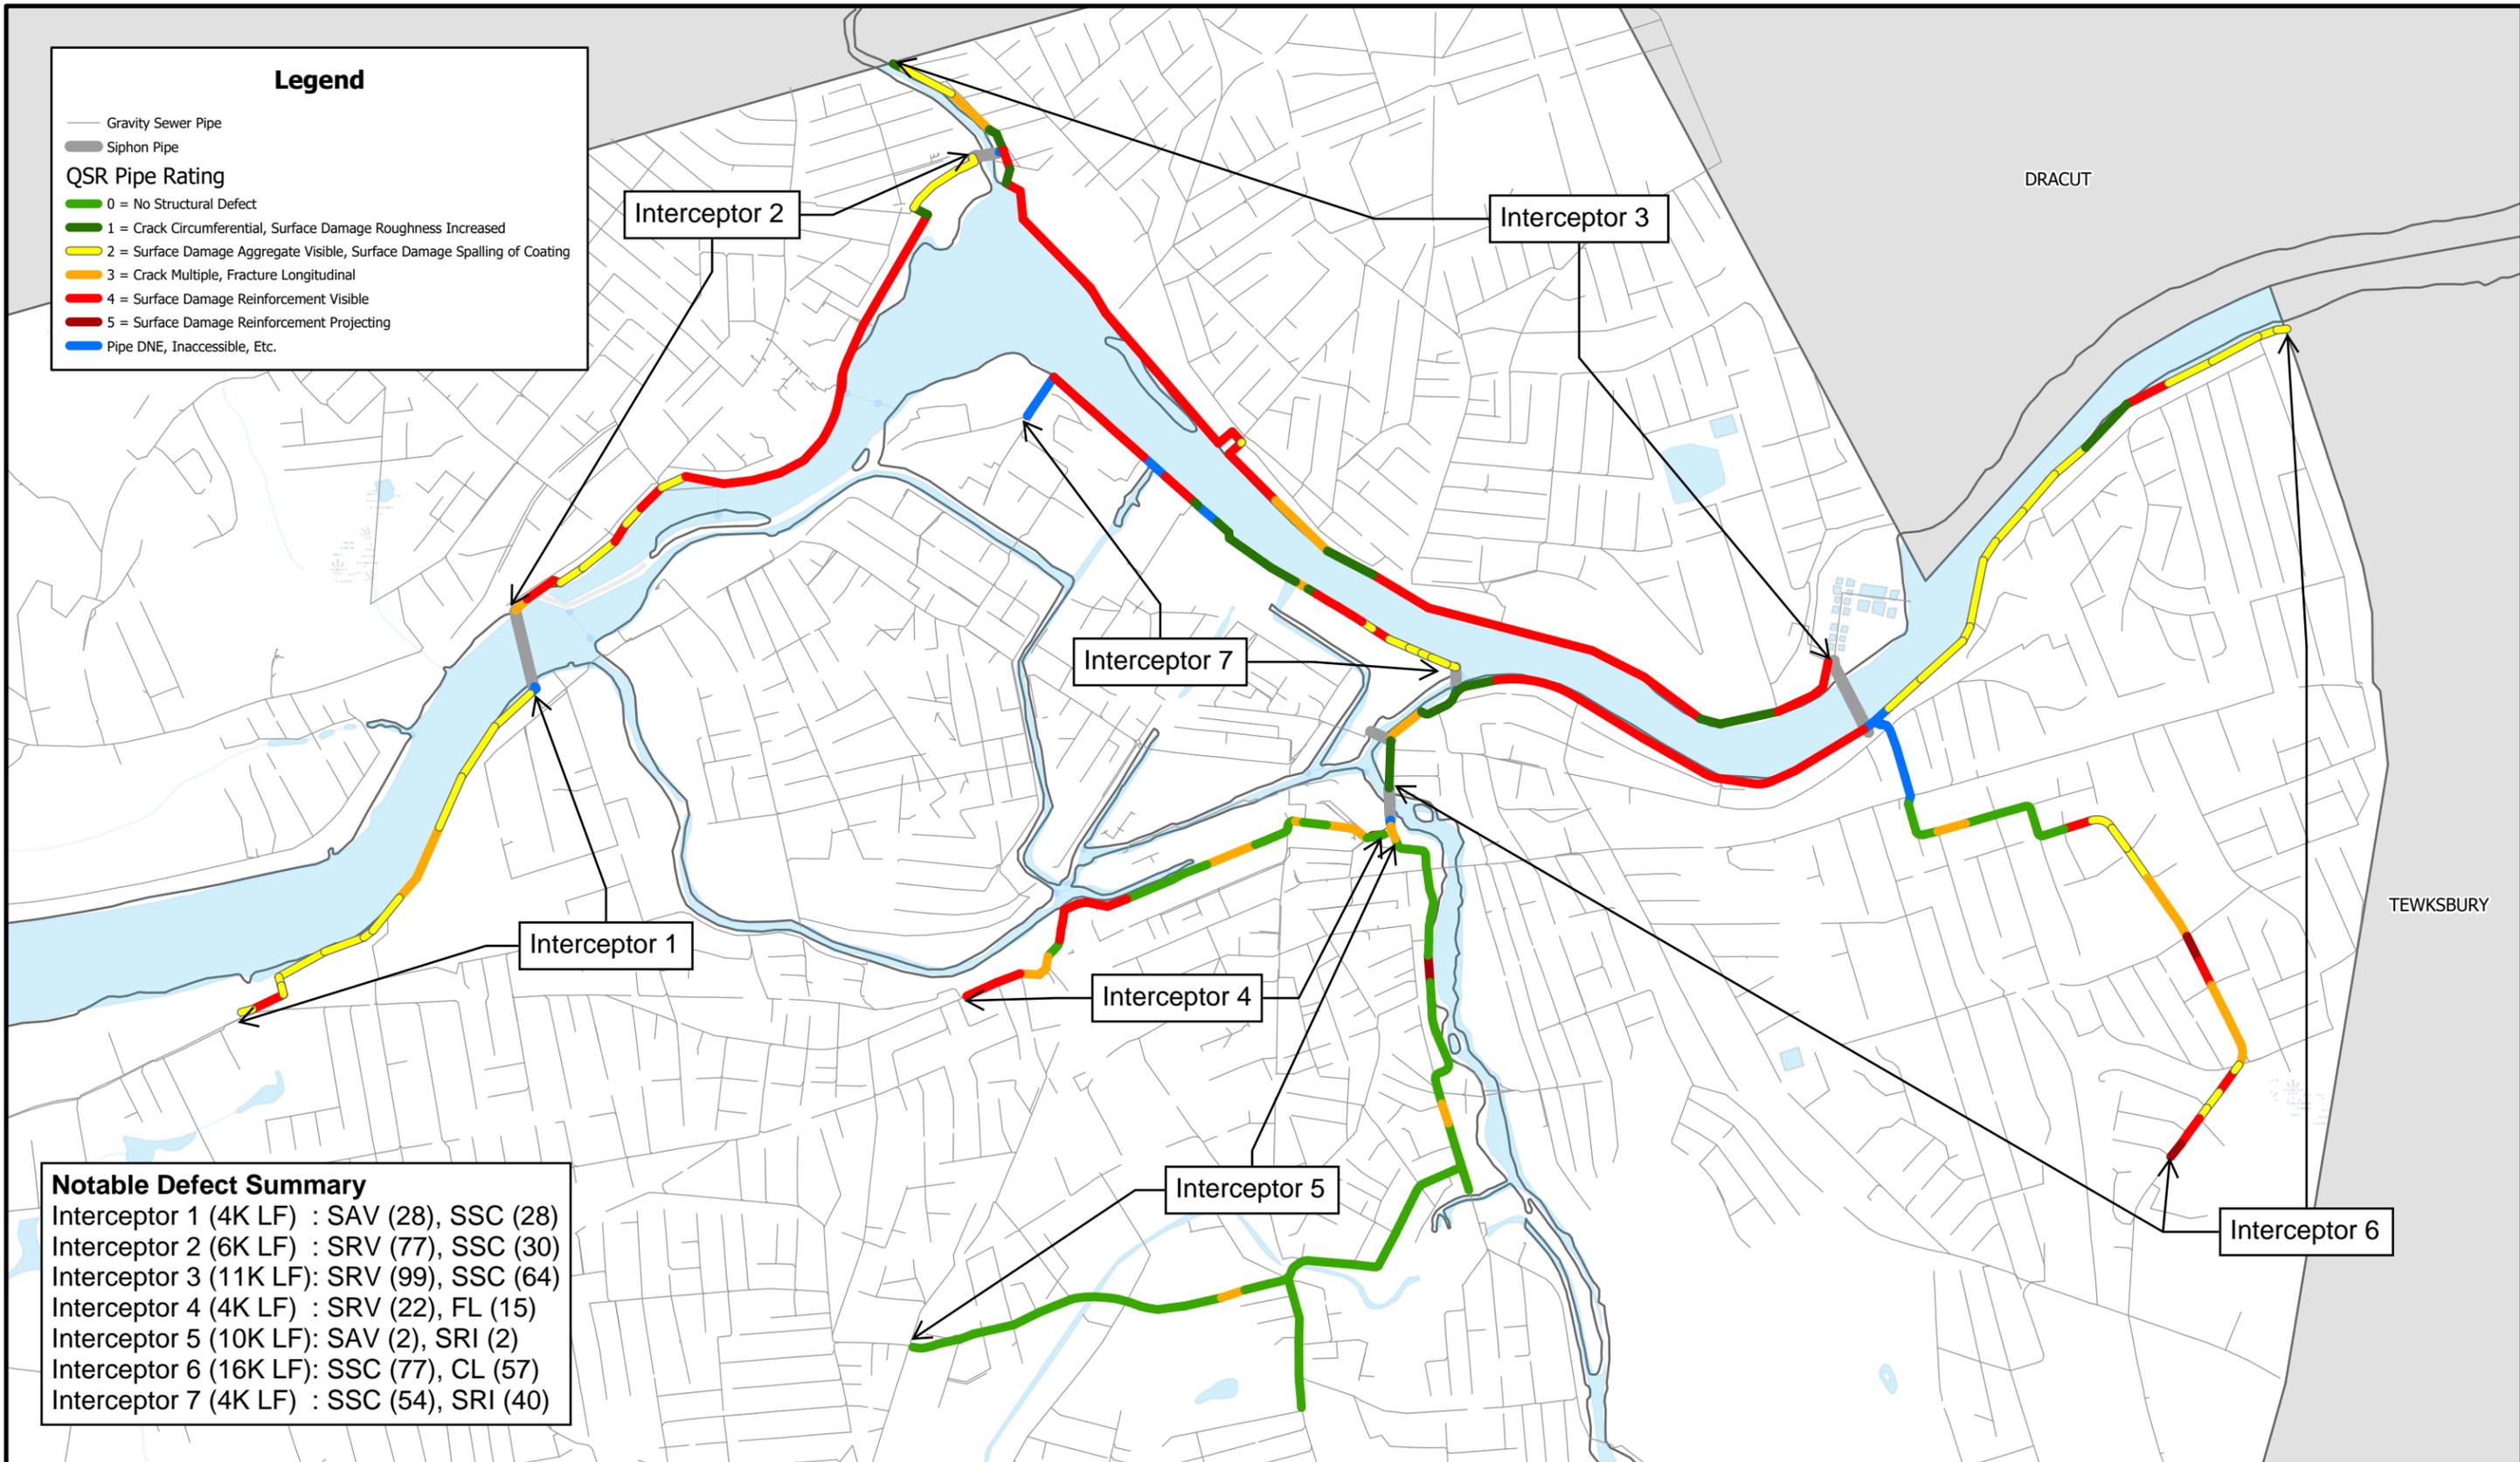
Notable Defect Summary

Interceptor 1 (4K LF)	: SAV (28), SSC (28)
Interceptor 2 (6K LF)	: SRV (77), SSC (30)
Interceptor 3 (11K LF)	: SRV (99), SSC (64)
Interceptor 4 (4K LF)	: SRV (22), FL (15)
Interceptor 5 (10K LF)	: SAV (2), SRI (2)
Interceptor 6 (16K LF)	: SSC (77), CL (57)
Interceptor 7 (4K LF)	: SSC (54), SRI (40)

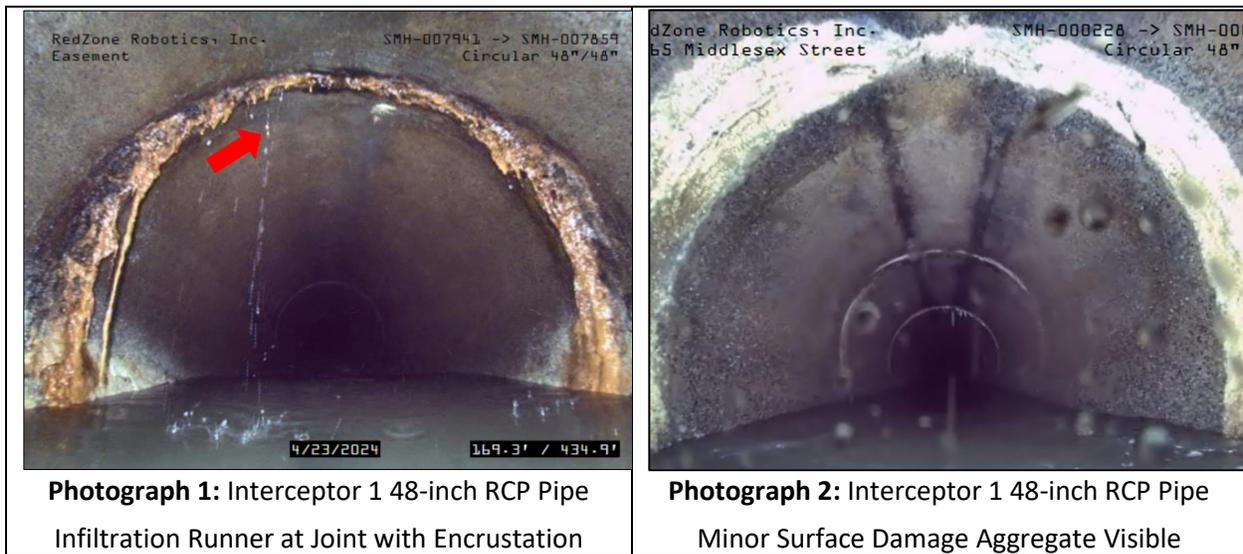
Interceptor 1 is comprised of approximately 4,027 linear feet of 48-inch reinforced concrete pipe (RCP) along the southern boundary of the Merrimack River, terminating at the Walker Siphon. The majority of maintenance defects in this section were deposit attached encrustation (DAE), which are evidence of infiltration, as well as infiltration weepers at joints (IWJ). Most structural defects were surface damage aggregate visible (SAV) and surface damage spalling of coating (SSC). The aforementioned defects were observed throughout the pipeline rather than in targeted instances. Although these defects indicate the initial signs of pipe deterioration, they do not appear to be severe in nature at this time. **Photographs 1 and 2** below show representative defects of typical observations for this interceptor section.

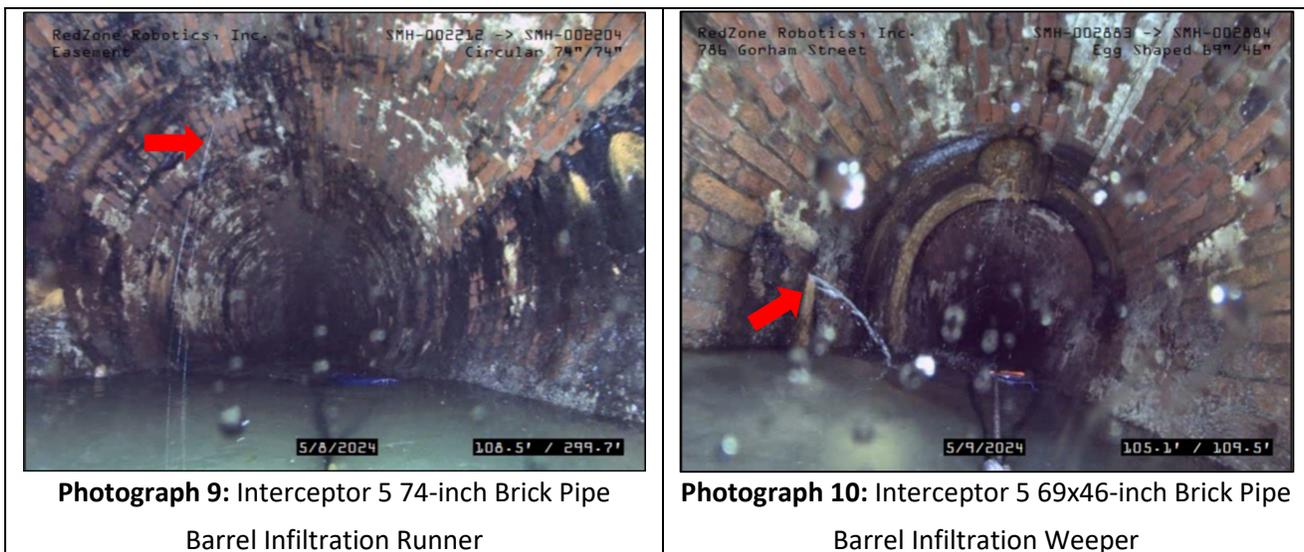
Interceptor 5 is comprised of approximately 10,157 linear feet of 72-inch and 84-inch brick pipe spanning along the Concord River and terminating at the Warren Siphon. The upstream reach of the interceptor crosses both the Lowell Connector and River Meadow Brook. The majority of maintenance defects in this section were deposits attached encrustation (DAE) and infiltration weeper at barrel (IWB). Most structural defects were surface damage aggregate visible (SAV) and surface damage roughness increased (SRI). Although these defects indicate the initial signs of pipe deterioration, they do not appear to be severe in nature at this time. **Photographs 9 and 10** below show representative defects of typical observations for this interceptor section.

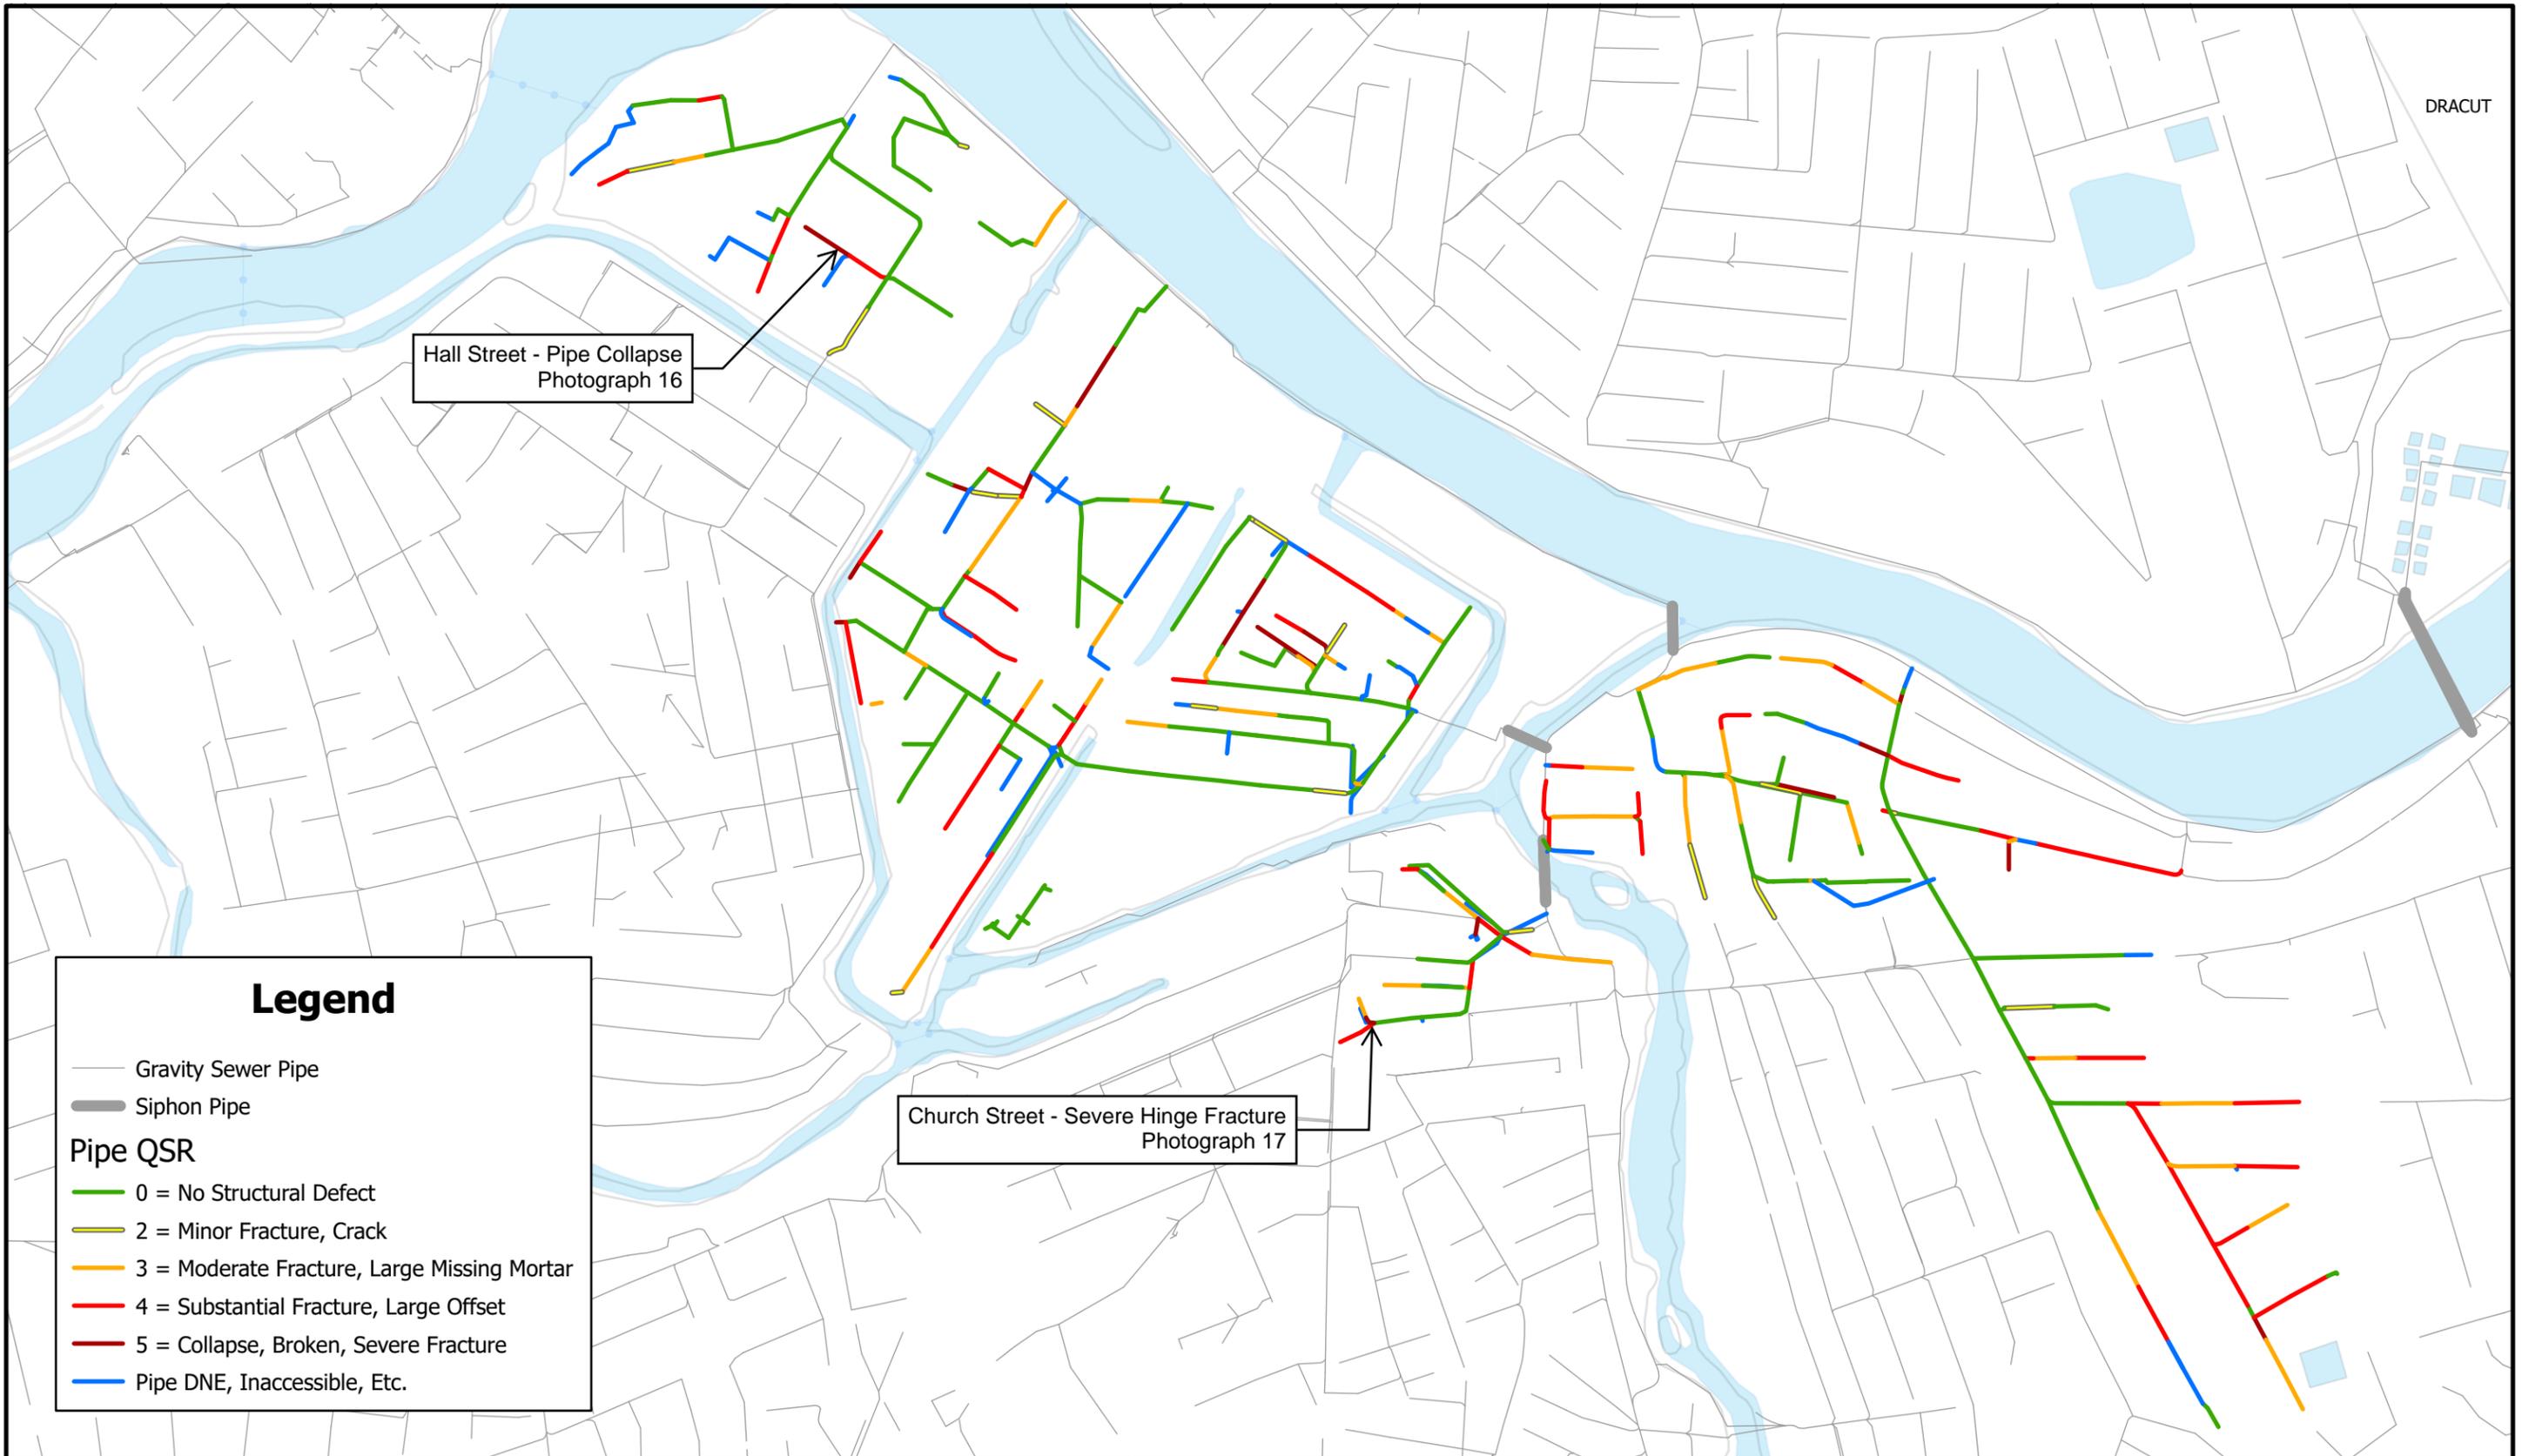
Phase 1 SSES Report 2023/2024 Downtown Pipe QSR Defect Map
Lowell Regional Wastewater Utility 451 First Street Blvd. Lowell, MA 01850

Additional maintenance defects were infiltration defects on Perkins Street, Cabot Street, and Market Street. As well as moderate structural defects such as broken soil visible, multiple fractures, and joint separated medium in Fairmount Street, Fairview Ave, Talbot Street, and Mansur Street Area.

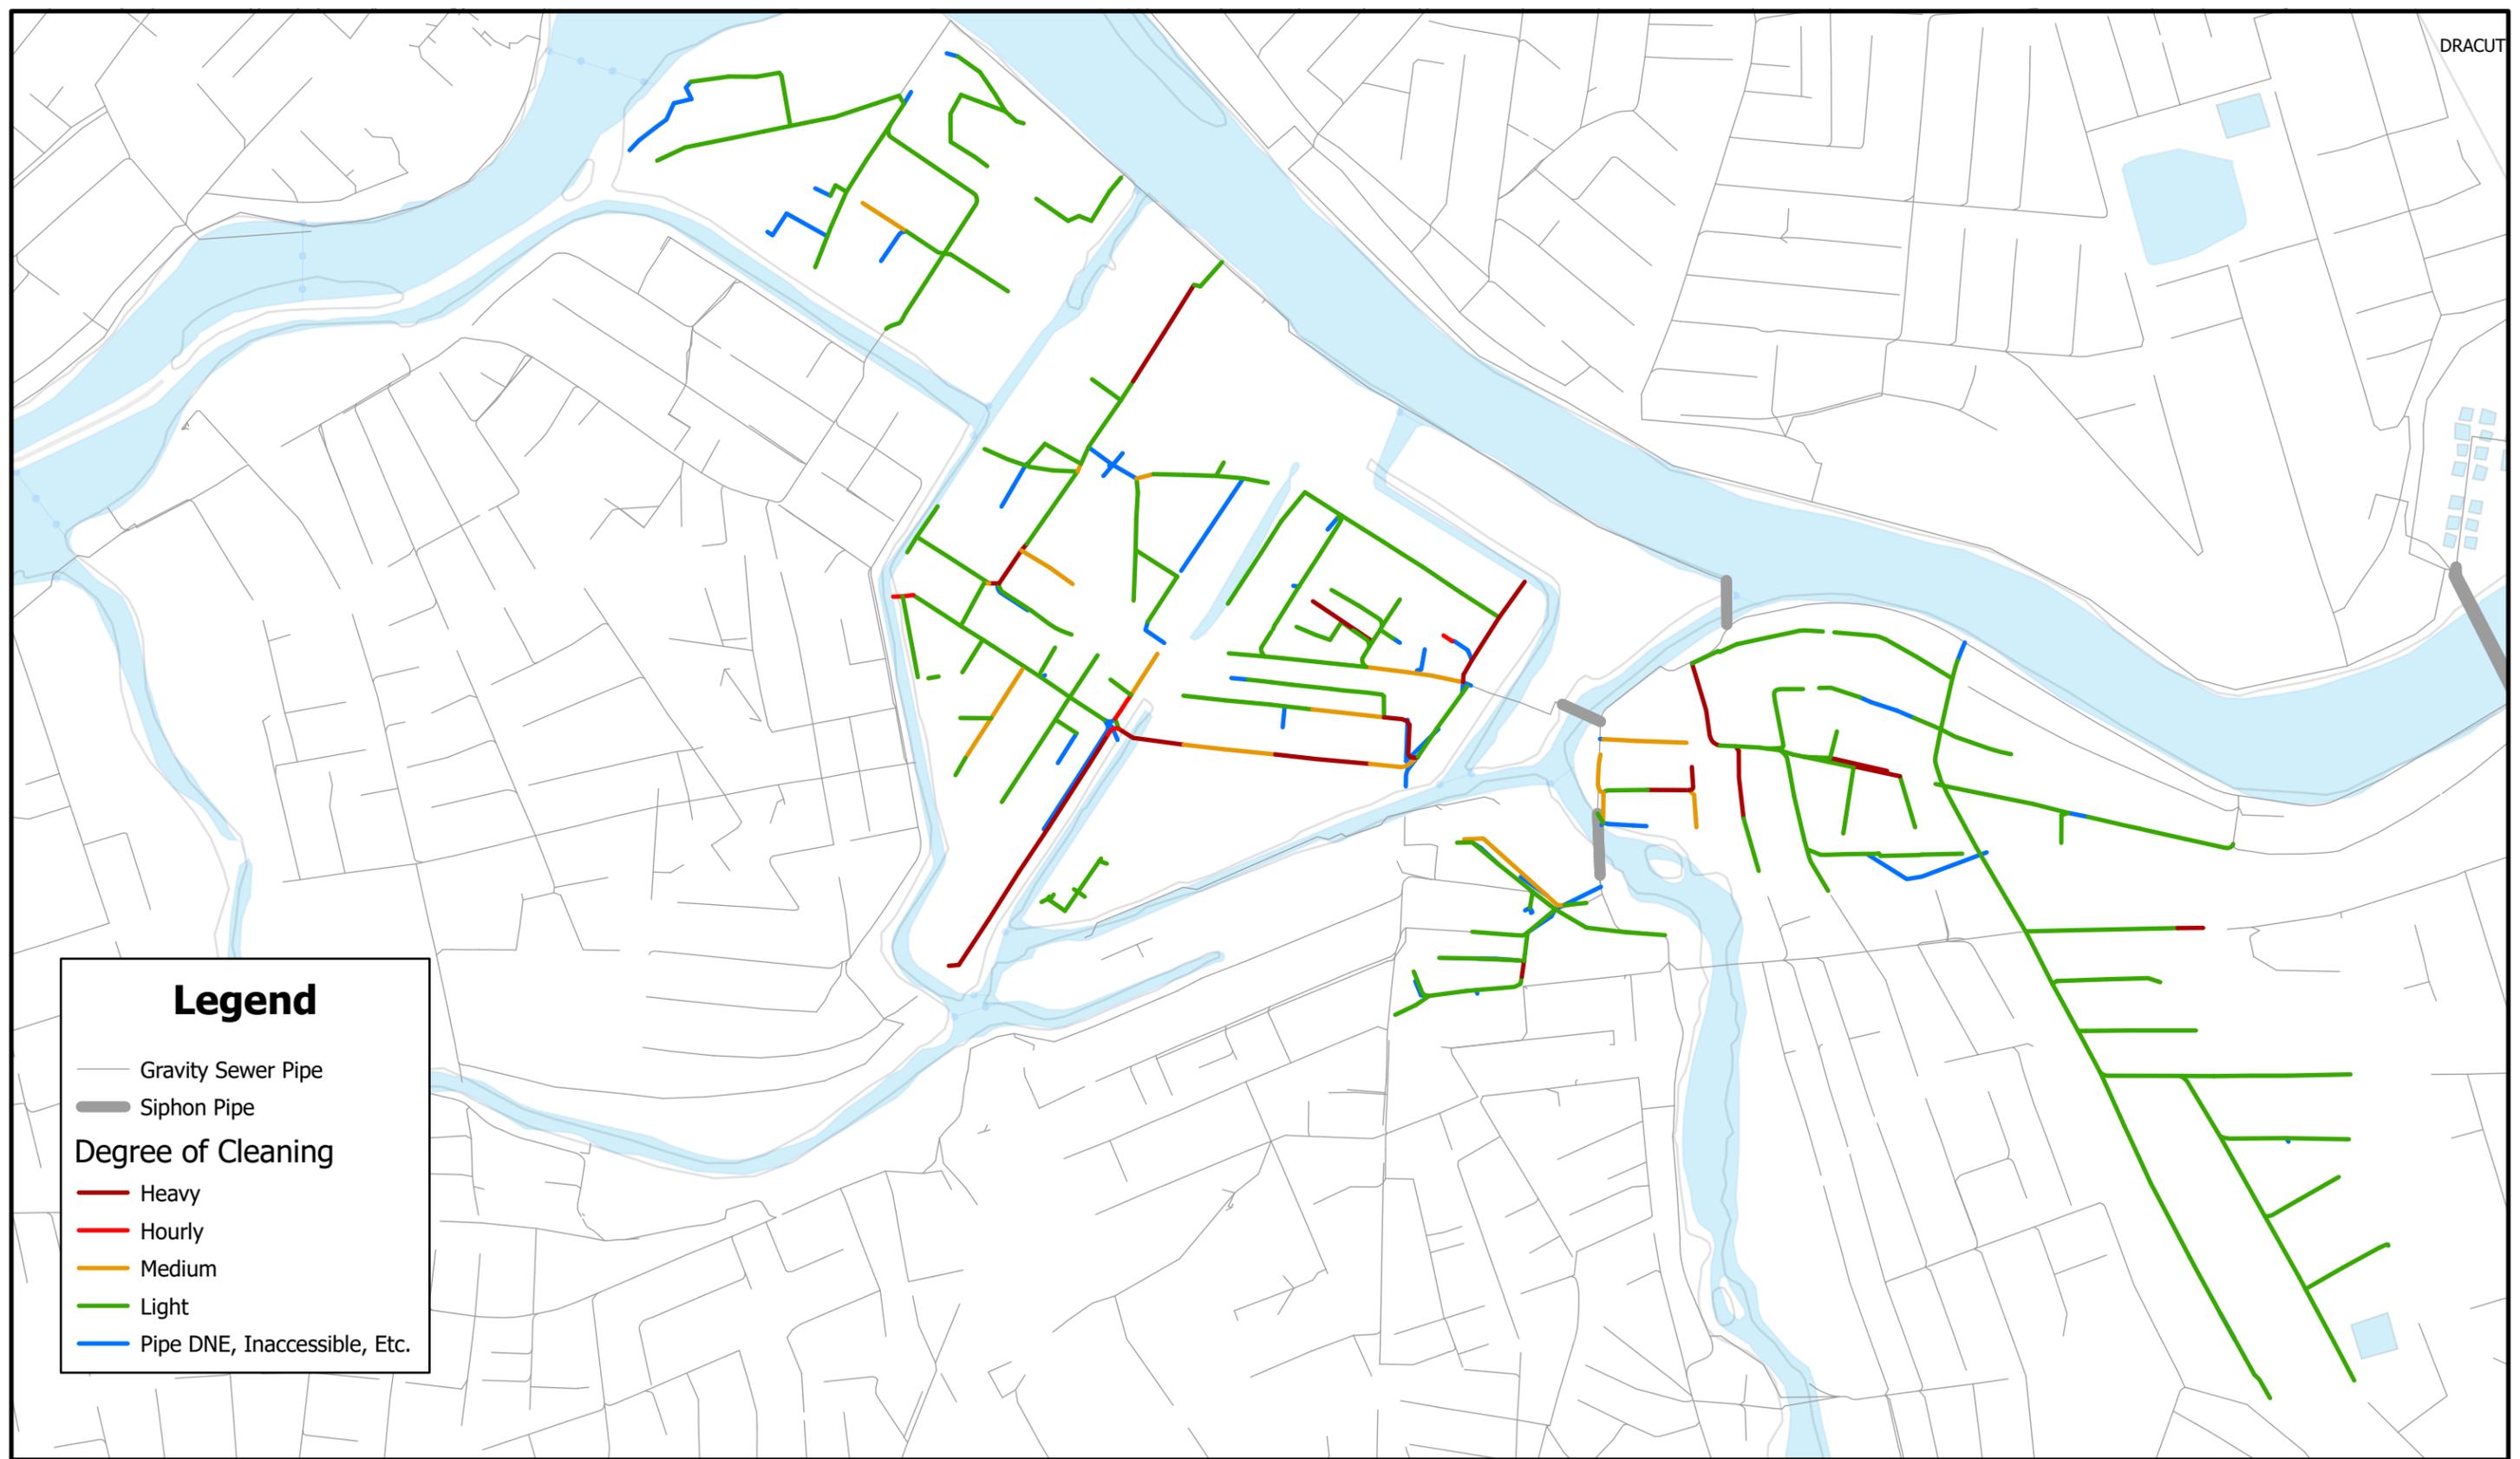
FIGURE
11

Figure 11 depicts the level of cleaning of the Downtown area from both the 2023 and 2024 field programs. Areas noted with medium to heavy cleaning may be used as indicators to prioritize cleaning of these individual pipelines in the Utility’s on-call collection system cleaning and CCTV program.

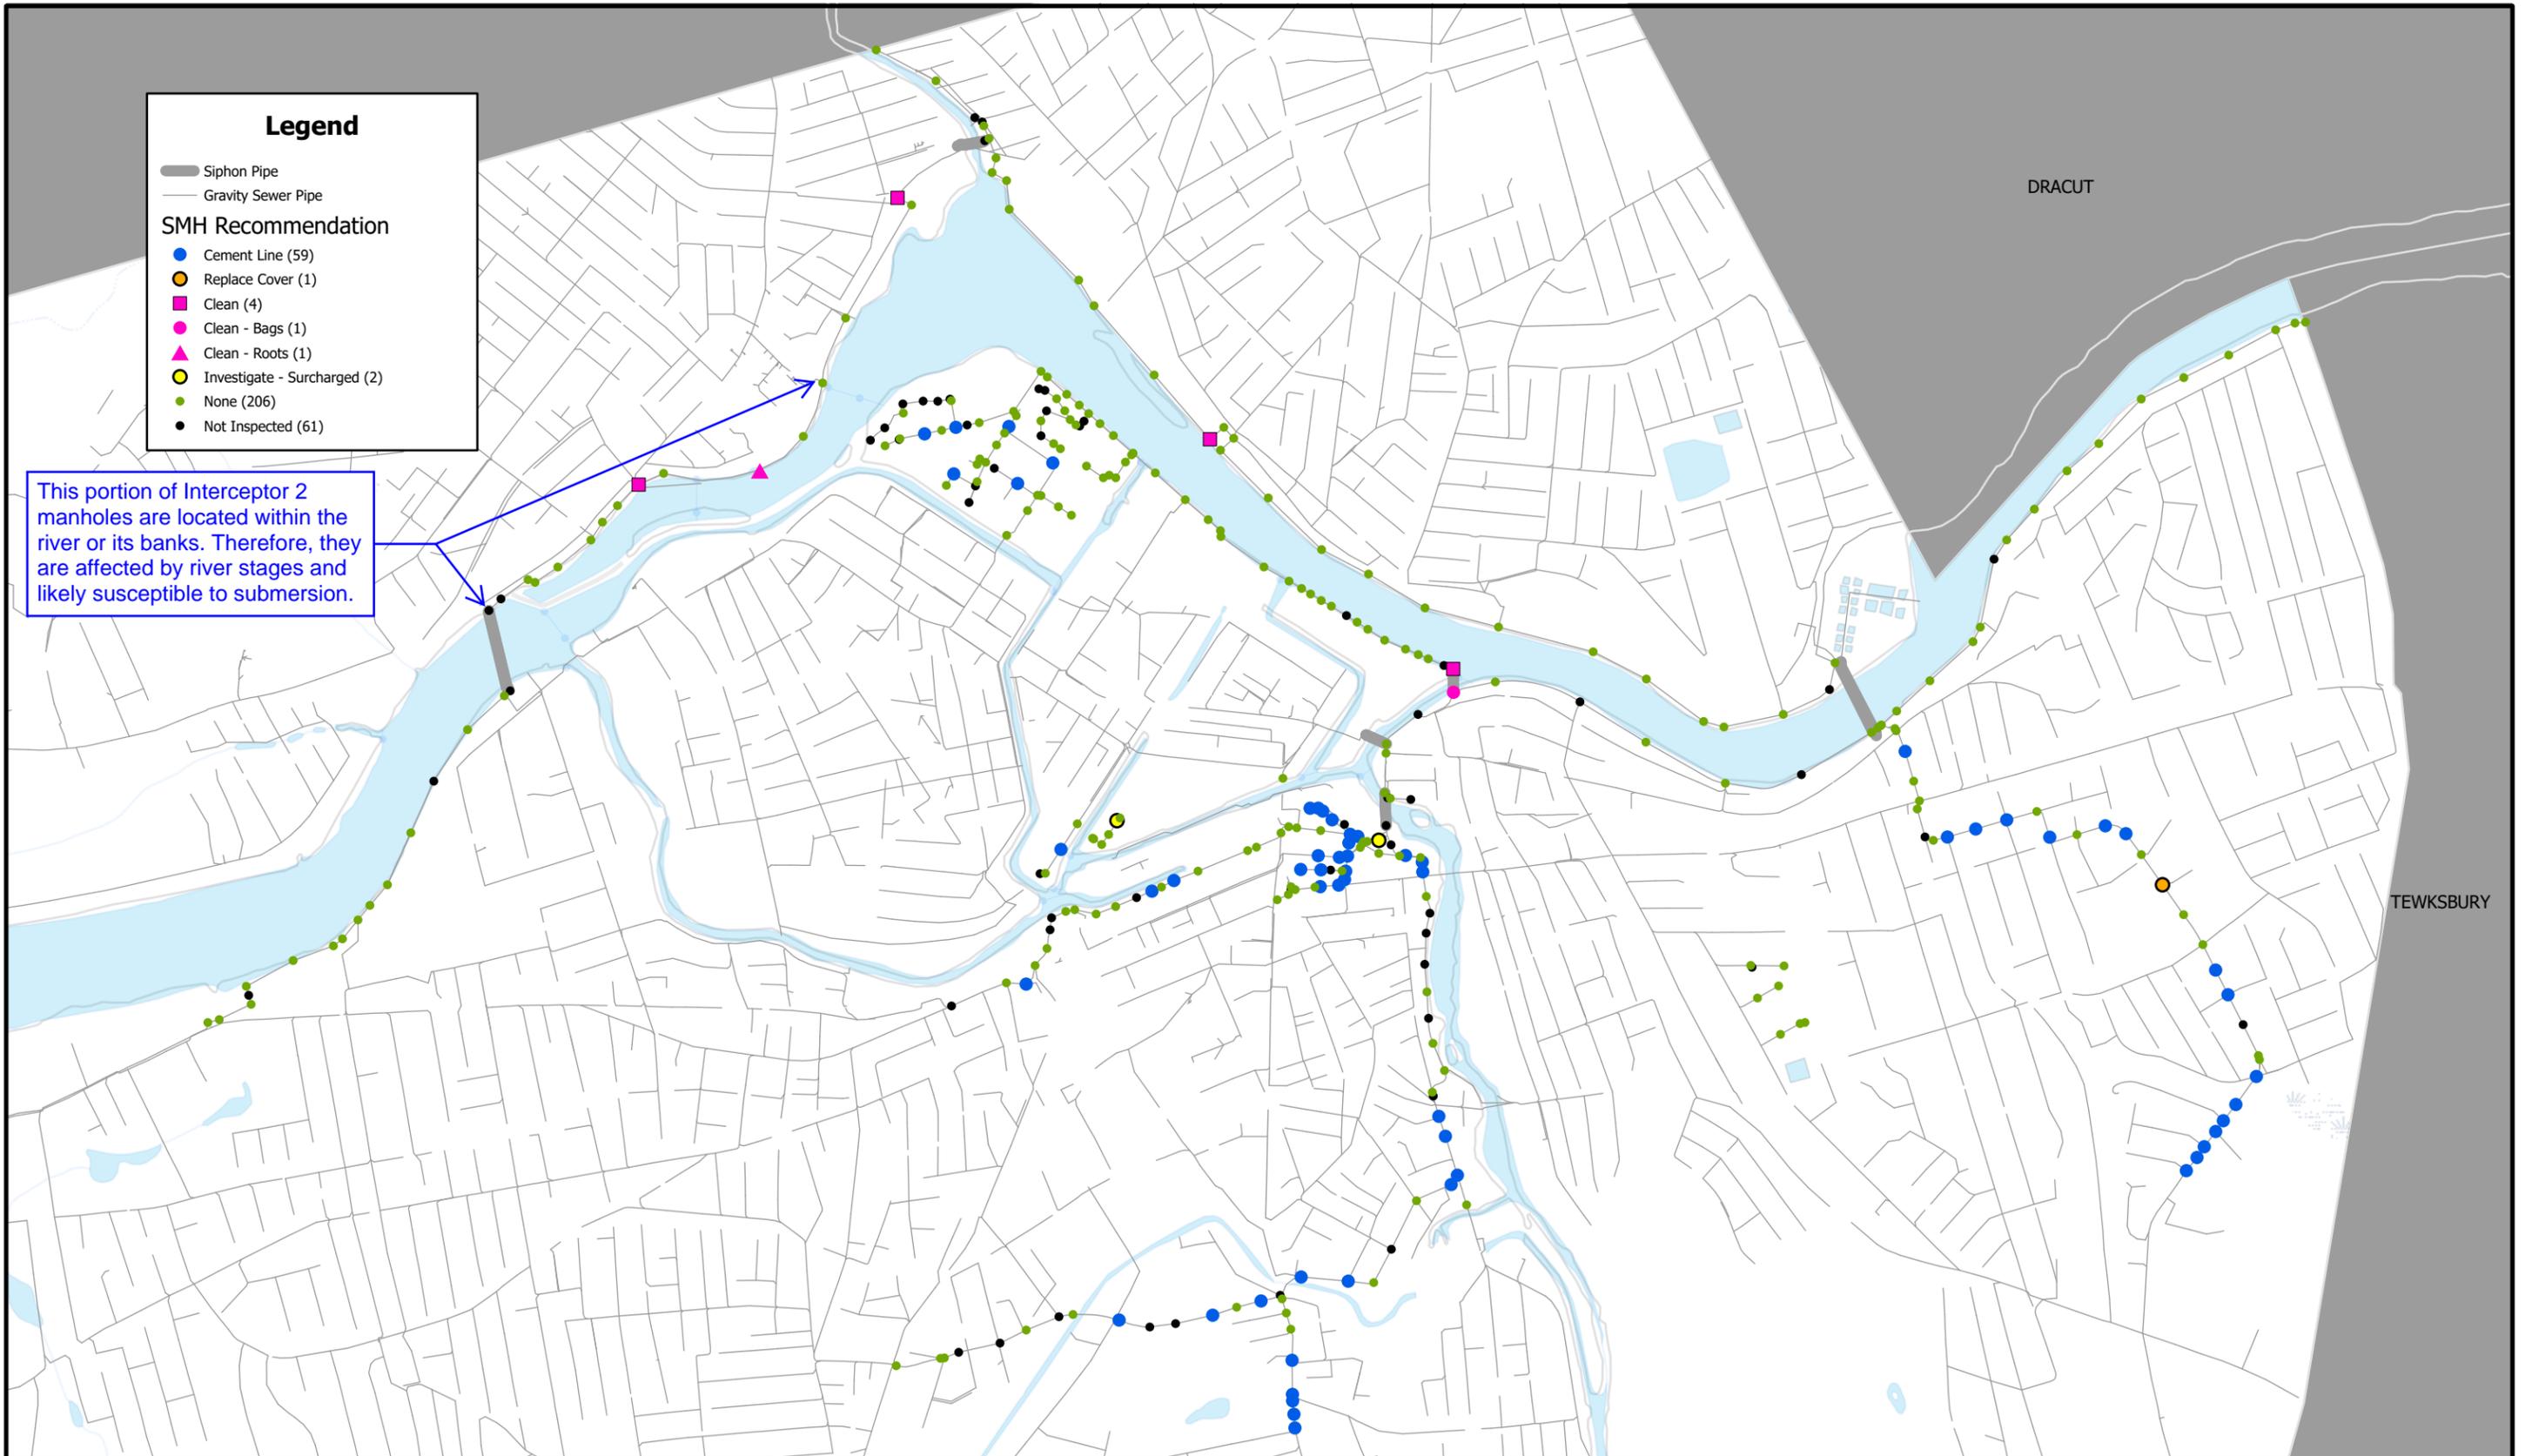
This portion of Interceptor 2 manholes are located within the river or its banks. Therefore, they are affected by river stages and likely susceptible to submersion.

- Cement Line (59)
- Replace Cover (1)
- Clean (4)
- Clean - Bags (1)
- ▲ Clean - Roots (1)
- Investigate - Surcharged (2)
- None (206)
- Not Inspected (61)
